Building Renovation & Department Relocation Master Plan

BROWN SCHOOL - FINAL REPORT VOL. II APPENDICES

MARCH 25, 2022

**HAZARDOUS BUILDING MATERIALS SURVEY REPORT
BROWN SCHOOL BUILDING
201 WILLOW AVENUE, SOMERVILLE, MA**

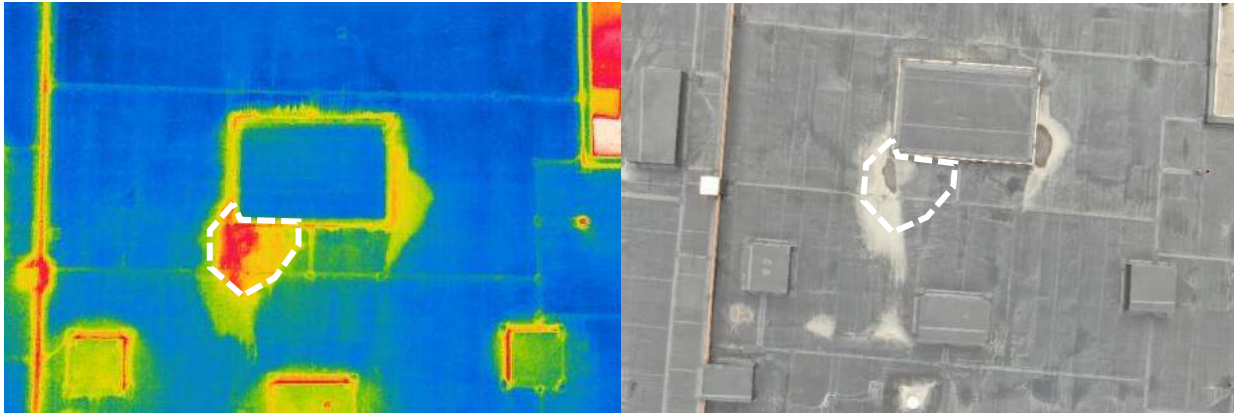
Figure 6. IR image (left) and visual light reference image (right) of thermal anomaly at corner of roof curb (dashed white area).

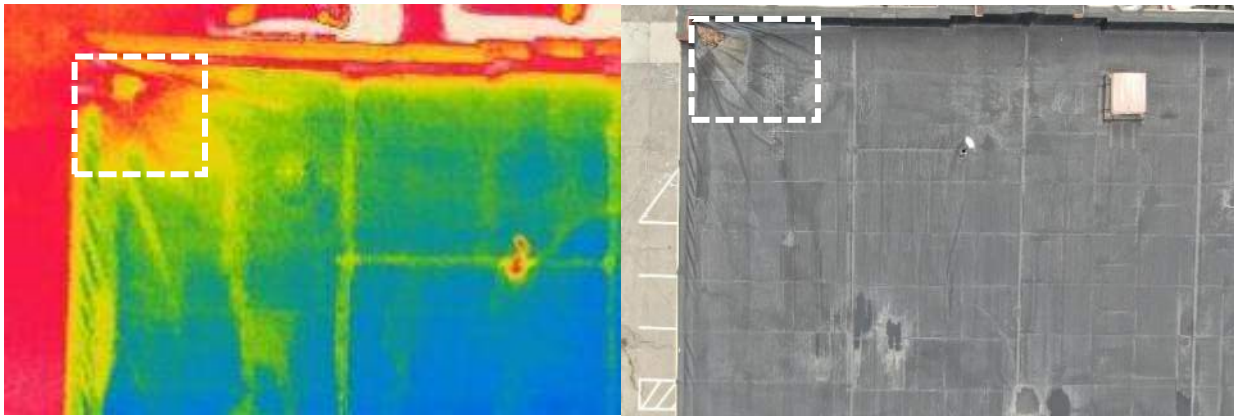
Figure 7. IR image (left) and visual light reference image (right) of thermal anomaly at corner of roof (dashed white area).

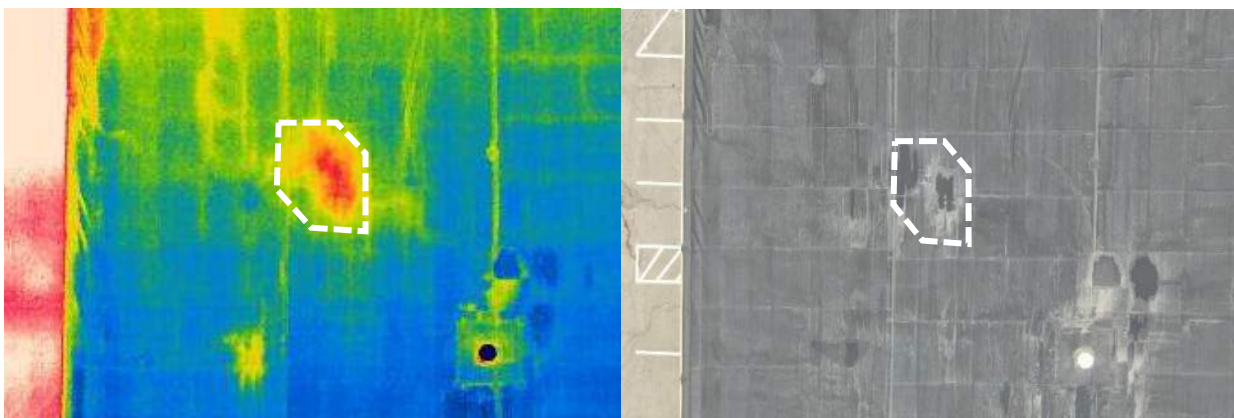
Figure 8. IR image (left) and visual light reference image (right) of thermal anomaly at field of roof (dashed white area).

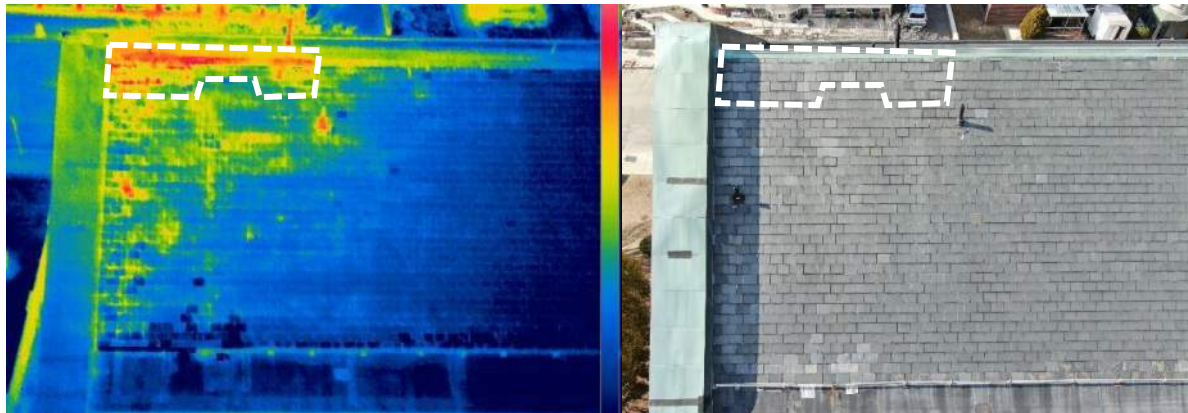
Figure 10. IR image (left) and visual light reference image (right) of thermal anomaly at ridge of slate roof (dashed white area).

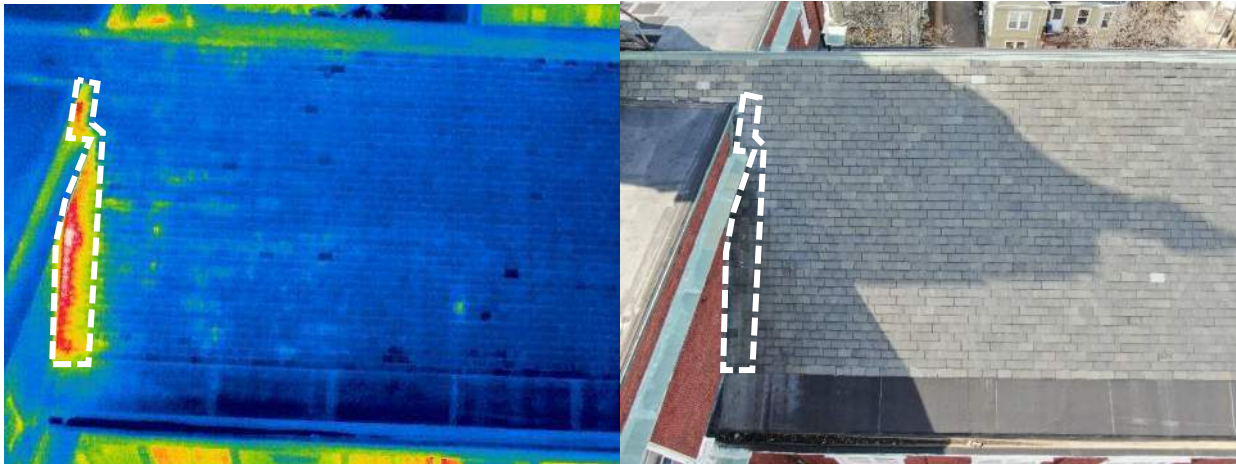
Figure 11. IR image (left) and visual light reference image (right) of thermal anomaly near intersection of slate and brick wall (dashed white area).

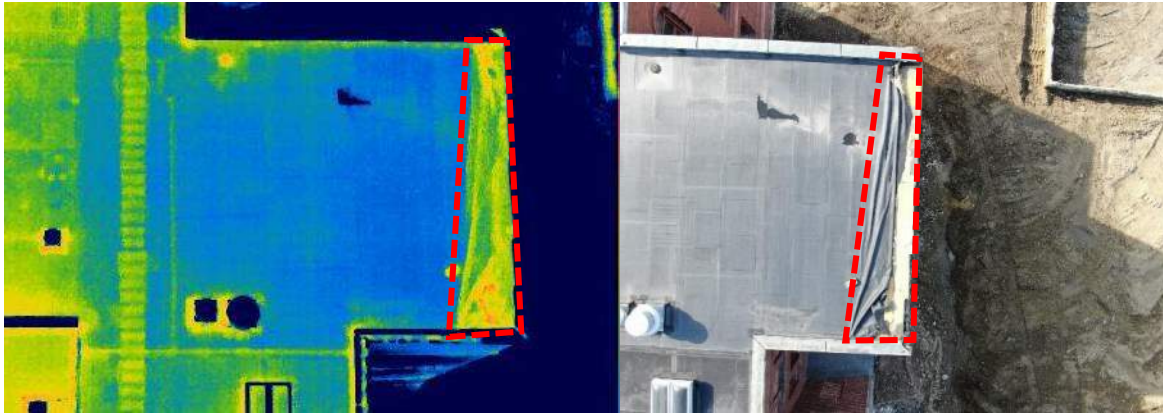
Figure 13. IR image (left) and visual light reference image (right) of thermal anomaly at northwest roof edge where the roofing membrane is loose and peeled back (dashed red areas).

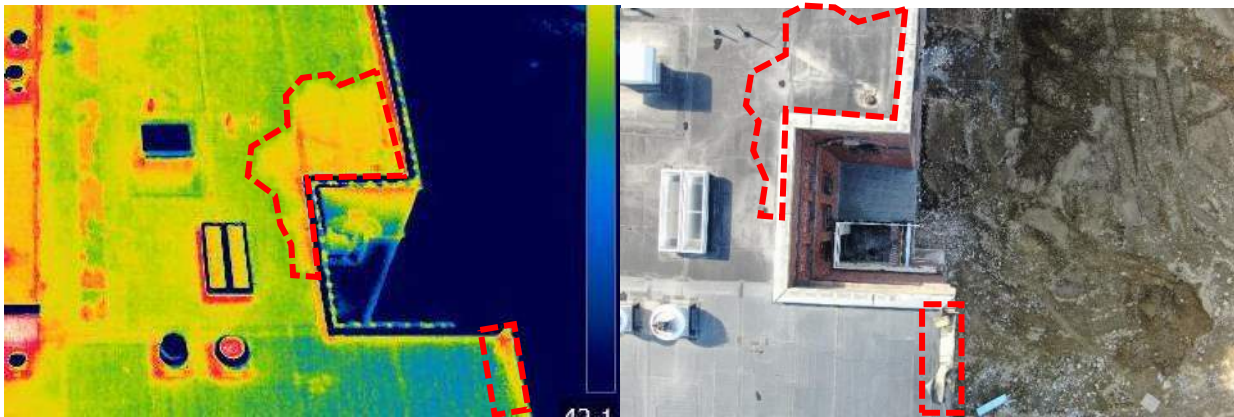
Figure 14. IR image (left) and visual light reference image (right) of thermal anomalies near drain and northeast roof edge where the roofing membrane is loose and peeled back (dashed red areas).

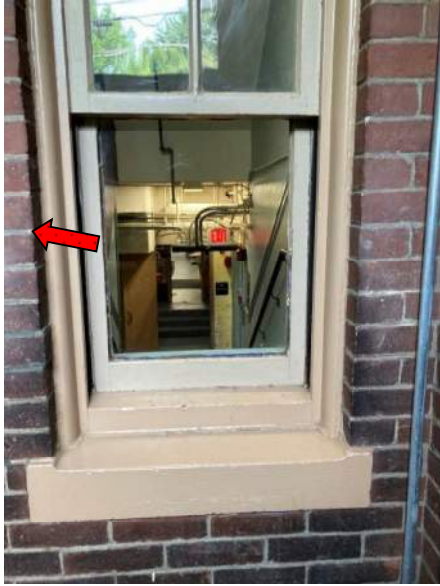
Photo 1

View of Asbestos-Containing Exterior Window Caulking

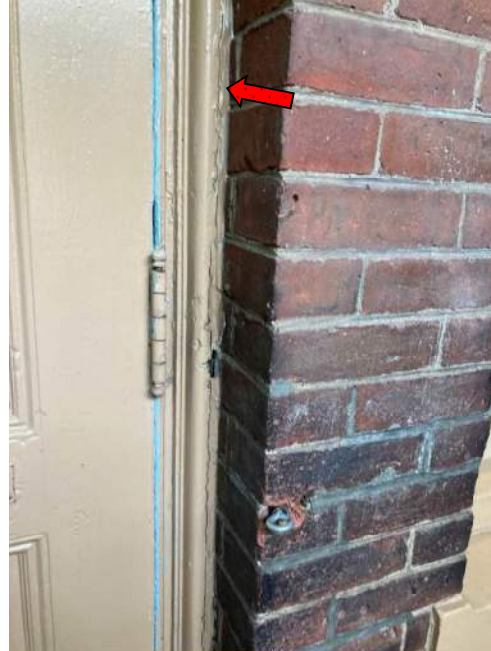
Photo 2

View of Asbestos-Containing Exterior Door Caulking

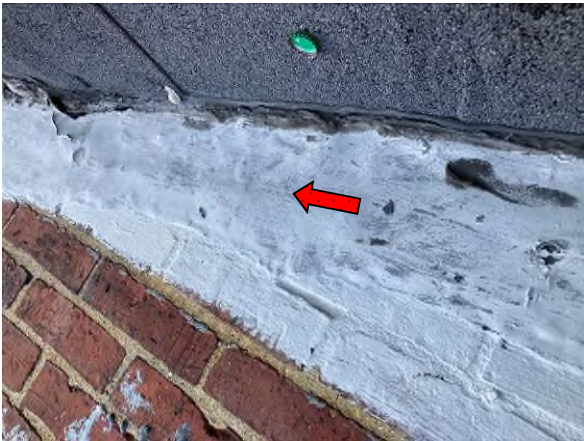
Photo 3

View of Asbestos-Containing Roof Cement Overhang Roof

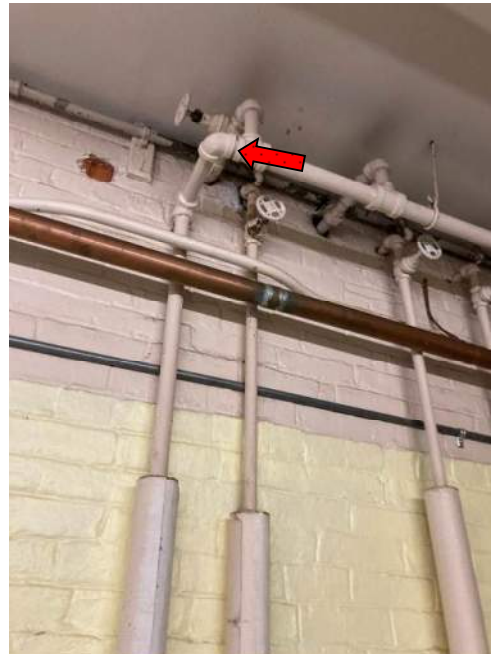
Photo 4

View of Asbestos-Containing Sprinkler Pipe Dope

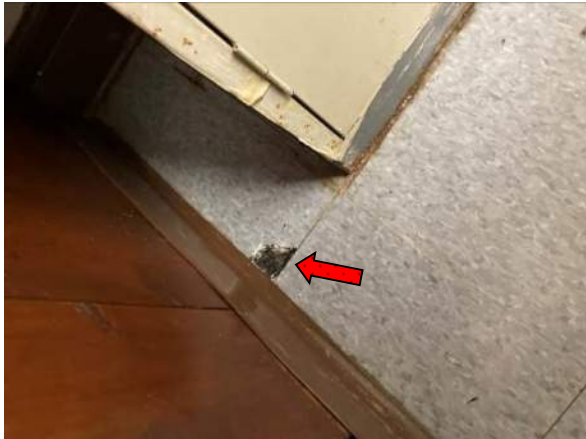
Photo 5

View of Asbestos-Containing 12" x 12" Blue Floor Tile Teachers lounge

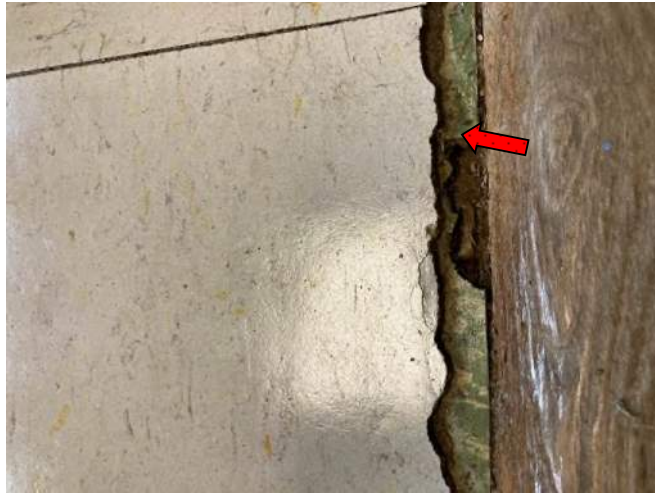
Photo 6

View of Asbestos-Containing 9" x 9" Green/Tan Floor Tile Bottom Layer

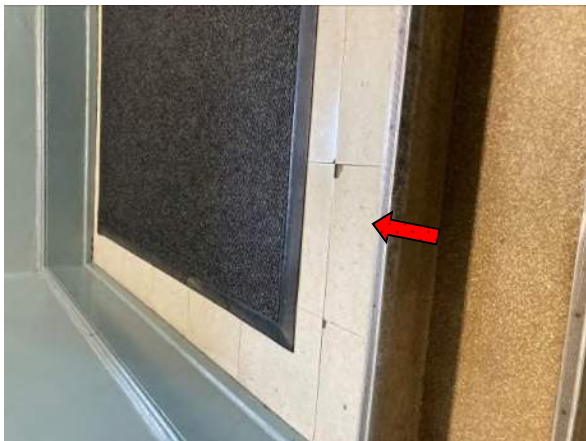
Photo 7

View of Asbestos-Containing 12" x 12" Beige Vinyl Floor Tile Stairwell

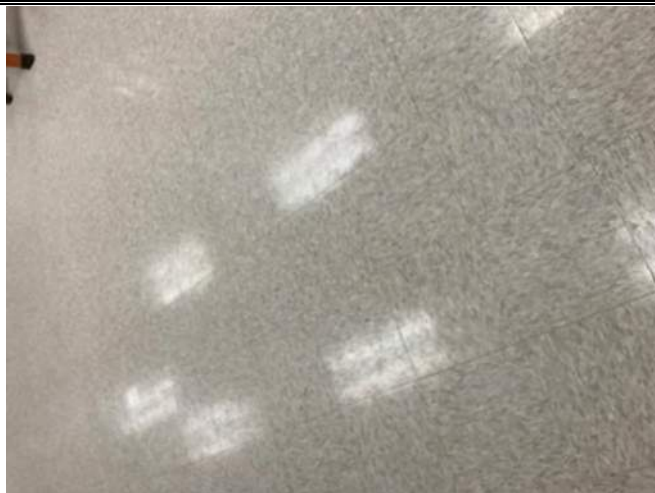
Photo 8

View of Asbestos-Containing 12" x 12" Beige w/Gray Streaks Floor Tile

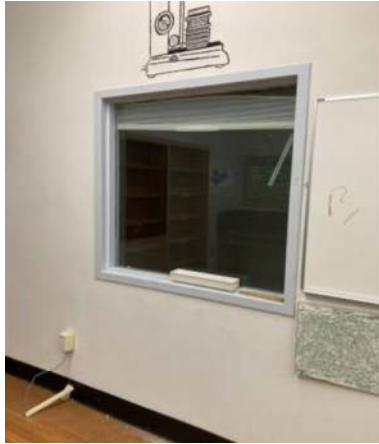
Photo 9

View of Asbestos-Containing Safety Glass

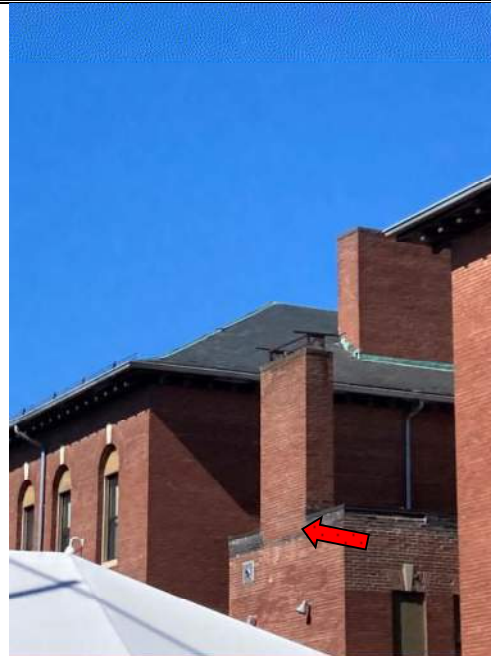
Photo 10

View of Asbestos-Containing Roof Cement
