# City of Somerville

Community Services and Activities Master Plan

FINAL REPORT VOLUME II - ADDITIONAL APPENDICES

NOVEMBER 24, 2021

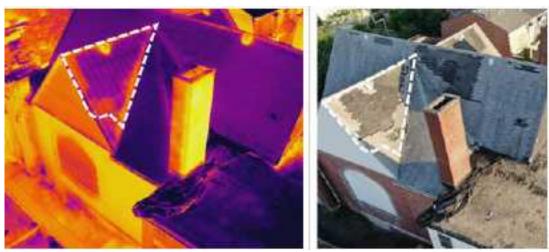
Figure 7. IR image (left) and visual light reference image (right) of thermal anomaly at field of roof (dashed white area). Note similar thermal anomalies are present at adjacent areas of missing shingles.

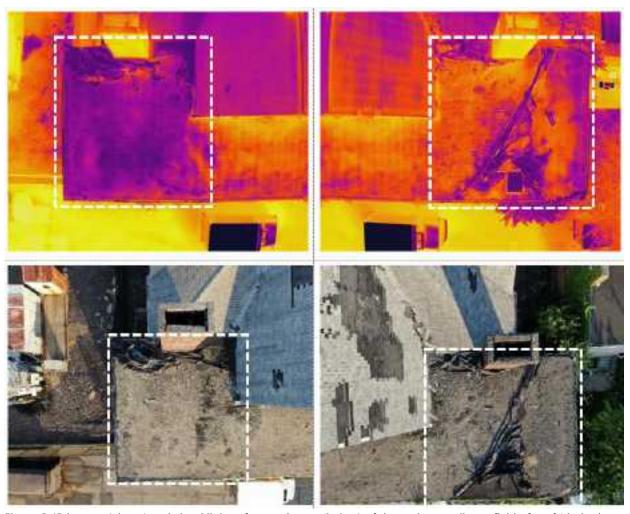
Figure 8. IR images (above) and visual light reference image (below) of thermal anomalies at field of roof (dashed white area)

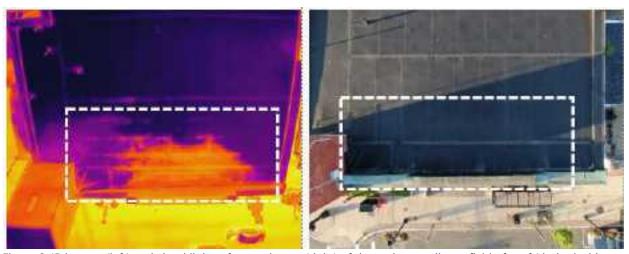
Figure 9. IR images (left) and visual light reference image (right) of thermal anomalies at field of roof (dashed white area)
