FY21 FUNDING CYCLE APPLICATION COVER PAGE

1. PROJECT INFOR	MATION	Ĺ			
PROJECT NAME:	Exteri	or Wood Ti	rim Repai	(5	
PROJECT LOCATION:	277	Broadway			
LEGAL PROPERTY OV	WNER OF	RECORD: The	2 Elizabe	eth Peaboo	y Hause Association
					to repair exterior wood trim (as
				J	exposure to the elements
Please indicate (X)			,		
	Open Space	Recreational Land	Historic Resources	Community Housing (blended projects only)	ESTIMATED START DATE: April 2021
Acquisition	40000000000	DESCRIPTION OF THE PARTY OF THE		projects ormy	
Creation					ESTIMATED COMPLETION DATE: May 2021
Preservation			X		104.00
Support					CPA FUNDING REQUEST: \$95,600
Rehabilitation/ Restoration			ıī		TOTAL BUDGET FOR PROJECT: \$95,000

Elizabeth Peabody House FY21 Grant Application

City of Somerville, Massachusetts Community Preservation Committee

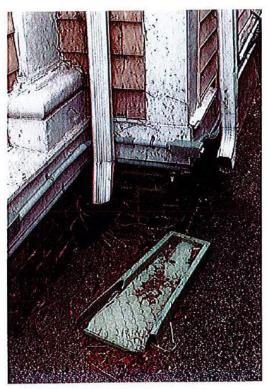
Some rain leaders do not reach grade. Of those that do, some downspouts are directed into storm drainage piping, and some are directed onto splash blocks pitching onto grade. Roof water run-off control should be improved to protect the walls and foundations, and also to eliminate ice build-up on the winter.

2 Downspouts at the southwest corner

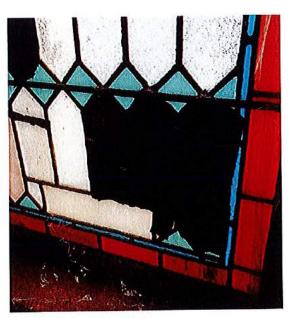
The stained glass windows are an important "character defining" historic element of the building. Unfortunately, stained glass windows are delicate and subject to stress from excessive heat or cold as well as age. Although much of the stained glass windows are intact, deterioration is occurring quickly. Most of the windows have an exterior panel which is failing. Consequently, many have lost lights and leading. A temporary remediation with building sealant tape has been done on many of the windows. It is effective but ugly and cannot be a long-term solution.

4 Patched stained-glass detail

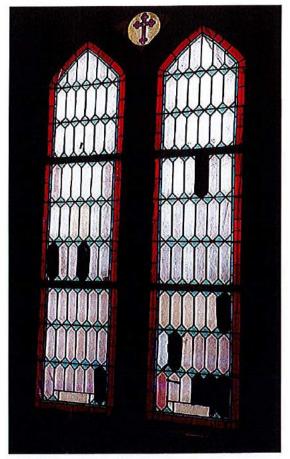
5 Patched stained-glass window

- Scrape, paint and replace as required the:
 - First floor window trim
 - Wooden spandrels between the first floor and upper level windows.
- Survey all other windows for thermal failure and create a schedule for restoration or replacement on a case-by-case basis.
- Repair the basement windows and screens.
- Create a capital reserve to restore and protect the stained-glass windows. Alternate proposals and prices should be solicited. Alternatively, this and other exterior restoration may qualify for CPA funding
