REPORT

IDDE Drainage Areas 7, 9 and 31
Investigations

May 3, 2018

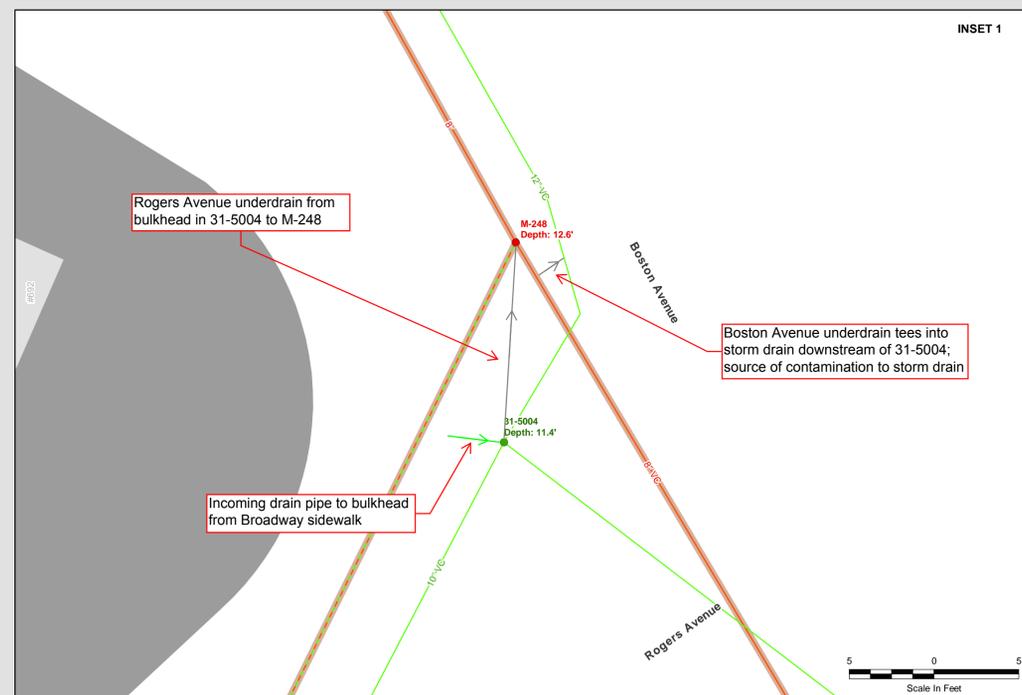
INSET 1

Rogers Avenue underdrain from bulkhead in 31-5004 to M-248

Boston Avenue underdrain tees into storm drain downstream of 31-5004; source of contamination to storm drain

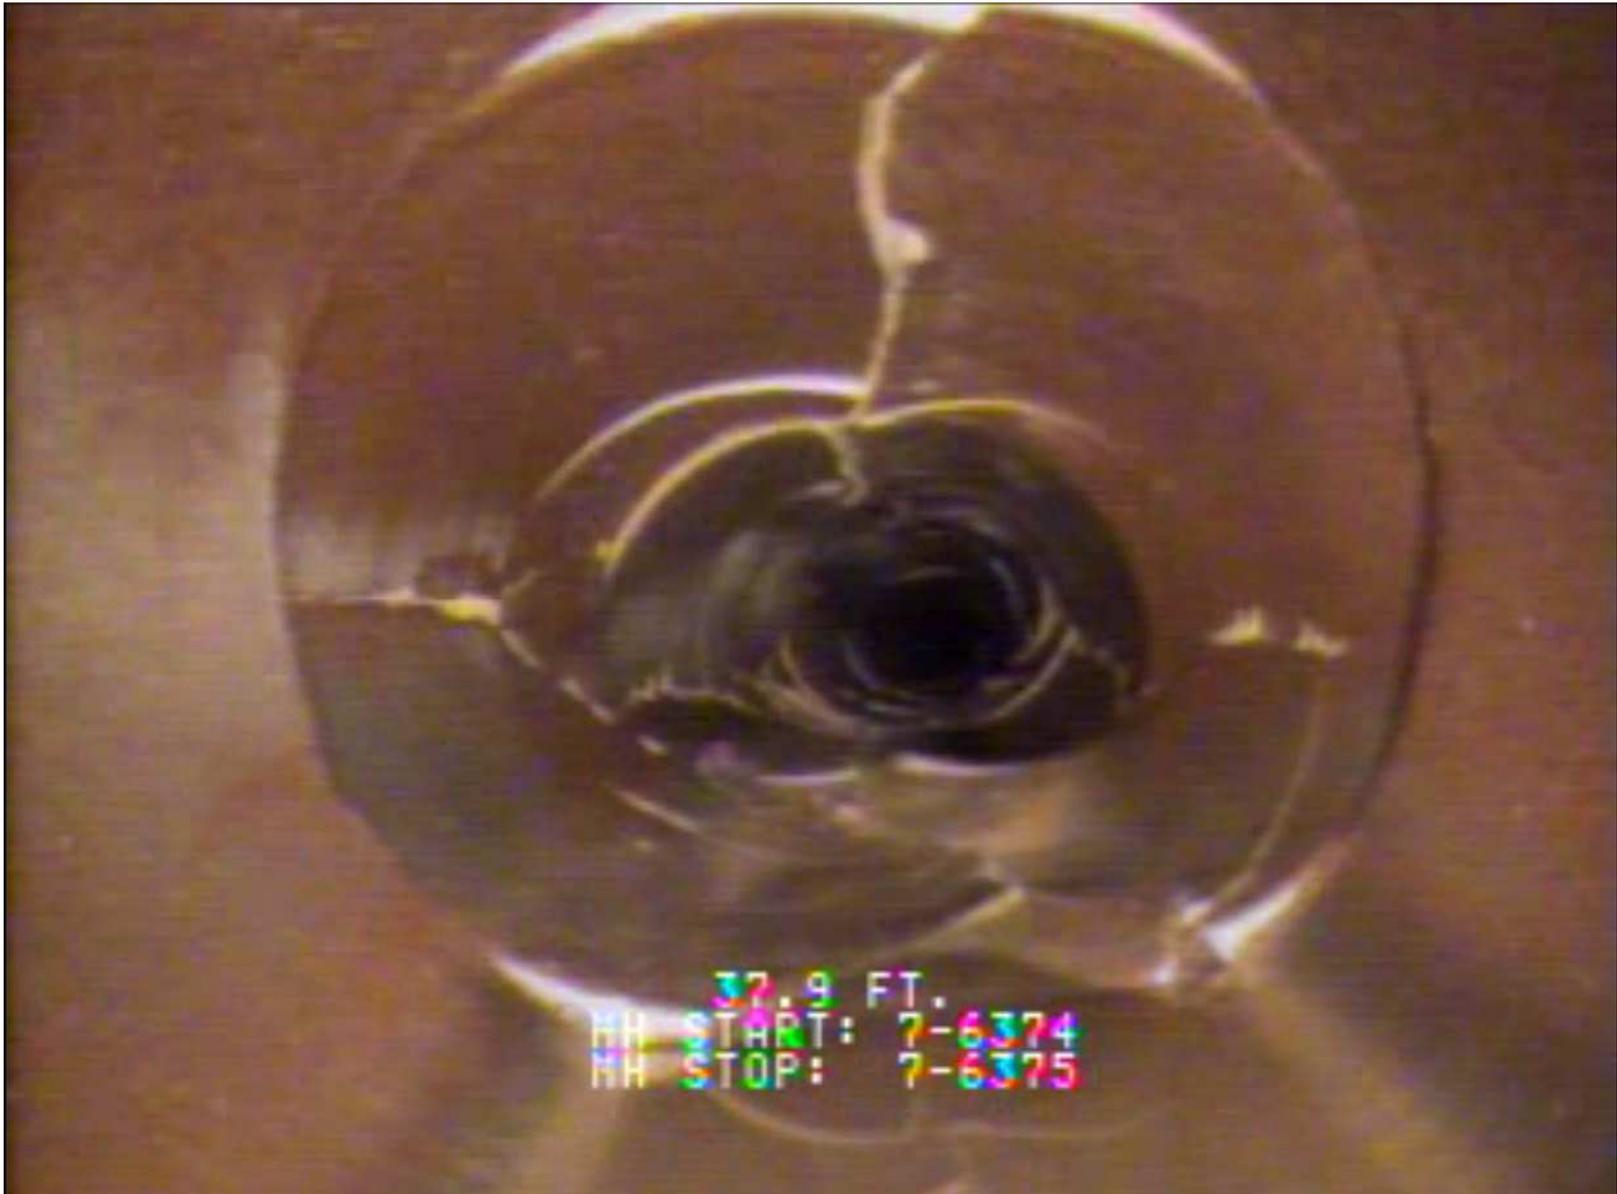
Television inspection identified two (2) locations in the storm drain with multiple fractures and a defective point repair, and one (1) location in the sewer with broken pipe. Defects at these locations are too severe to be rehabilitated with trenchless methods and are recommended to be repaired with open cut point repairs. These defects are indicated on the IDDE Investigations Map and are included in Table 2, Open Cut Point Repairs. Photographs of these defects are included in Appendix B, Photos 1-3.

Photo 1 – Multiple fractures in 7-6374 to 7-6375

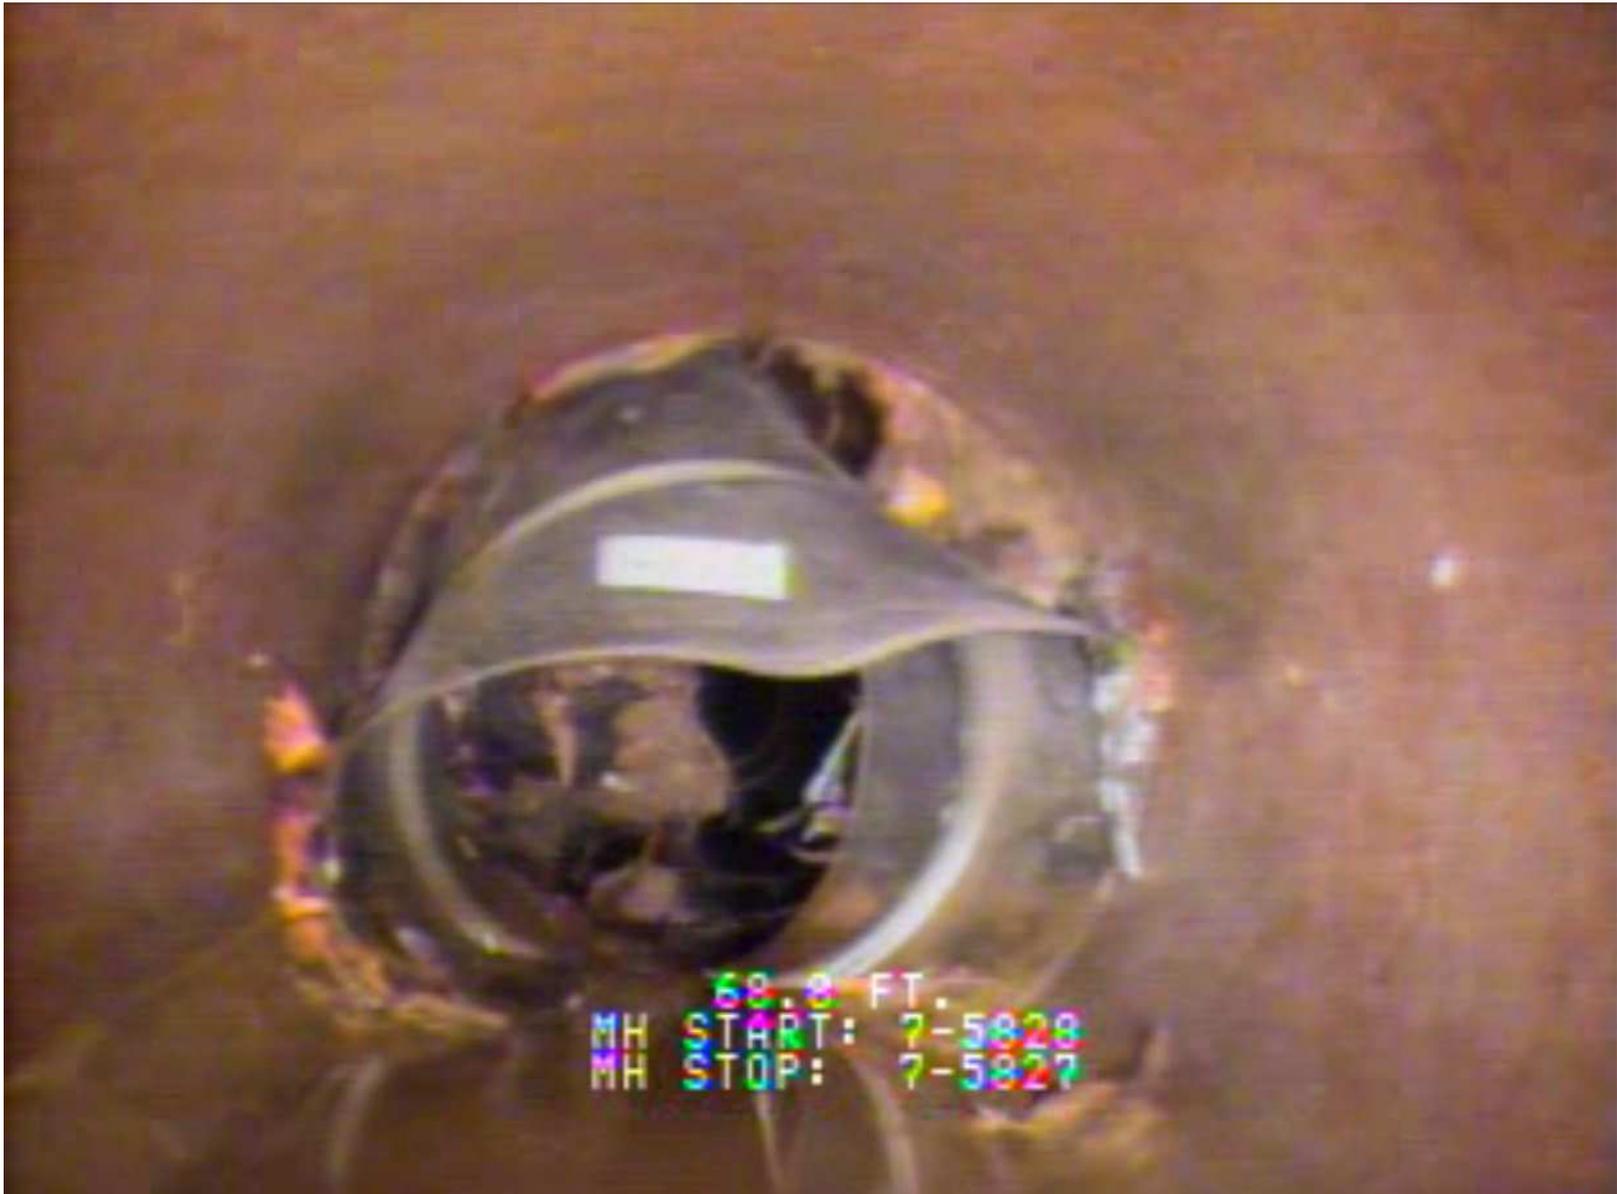
Photo 2, Defective point repair in 7-5828 to 7-5827

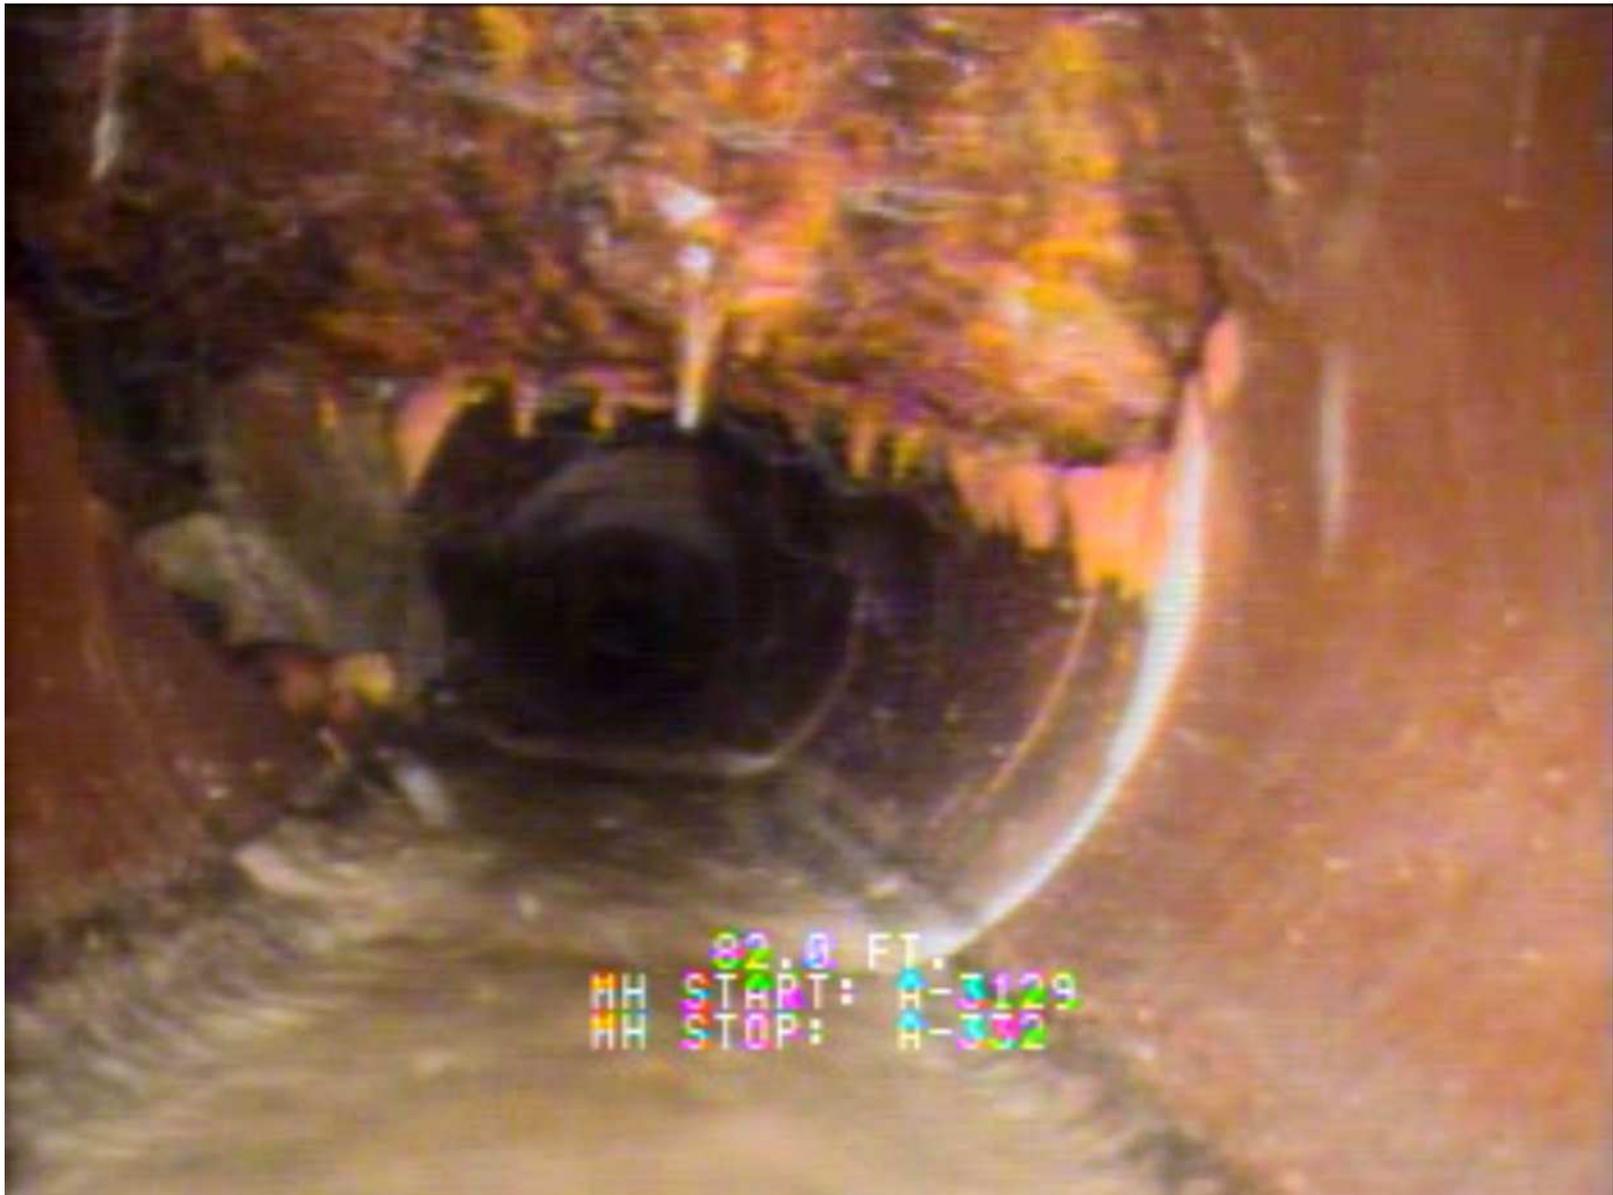
Photo 3 – Pipe through the crown of the sewer in A-3129 to A-332

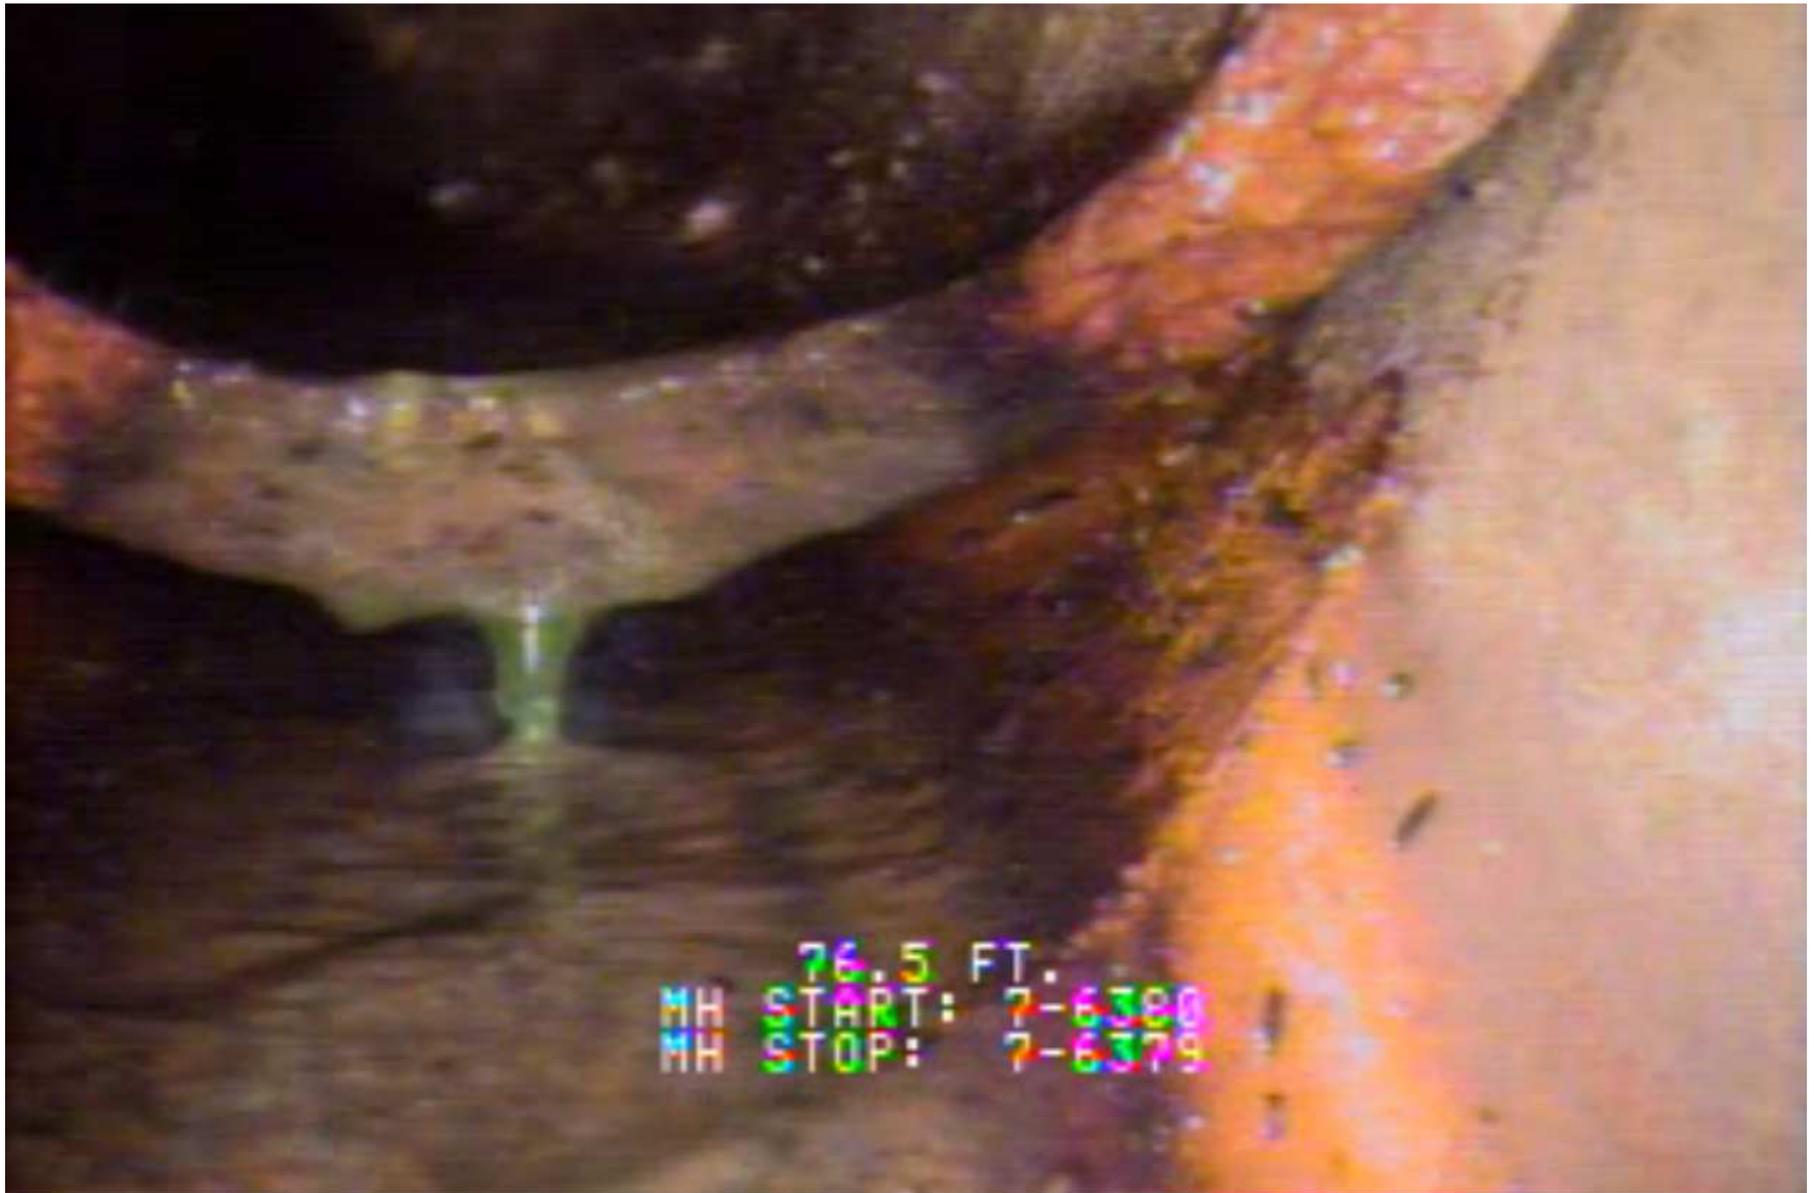
- **1305 Broadway (LA Market):** The suspect lateral connection in pipe segment 7-6379 to 7-6380 is coming from 1305 Broadway. Dyed water was poured down the bathroom sink and was observed entering the storm drain (Appendix B, Photo 4). However, a subsequent dye test was performed and dye was also observed in the sanitary sewer and underdrain cavern in sewer manhole A-336 (Appendix B, Photos 5-6). Based on the dye test results, the building either has both a sanitary sewer and storm drain building connection or sewage from the sewer connection is exfiltrating into the storm drain connection. Weston & Sampson recommends inspecting the building plumbing to determine whether this building has a direct or indirect connection to the storm drain system. Inspecting the building connection(s) from the mainline storm drain and/or sewer using a lateral launcher may also be required.

Photo 4 – Dye from LA Market in drain 7-6379 to 7-6380 at 76 linear feet upstream from 7-6380

- Perform a building inspection at 1305 Broadway (LA Market) of the internal plumbing. Inspect sewer and drain laterals with lateral launcher to confirm connectivity and source of dye in the drain.
- Inspect confirmed sources of dry weather flow in 7-6377 to 7-6378, 7-6383 to 7-5435, and 7-5191 to 7-5829 with a lateral launcher to determine sources of flow.
- Clean and inspect sanitary sewers on Broadway, from A-47 to A-3129, and all sewer-drain crossings tributary to this sewer to identify any structural defects that may allow sewer to exfiltrate into the storm drain.

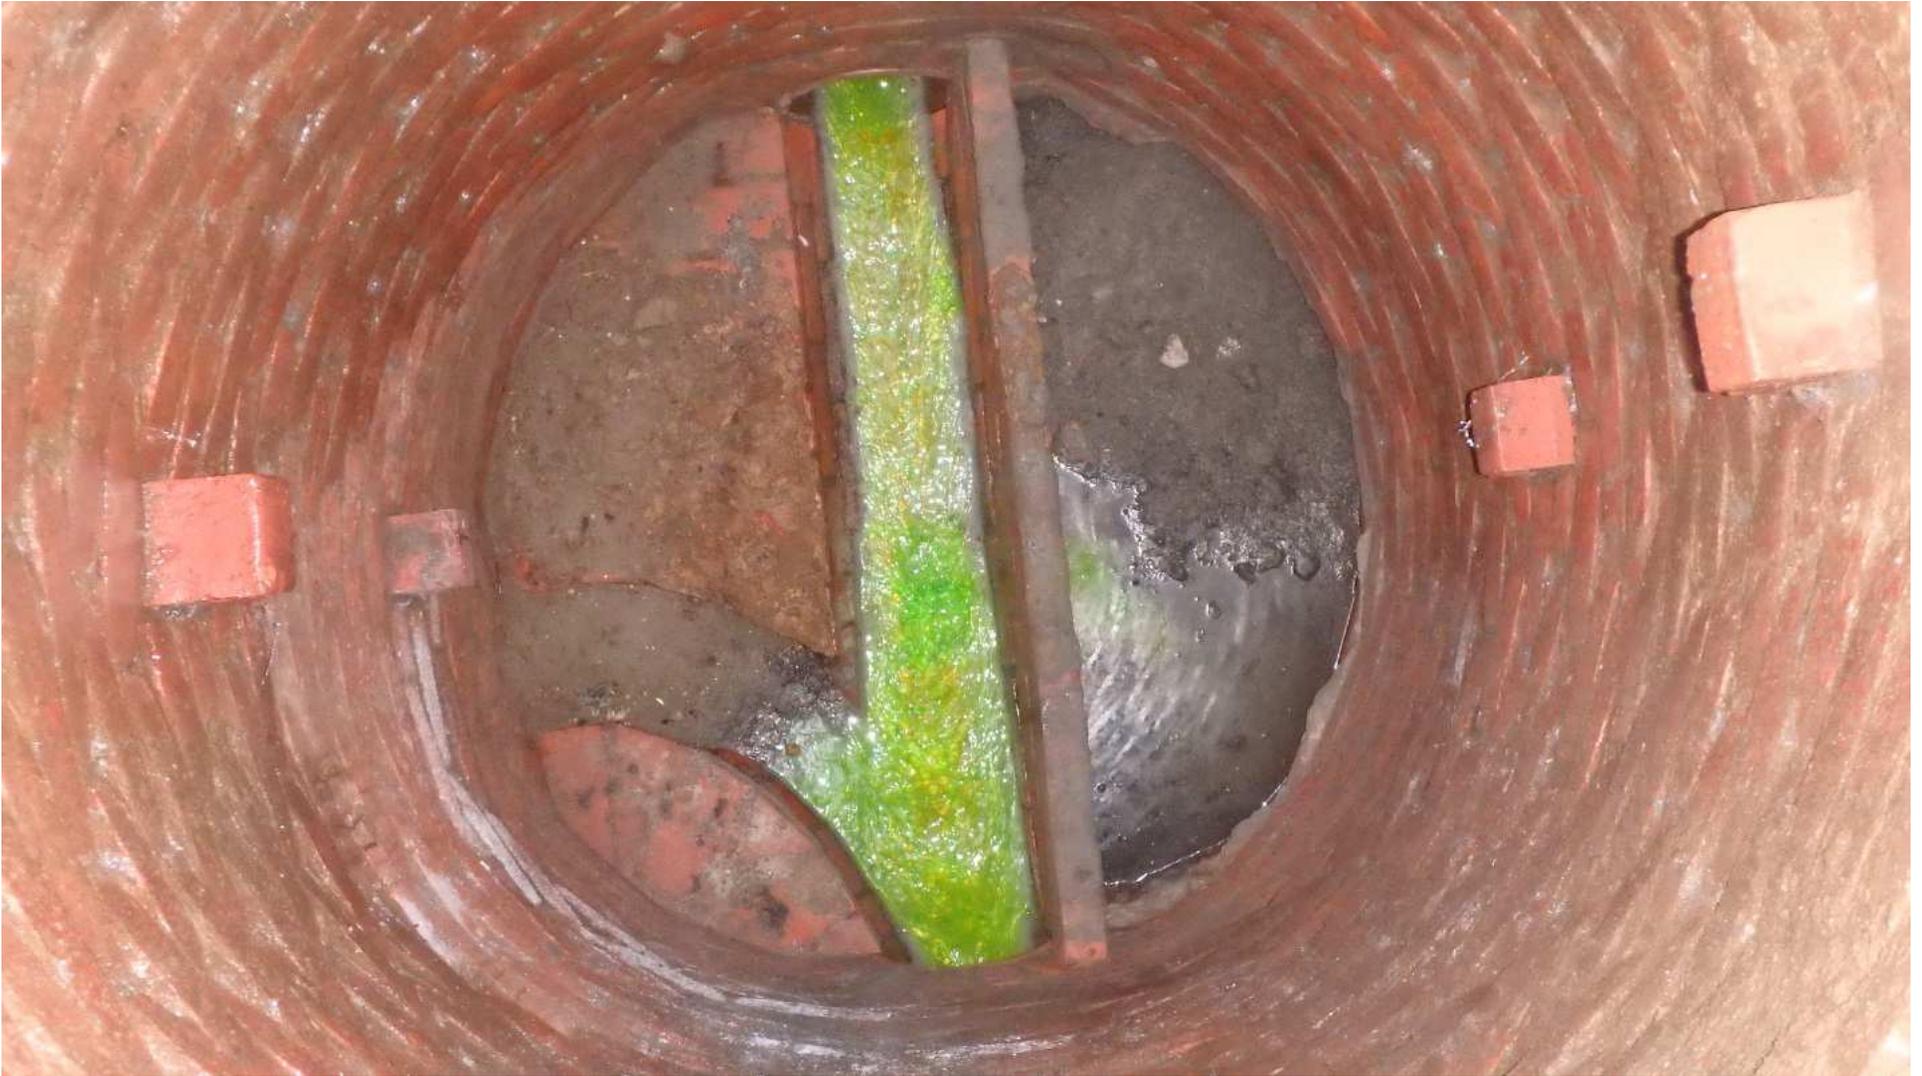
Photo 5 – Dye from LA Market in sewer manhole A-336 invert

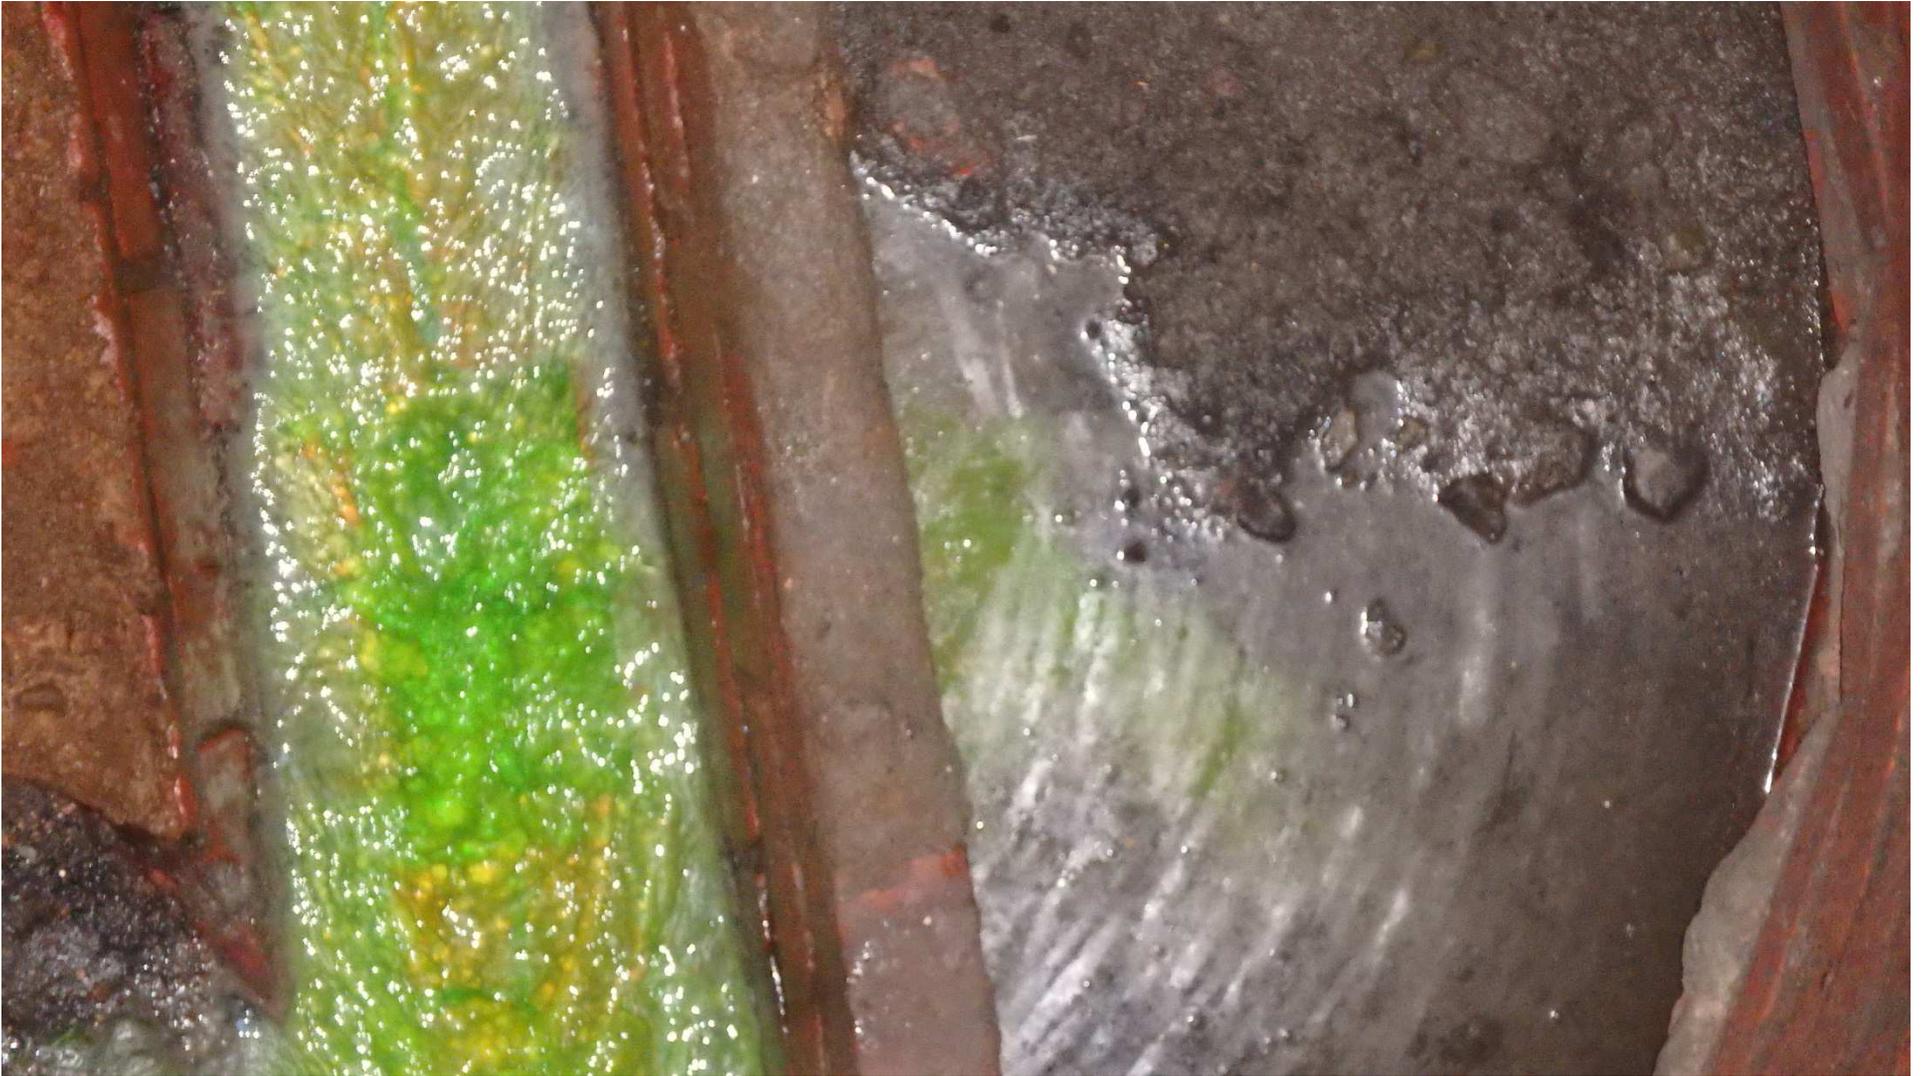
Photo 6 – Dye from LA Market in sewer manhole A-336 underdrain cavern

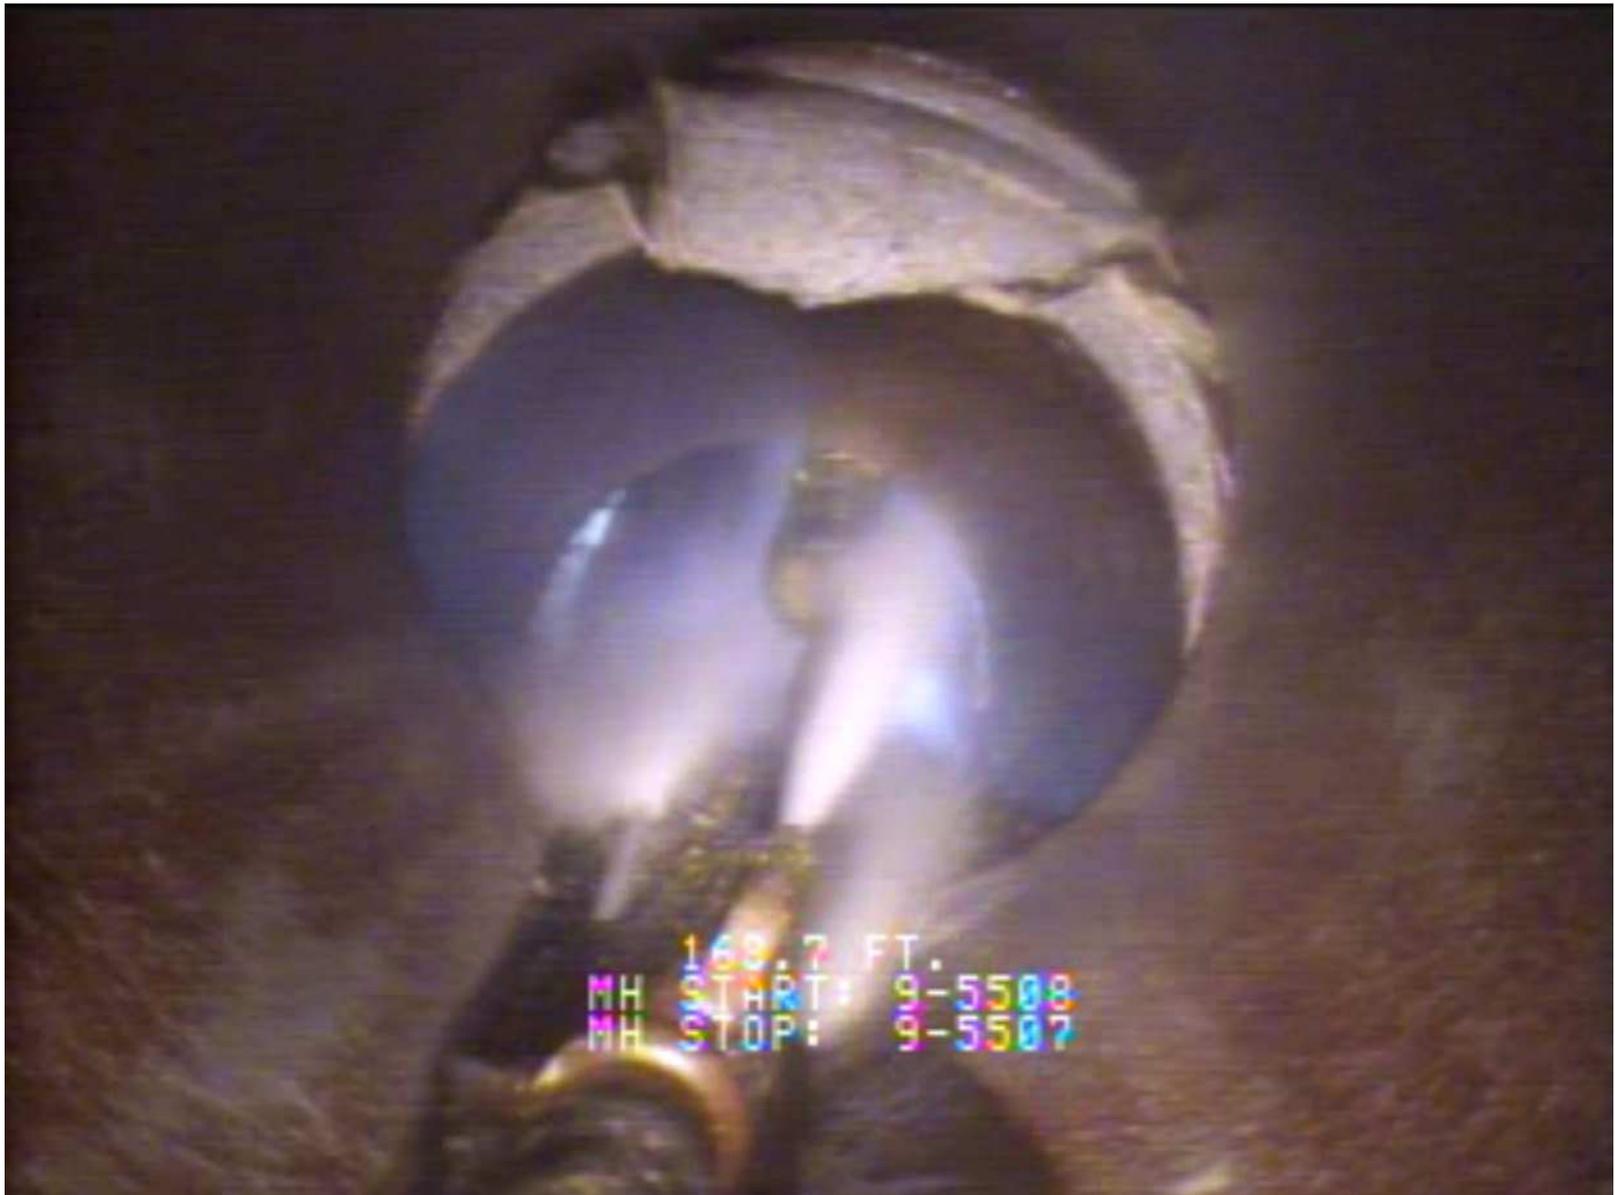
Television inspection identified two (2) storm drain locations and one (1) sanitary sewer location with multiple fractures, a severe offset joint, and collapsed pipe. Defects at these locations are too severe to be rehabilitated with trenchless methods and are recommended to be repaired with open cut point repairs. These defects are indicated on the IDDE Investigations Map and are included in Table 2, Open Cut Point Repairs. Photographs of these defects are included in Appendix B, Photos 7-9.

Photo 7, Multiple fracture in 9-5508 to 9-5507

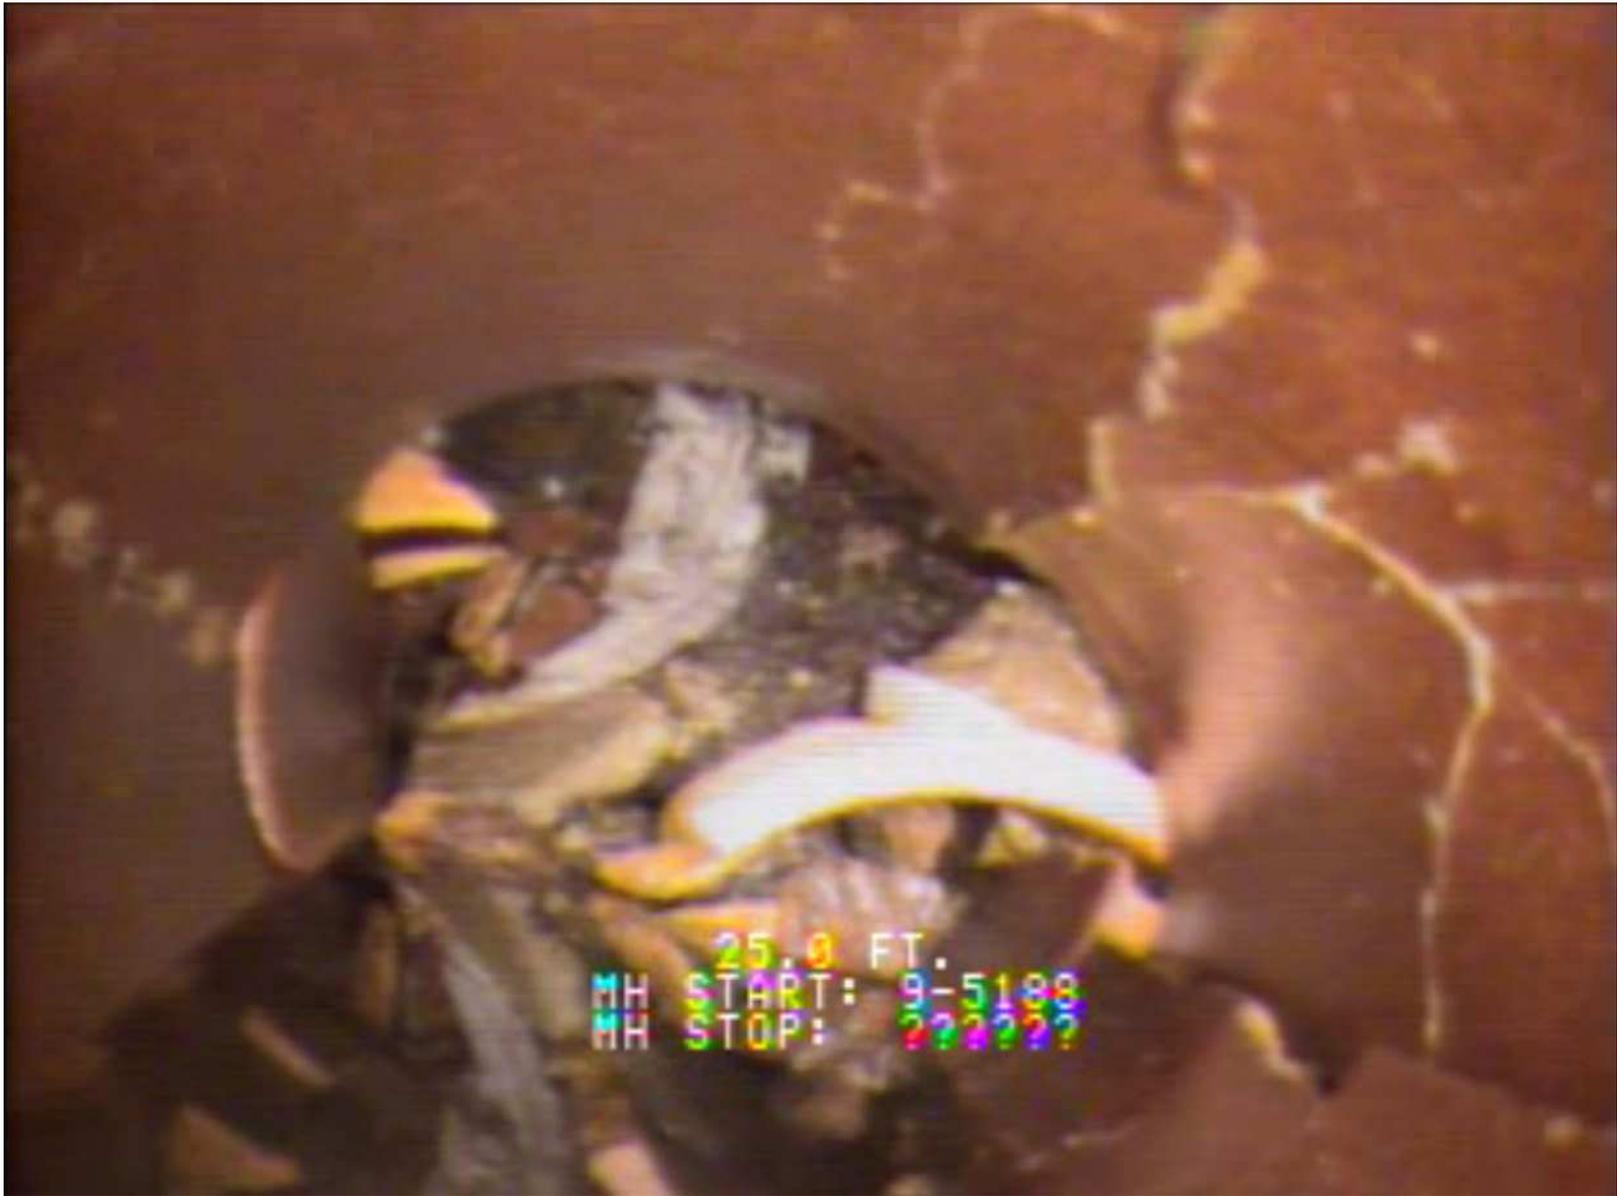
Photo 8, Collapsed pipe in 9-5188 to catch basin at 61 North Street

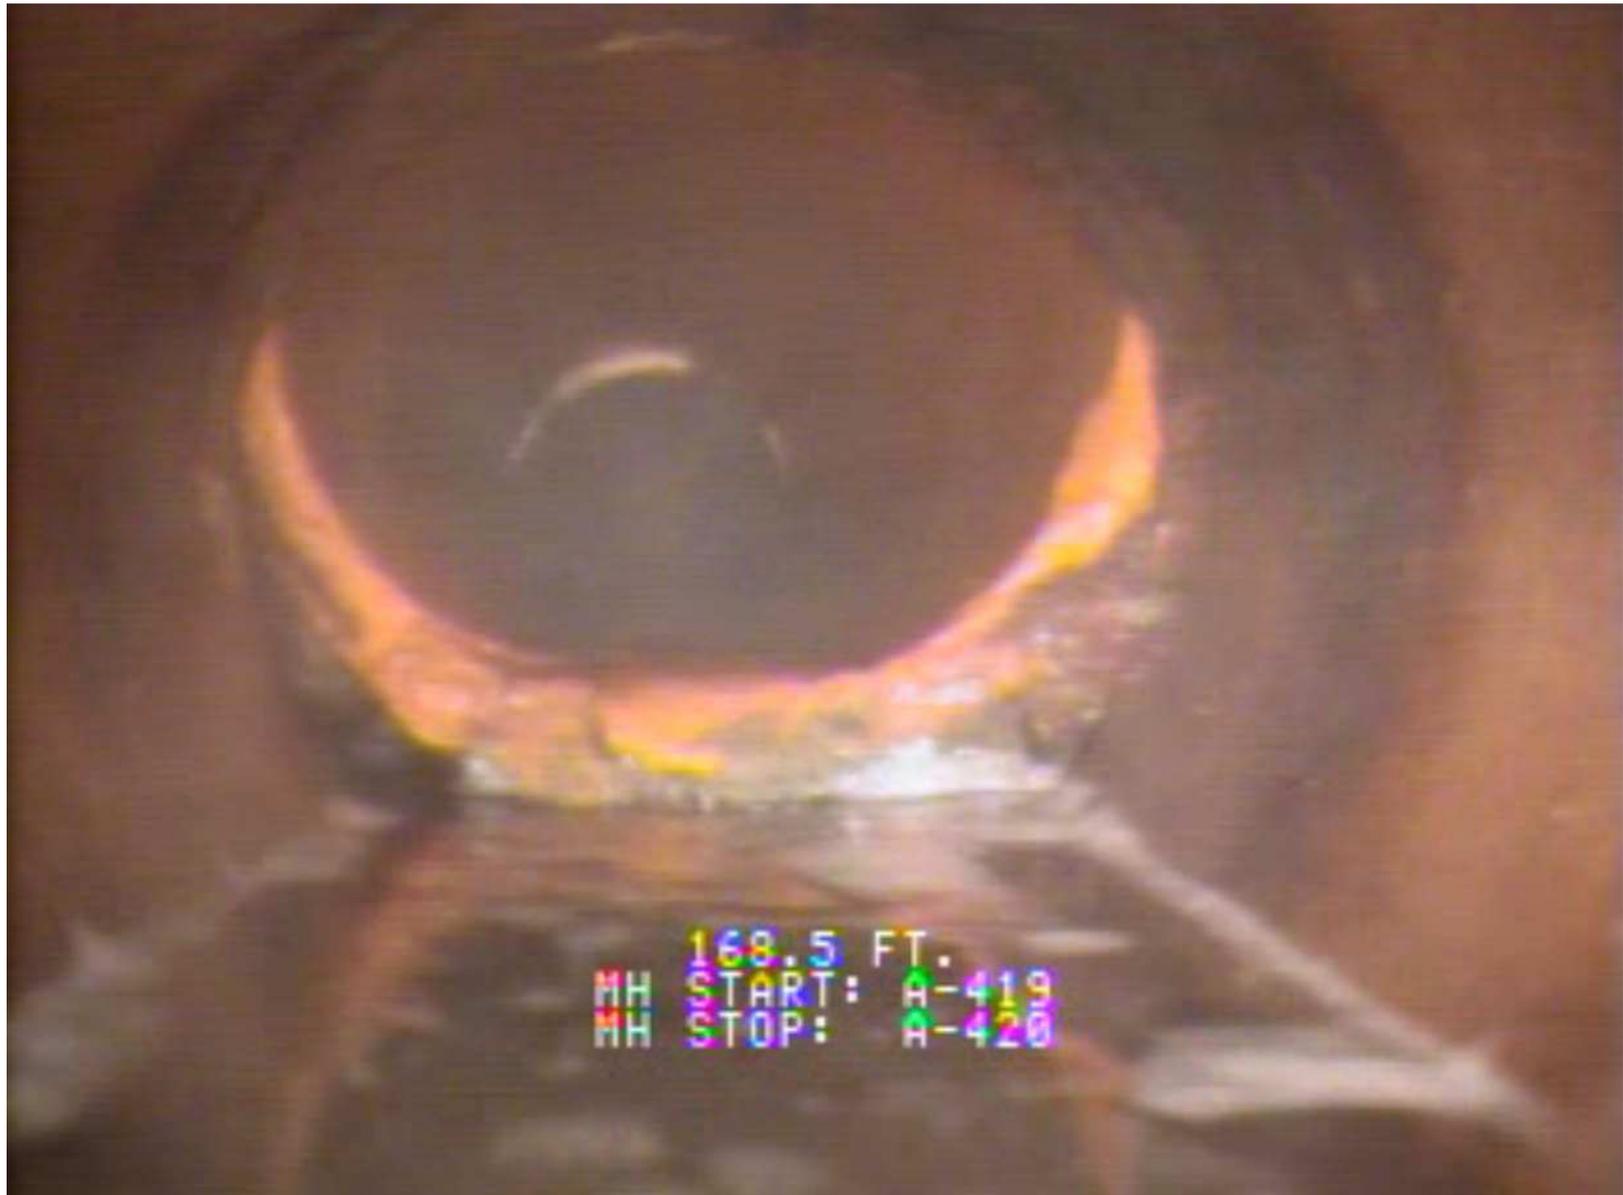
Photo 9, Severe offset in A-419 to A-420

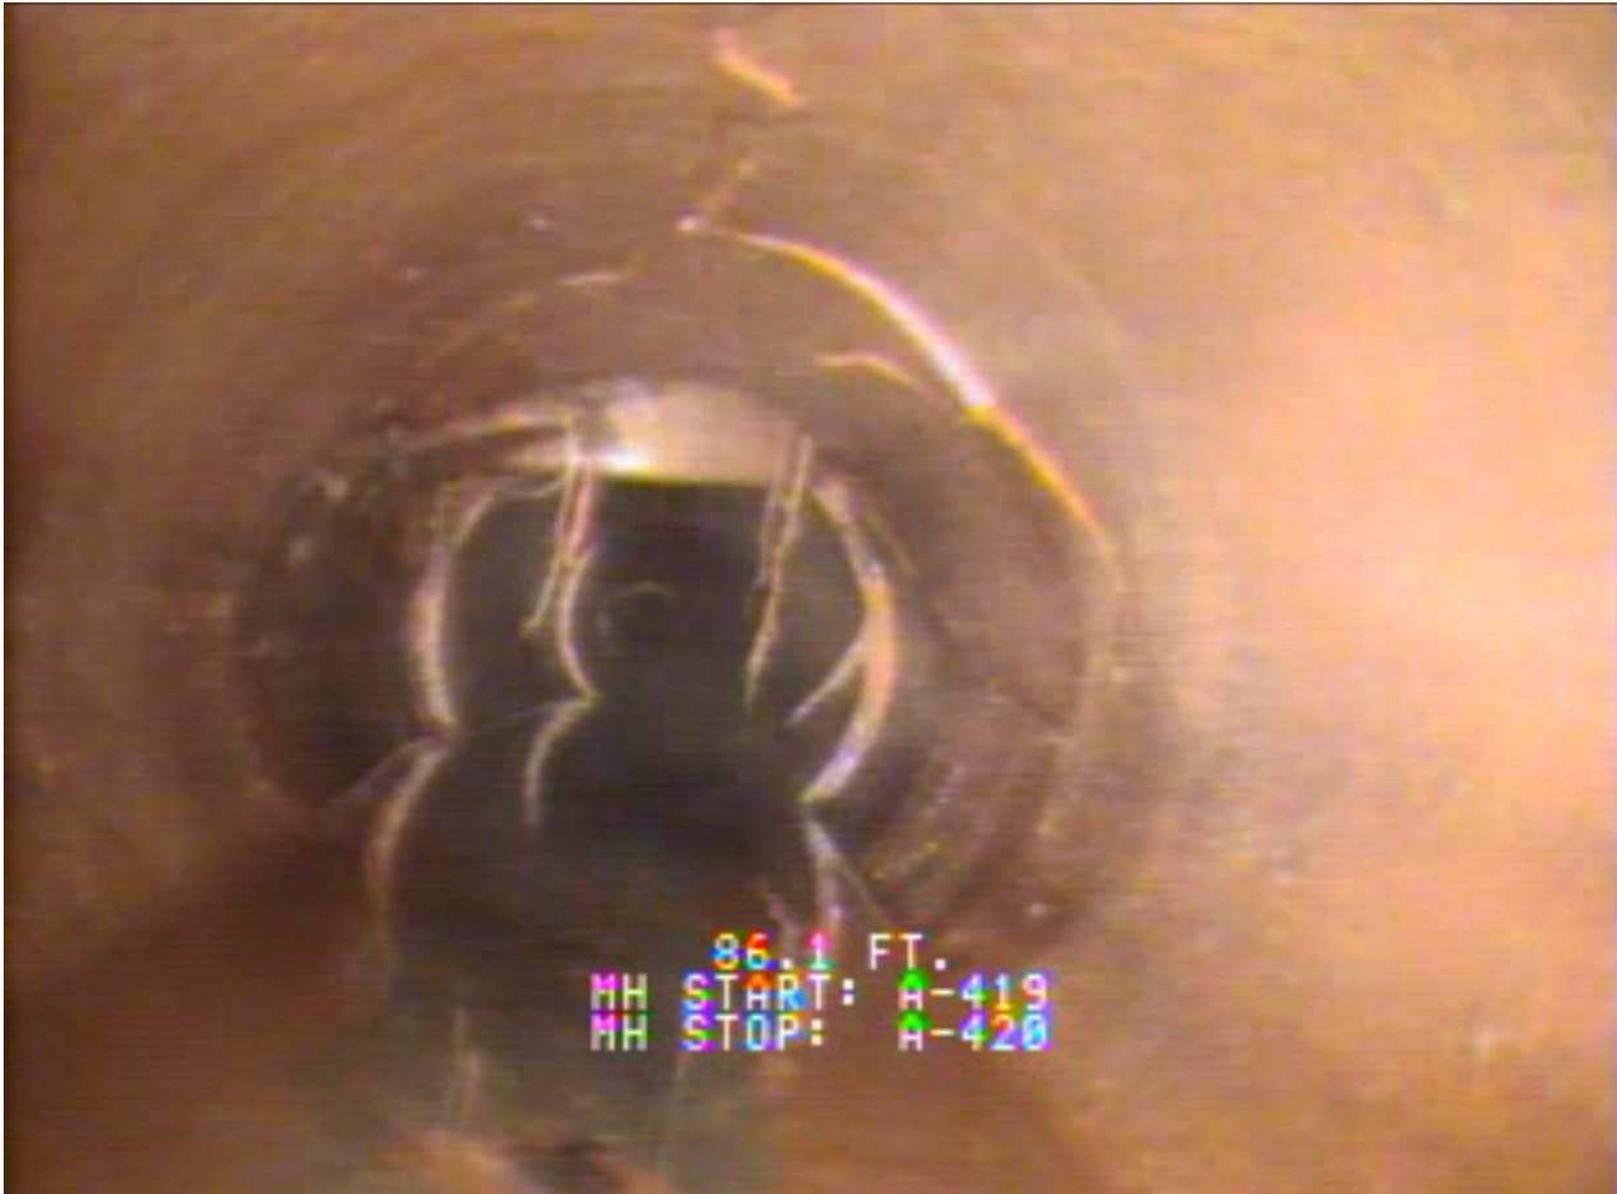
Television inspection identified a broken sanitary sewer lateral wye connection at one (1) location. The condition of the wye connection is too severe to be rehabilitated with trenchless rehabilitations. Weston & Sampson recommends replacing the sewer service in this location. This repair is indicated on the IDDE Investigations Map and is included in Table 3, Replacement of Service Connection Wyes. A Photograph of this defect is included in Appendix B, Photo 10.

Photo 10, Collapsed wye in A-419 to A-420
