REPORT

IDDE Drainage Areas 7, 9 and 31
Investigations

May 3, 2018

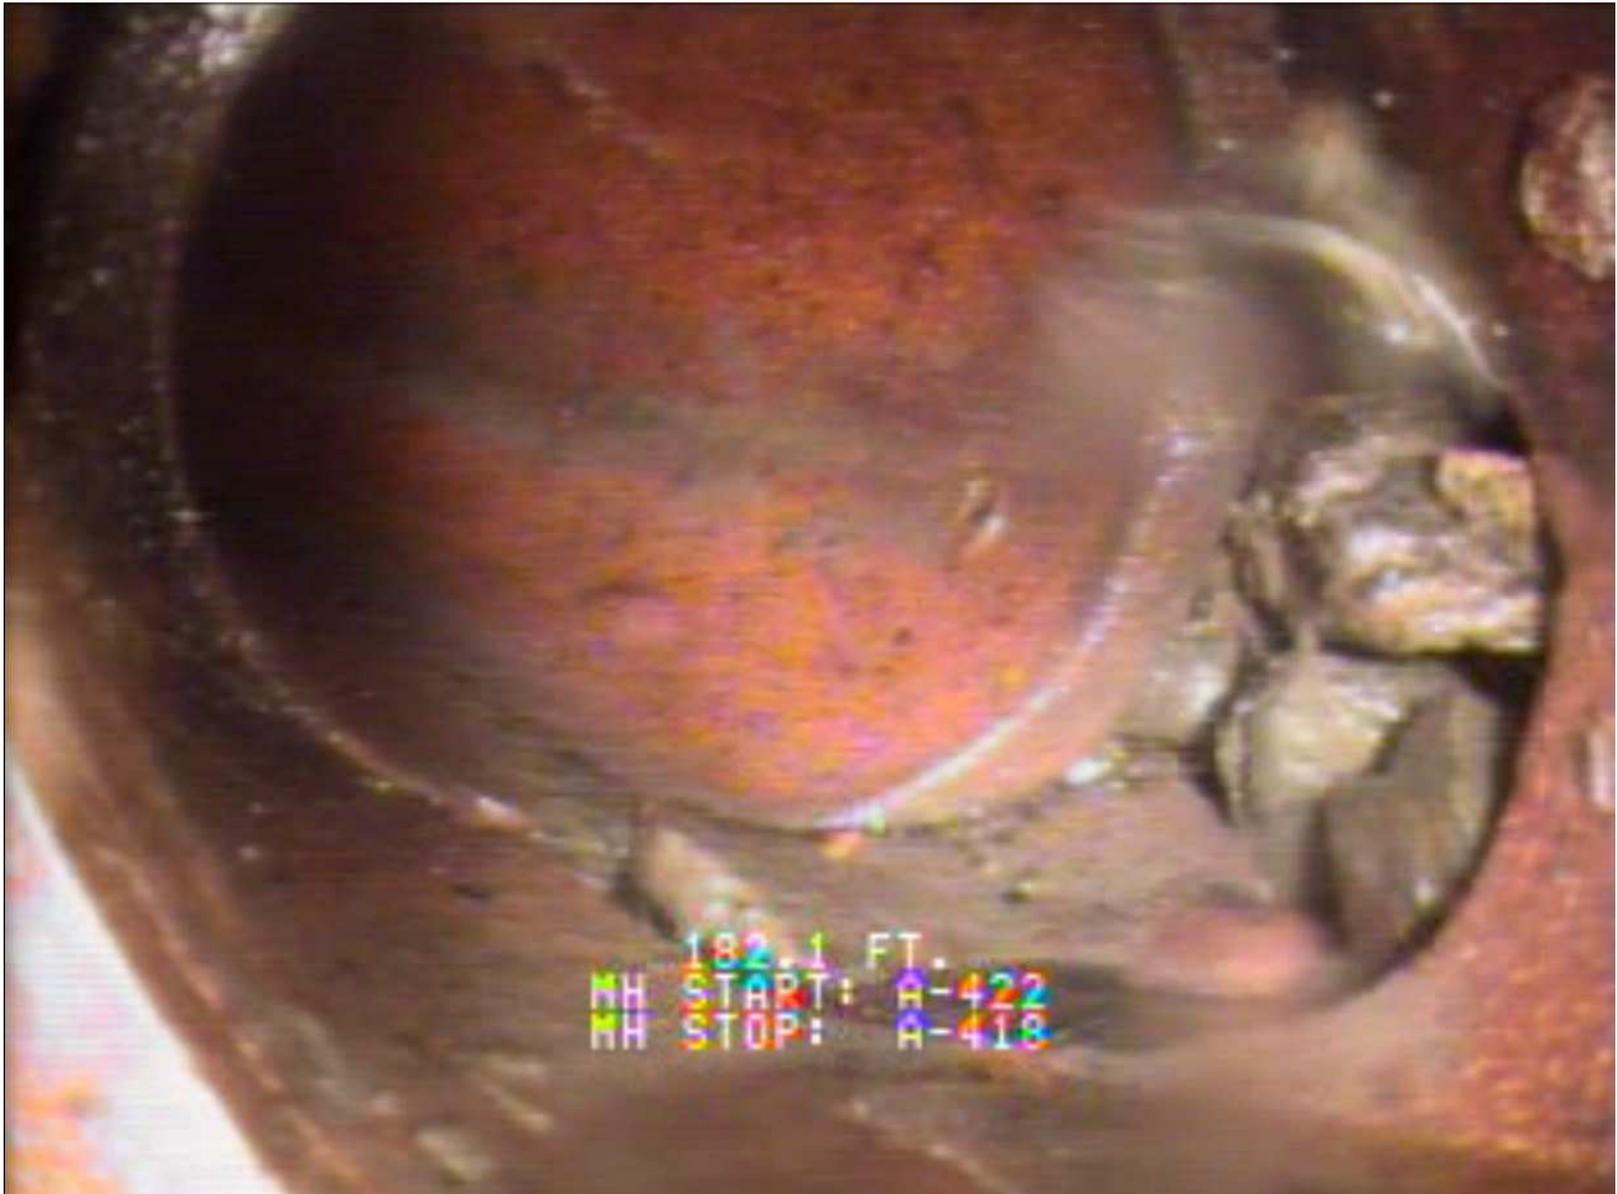
Sewer service connections with open joints at the mainline connection were identified in three (3) locations. Open joints in these locations may allow sewer flow to exfiltrate into the ground. Weston & Sampson recommends sealing these connections with lateral liners. Photographs of these defects are included in Appendix B, Photos 11-13.

Photo 11, Lateral not sealed at mainline in A-422 to A-418

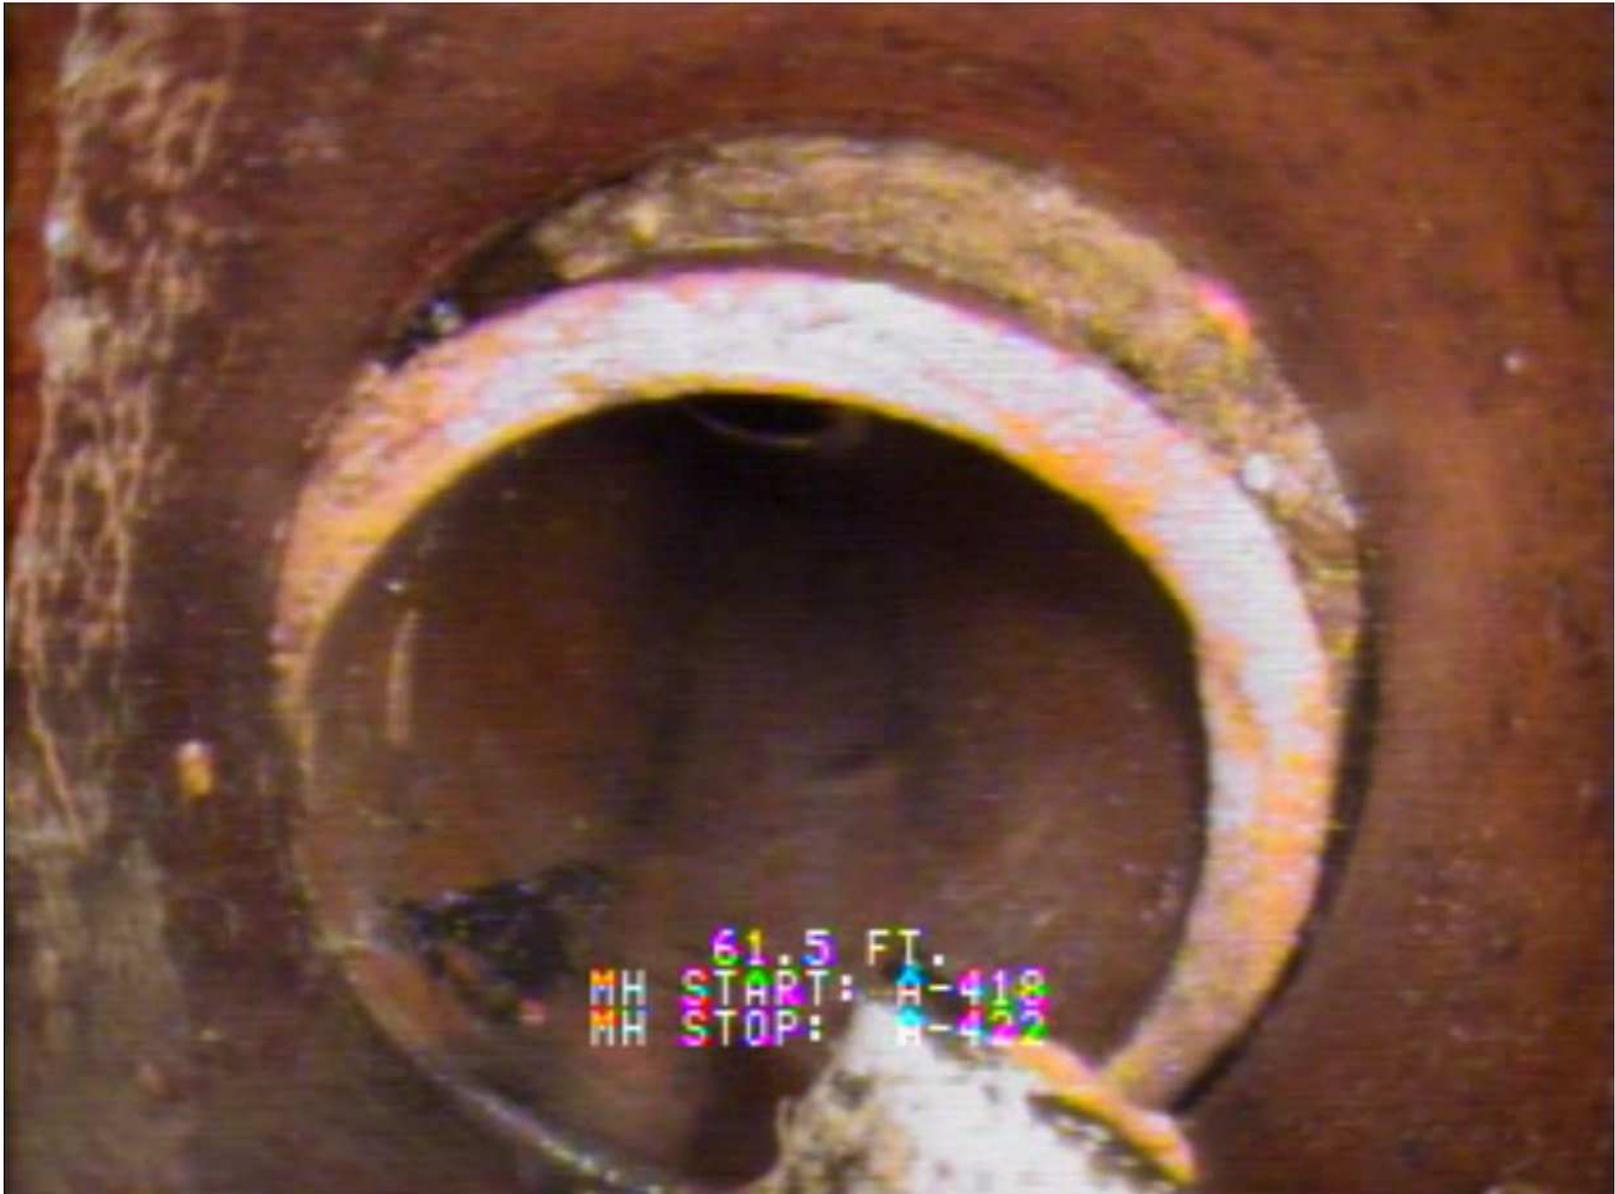
Photo 12, Lateral not sealed at mainline in A-418 to A-422

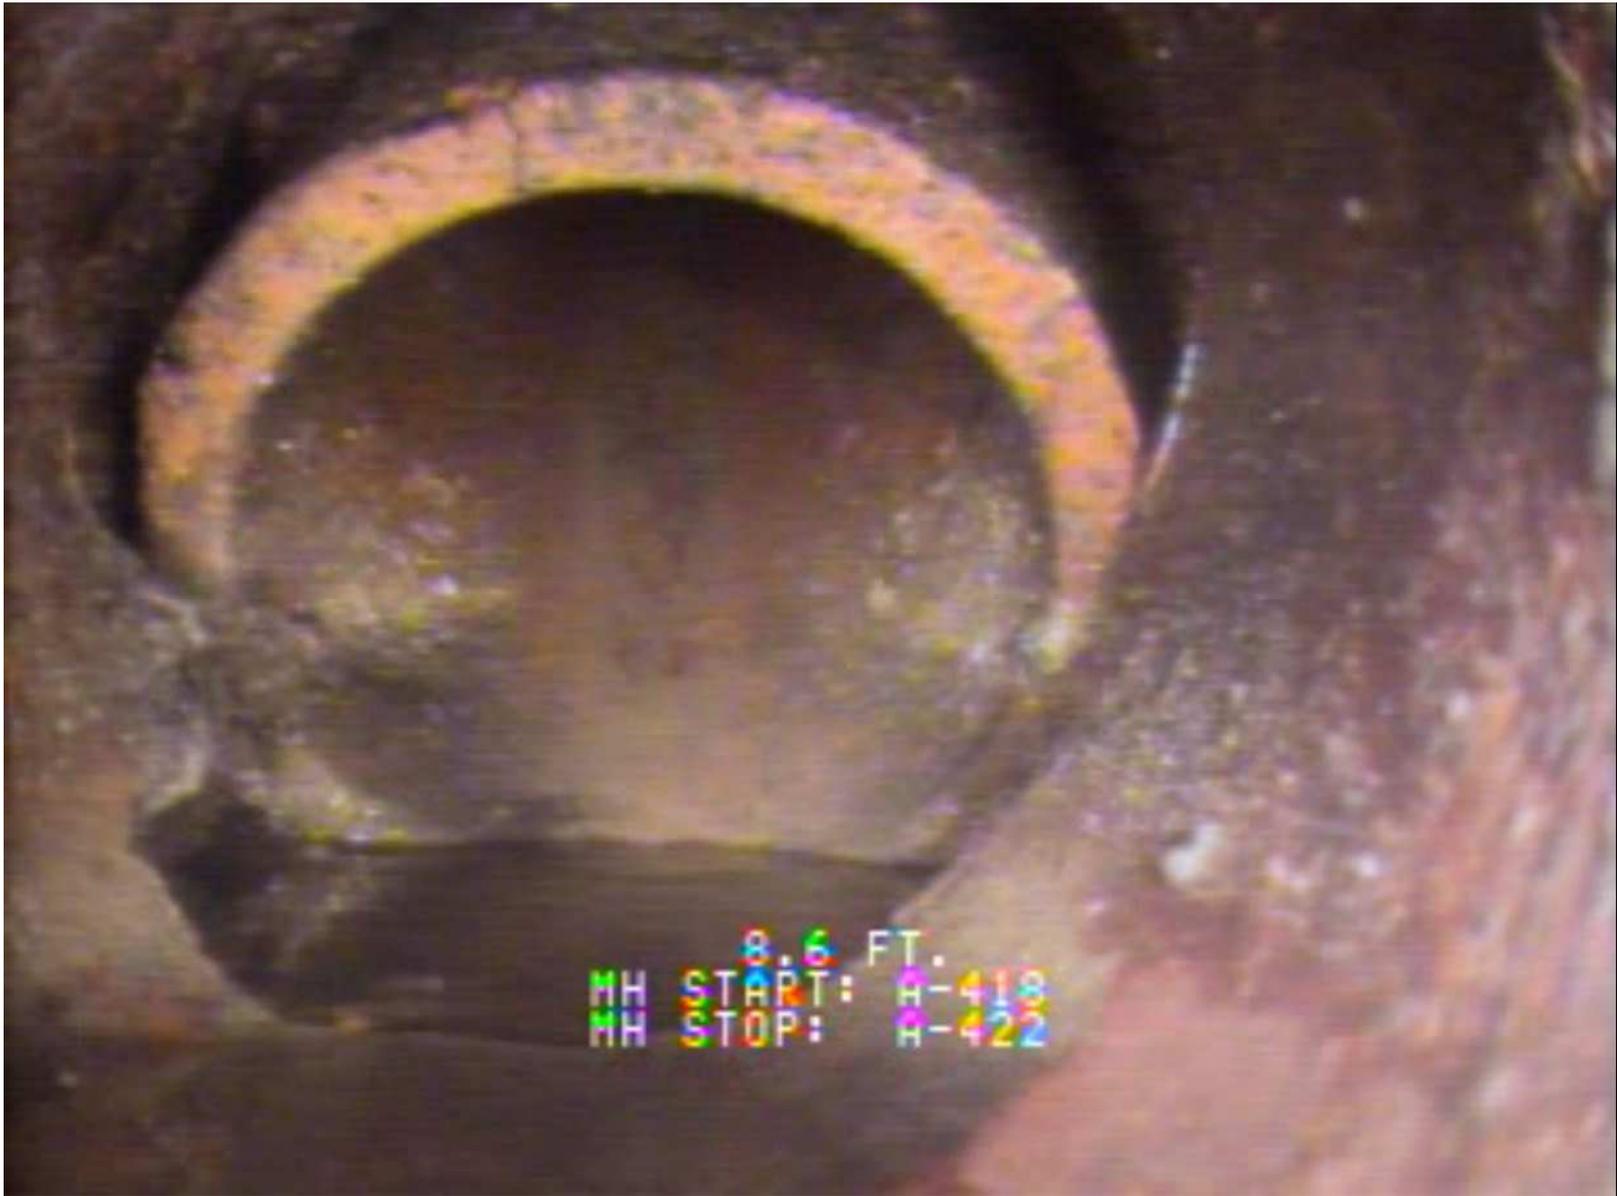
Photo 13, Lateral not sealed at mainline in A-418 to A-422

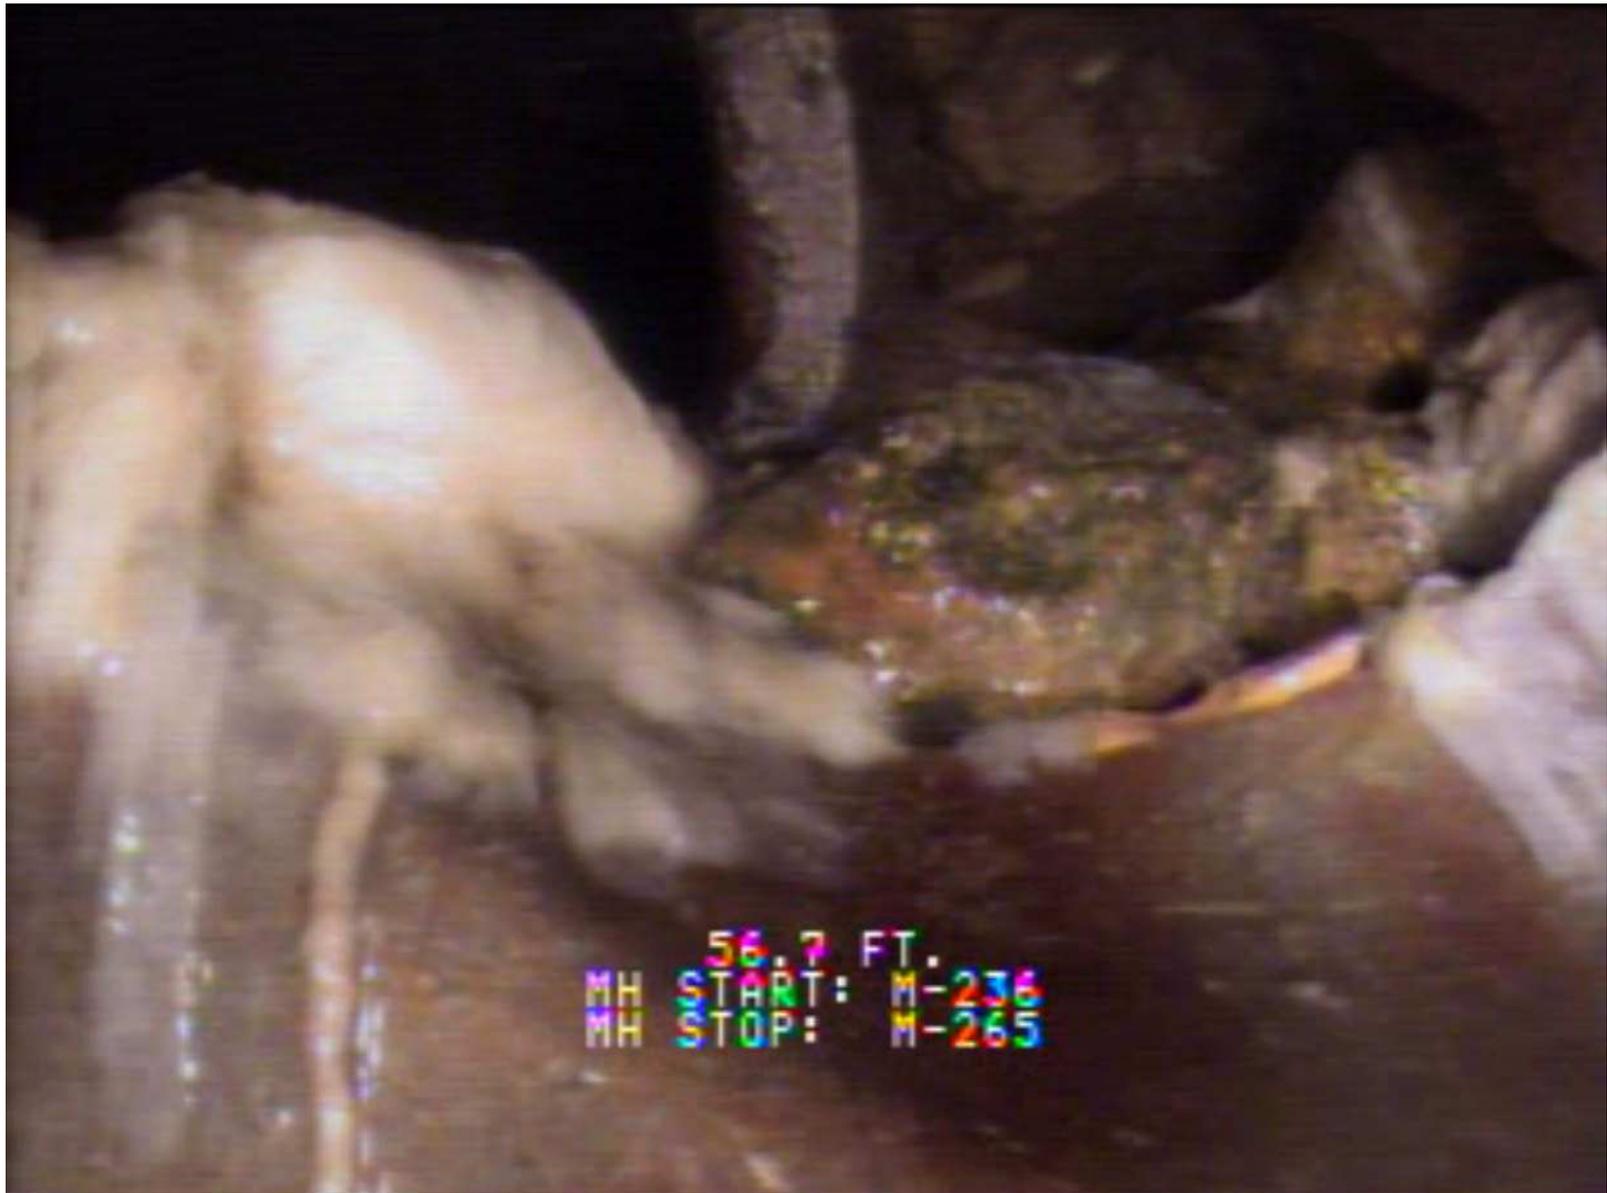
Television inspection identified broken sanitary sewer lateral wye connections at two (2) locations. The condition of each wye connection is too severe to be rehabilitated with trenchless rehabilitations. Weston & Sampson recommends replacing the sewer services at these locations. These defects are indicated on the IDDE Investigations Map and are included in Table 3, Replacement of Service Connection Wyes. Photographs of these defects are included in Appendix B, Photos 14-15.

Photo 14, Partially collapsed lateral in M-236 to M-265

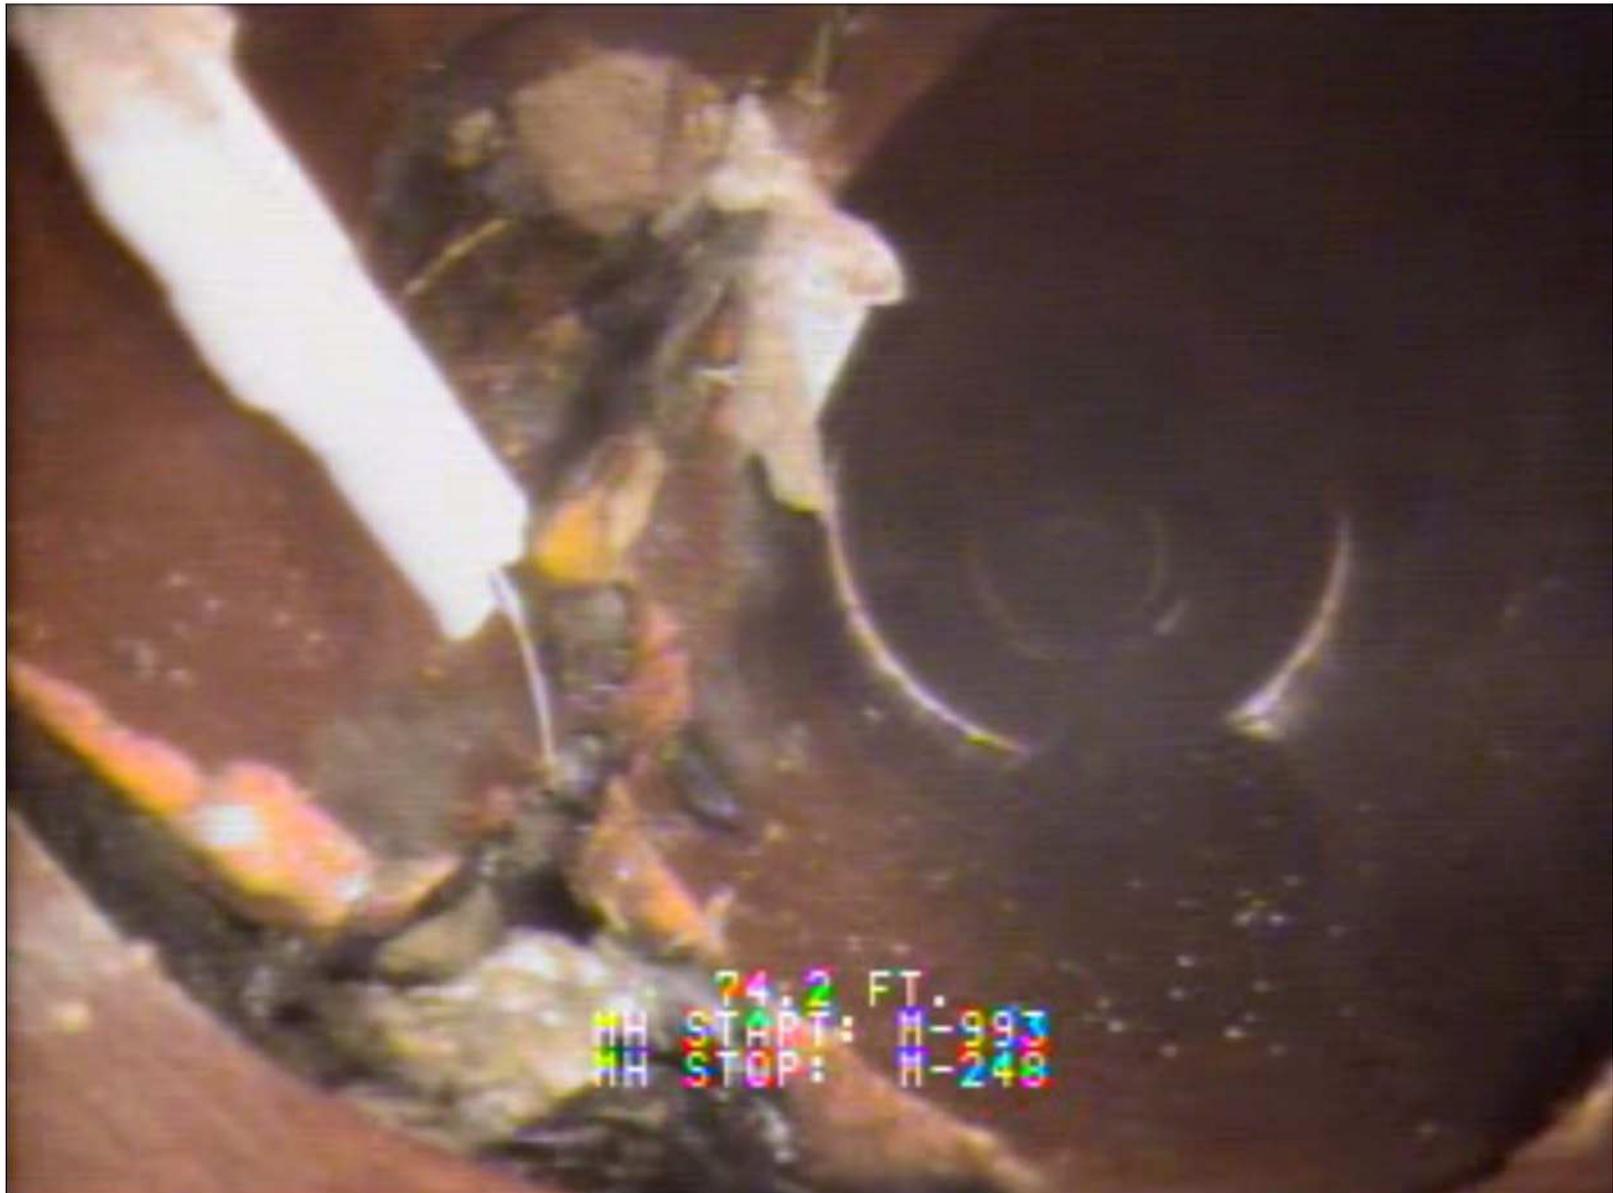
Photo 15, Partial collapse at a lateral in M-393 to M-248

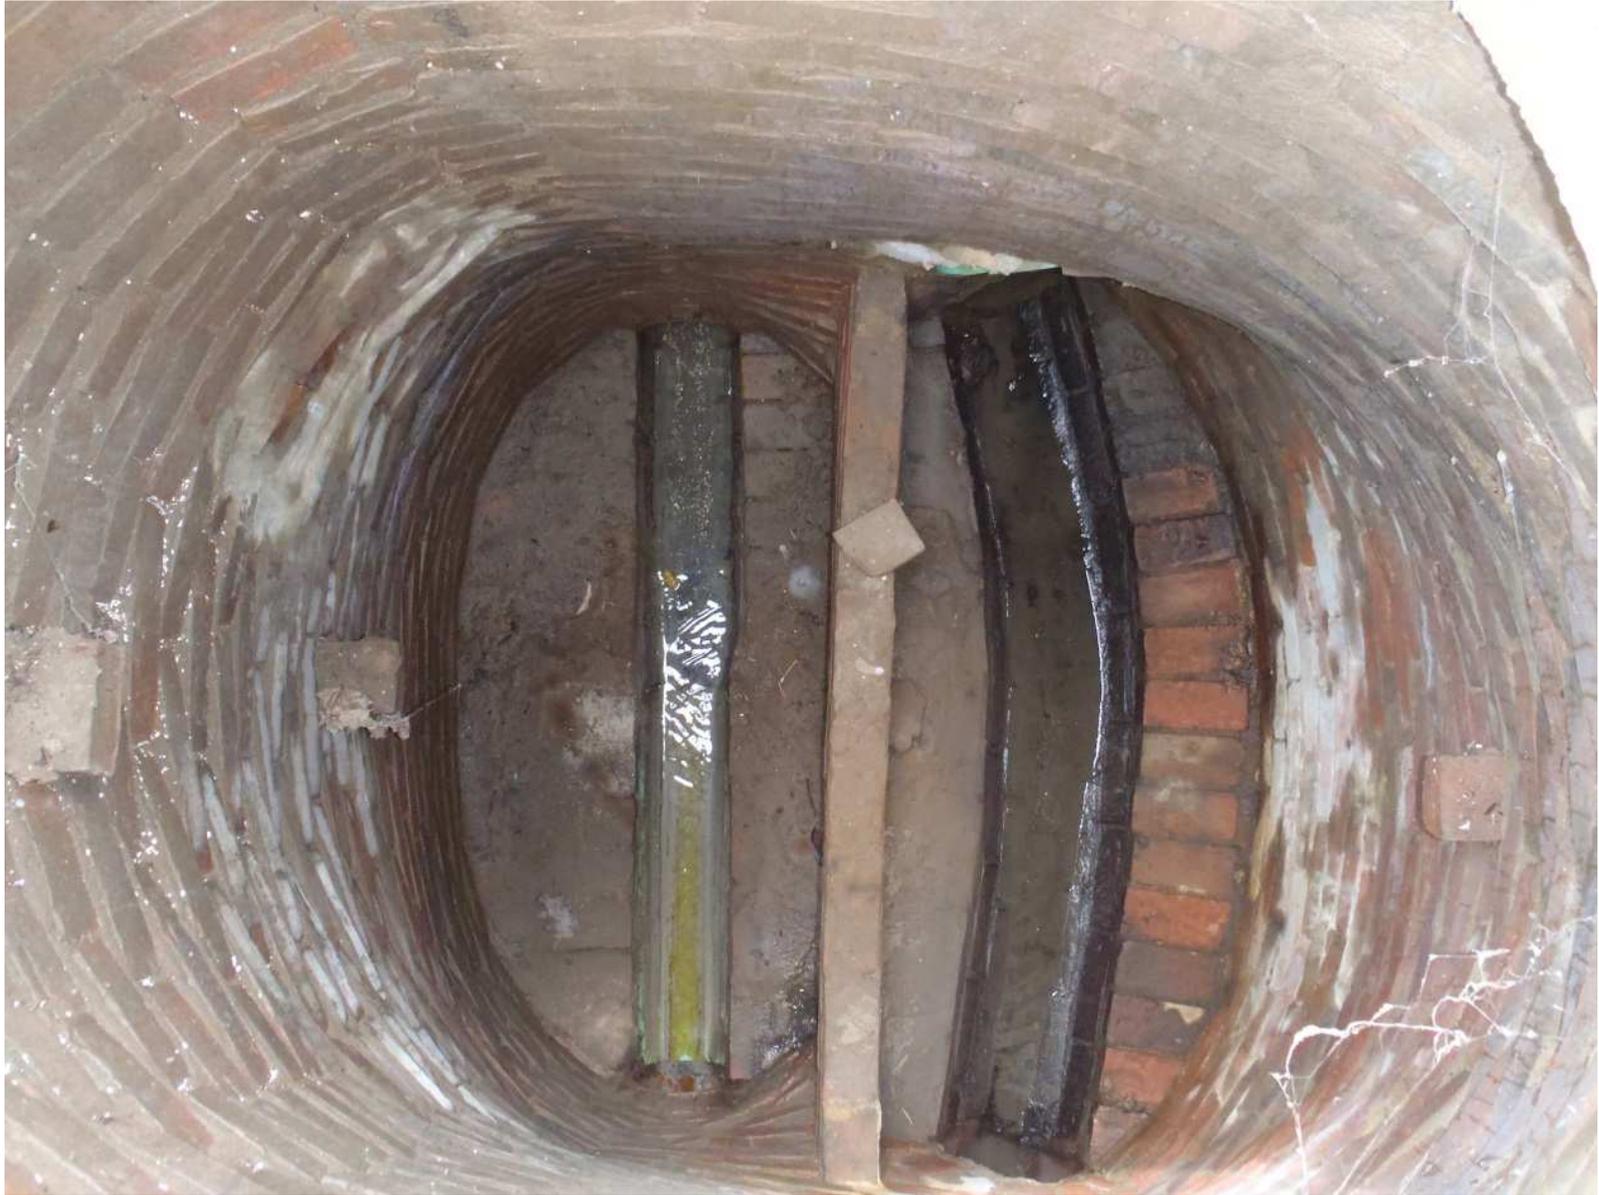
A shared manhole was identified on Rogers Avenue, SMH M-246. The storm drain is higher than the sewer main and is separated with a baffle wall (Appendix B, Photo 16). During surcharged conditions, it is possible that sewage could overflow into the storm drain; however, there is no evidence of previous surcharge in this manhole.

Photo 16, Internal photo of shared manhole M-246

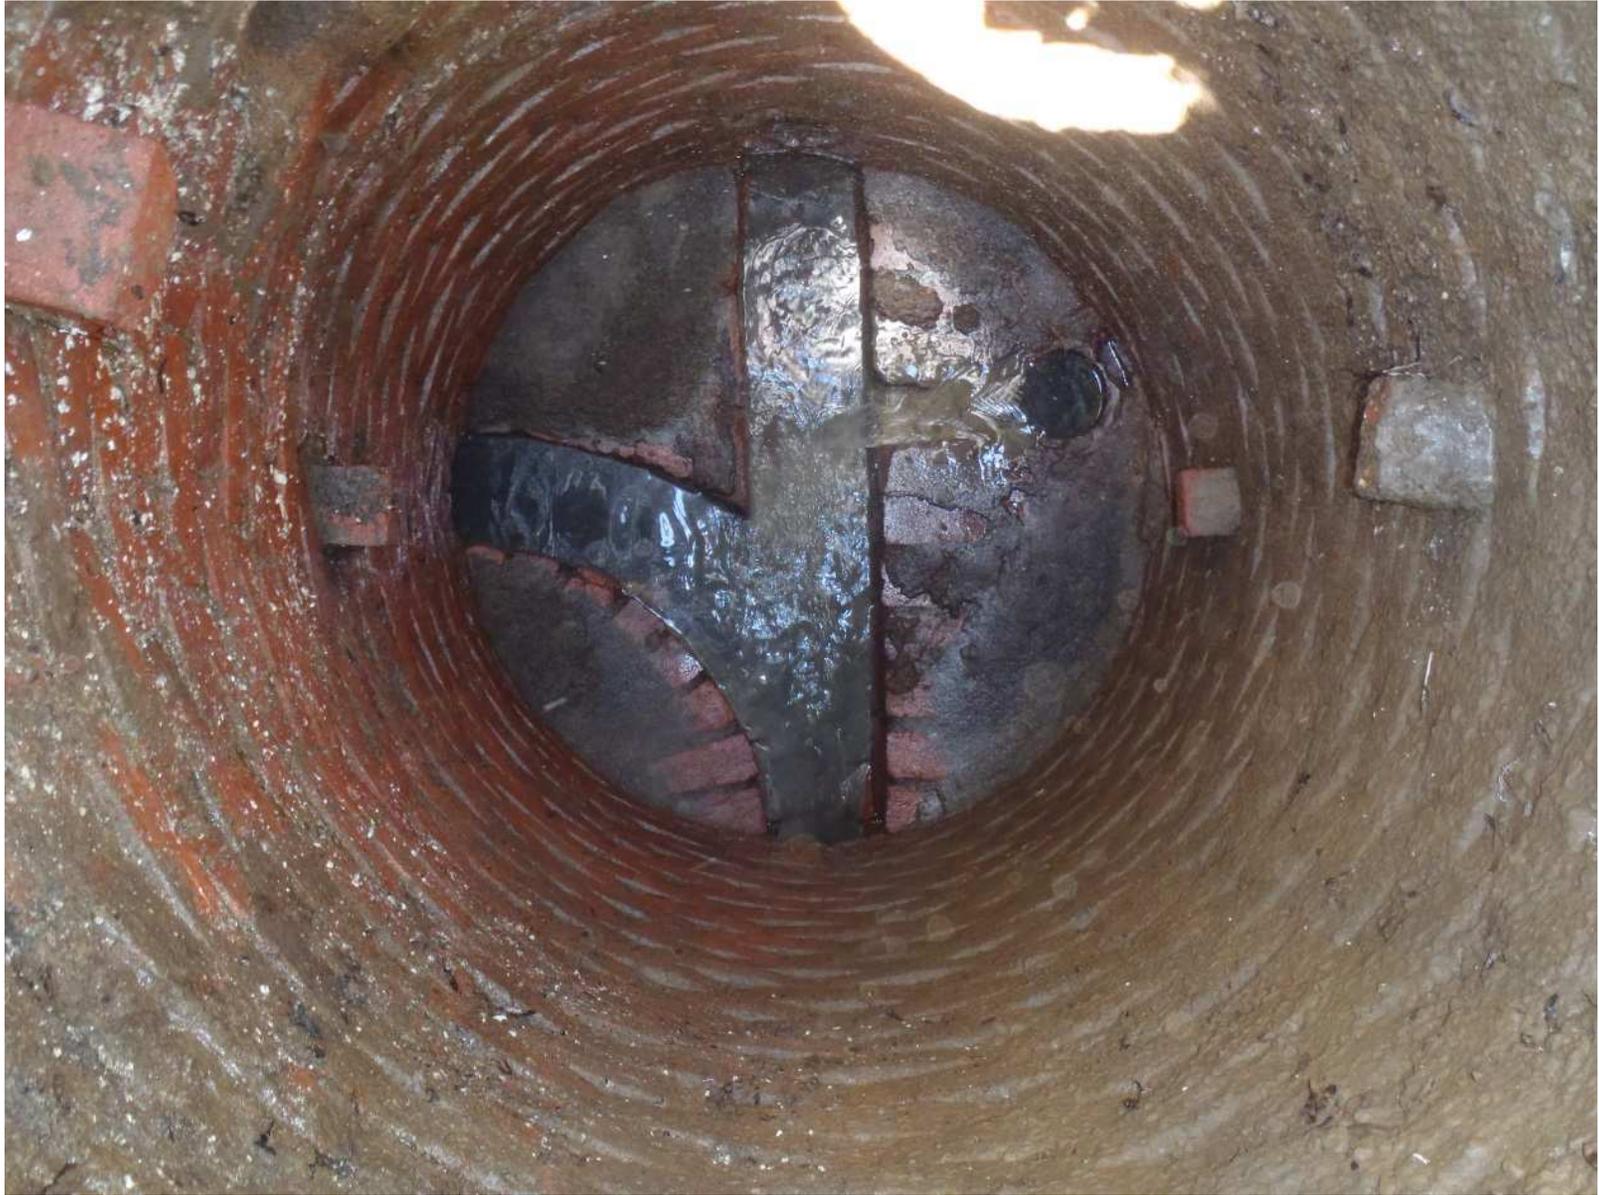
An open underdrain access port was observed on the bench of SMH M-265, allowing sewer to flow into the underdrain and the underdrain to flow into the sewer. Capped underdrain connections were also observed in DMH 31-5003 and DMH 31-5012. These connections were not leaking during the IDDE investigation; however, these connections were observed to be leaking to the storm drain during the CIP Project 1 Manhole Inspection Project (spring 2017). These capped underdrain connections may be a source of contamination to the storm drain. Weston & Sampson recommends sealing the access port in SMH M-265 (included in CIP Project 1 Manhole Rehabilitations) and completely sealing the underdrain connections in DMH 31-5003 and DMH 31-5012. Photographs of these underdrain connections are included in Appendix B, Photos 17-19. In addition, sewers over underdrains in these locations should be lined to prevent sewer exfiltration into the underdrain.

Photo 17, Open underdrain access point in M-265

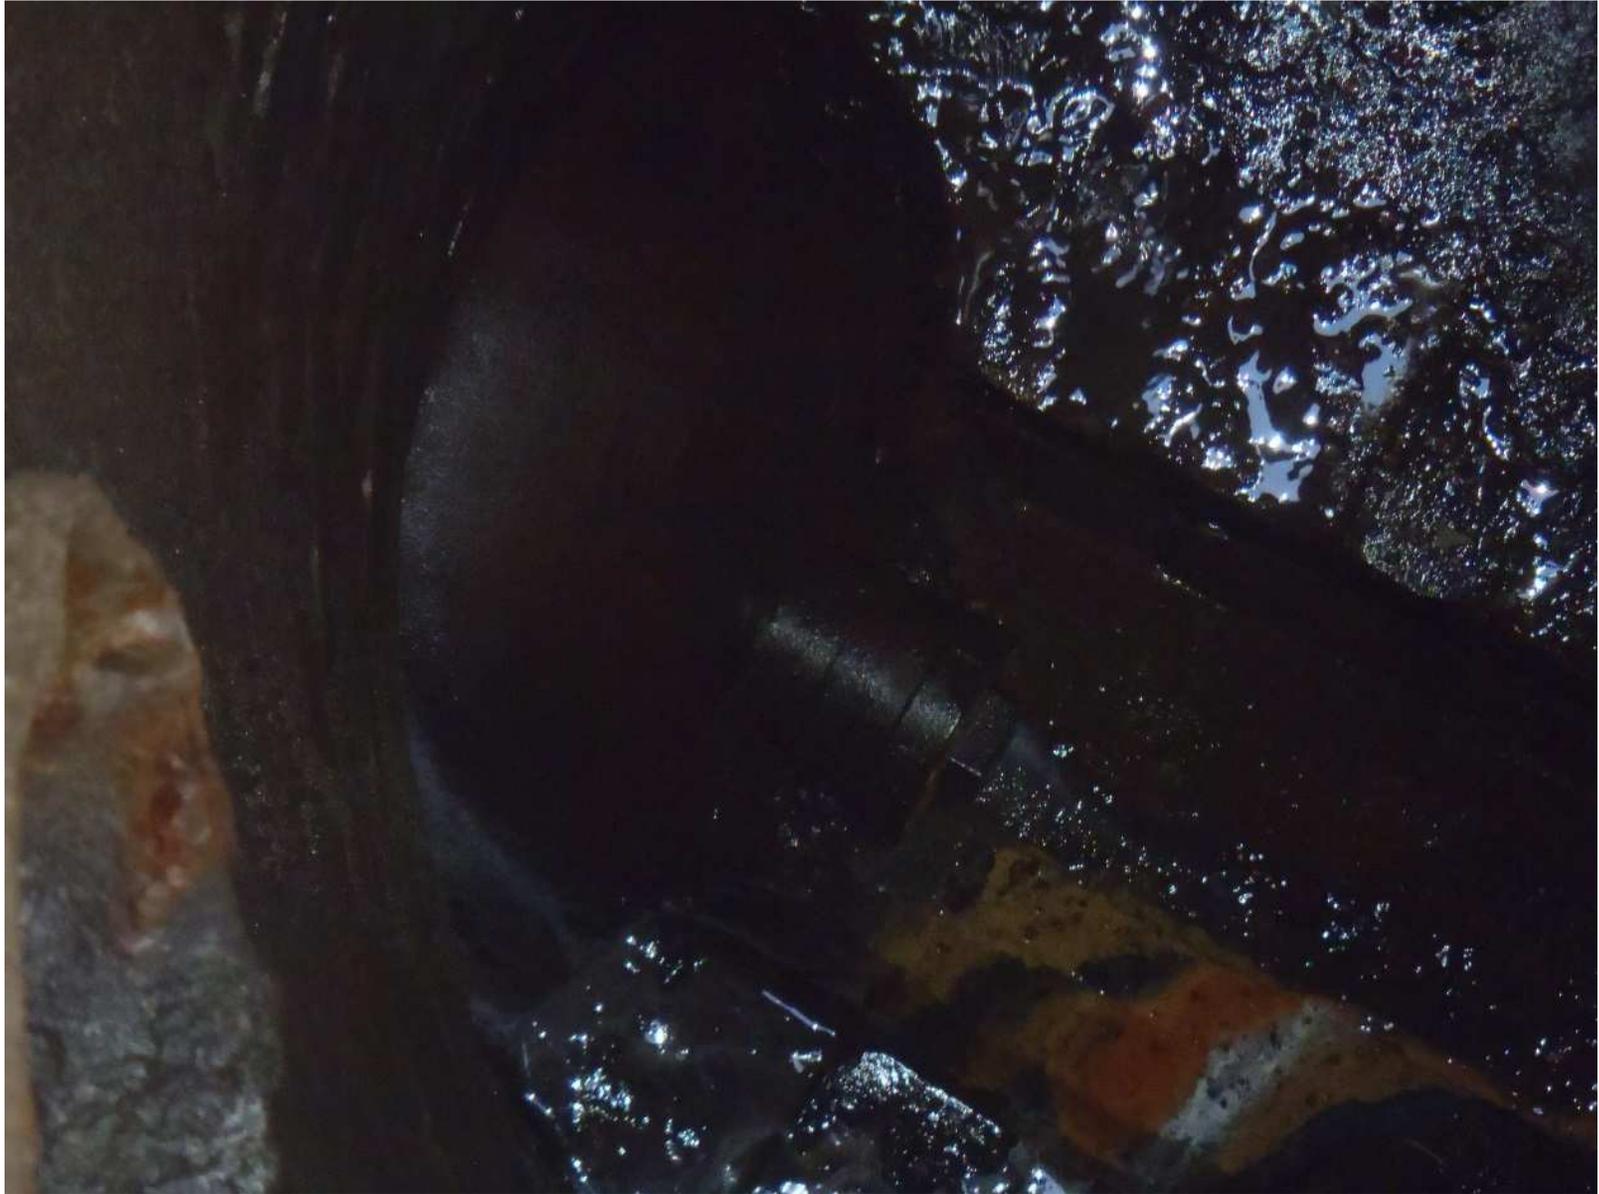
Photo 18, Abandoned underdrain connection in 31-5003

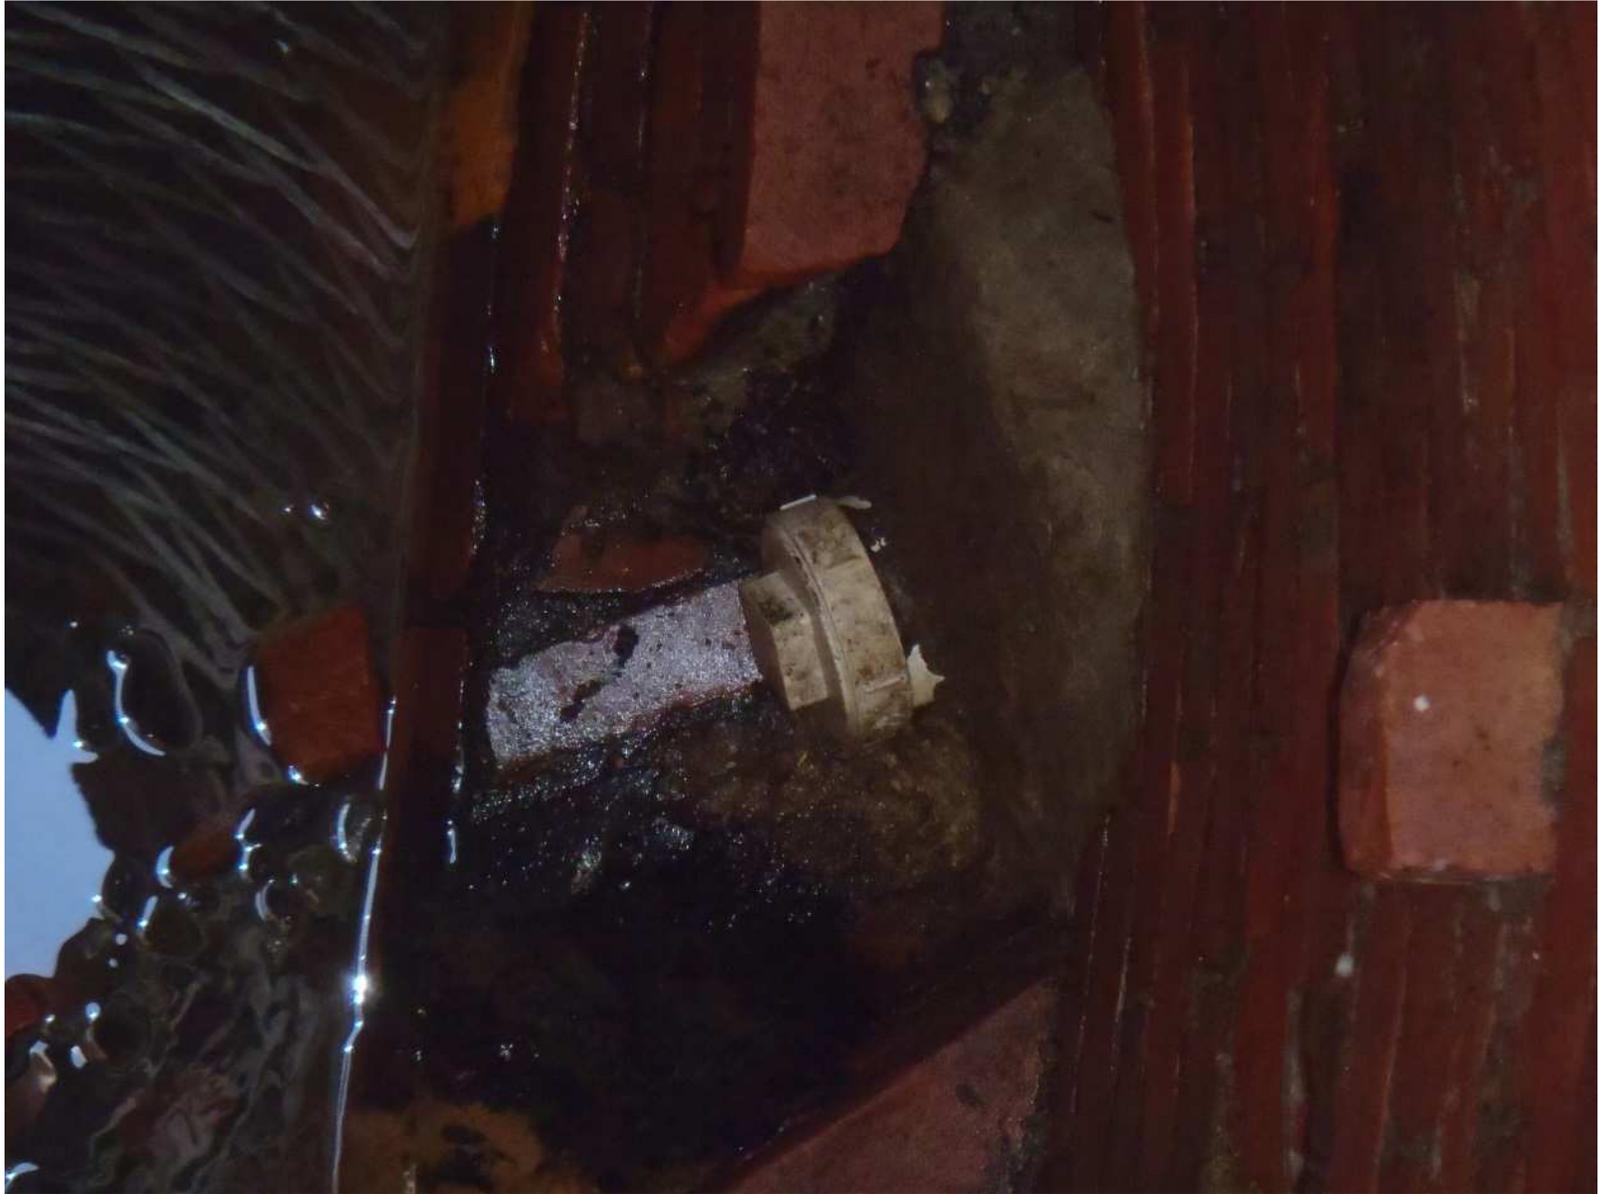
Photo 19, Abandoned underdrain connection in 31-5012

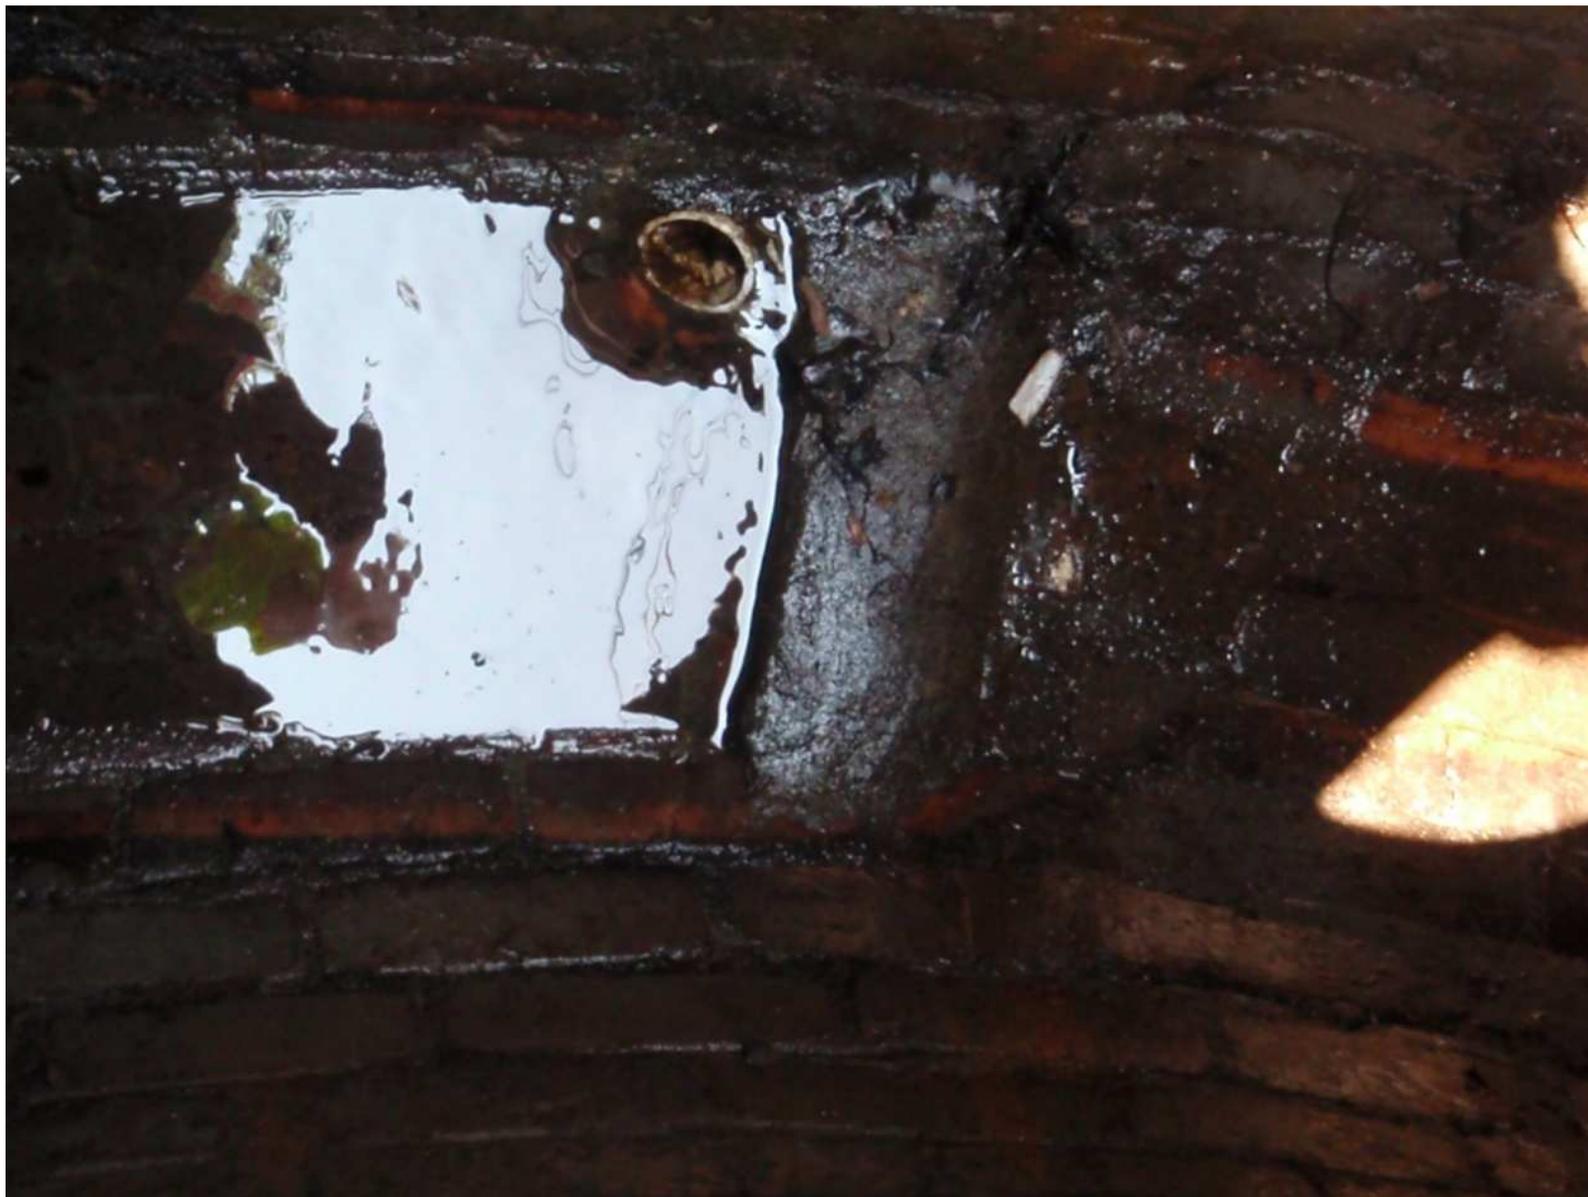
A weir wall (approximately 6-inches tall) was identified in drain manhole 31-5015 on Pearson Road. The weir wall redirects dry weather flow to a 2-inch PVC pipe that is connected to the adjacent sewer manhole (M-3337). Inspection of manhole 31-5015 indicated the 2-inch pipe was clogged, allowing contaminated dry weather flow to continue downstream. Although this connection diverts contaminated flow during dry weather, it also provides a source of Inflow and Infiltration (I/I) into the sewer system. This connection should be abandoned once the source of upstream contamination is eliminated. Photographs of the 2-inch PVC connection are included in Appendix B, Photos 20-21.

Photo 20, Weir wall and diversion pipe in 31-5015

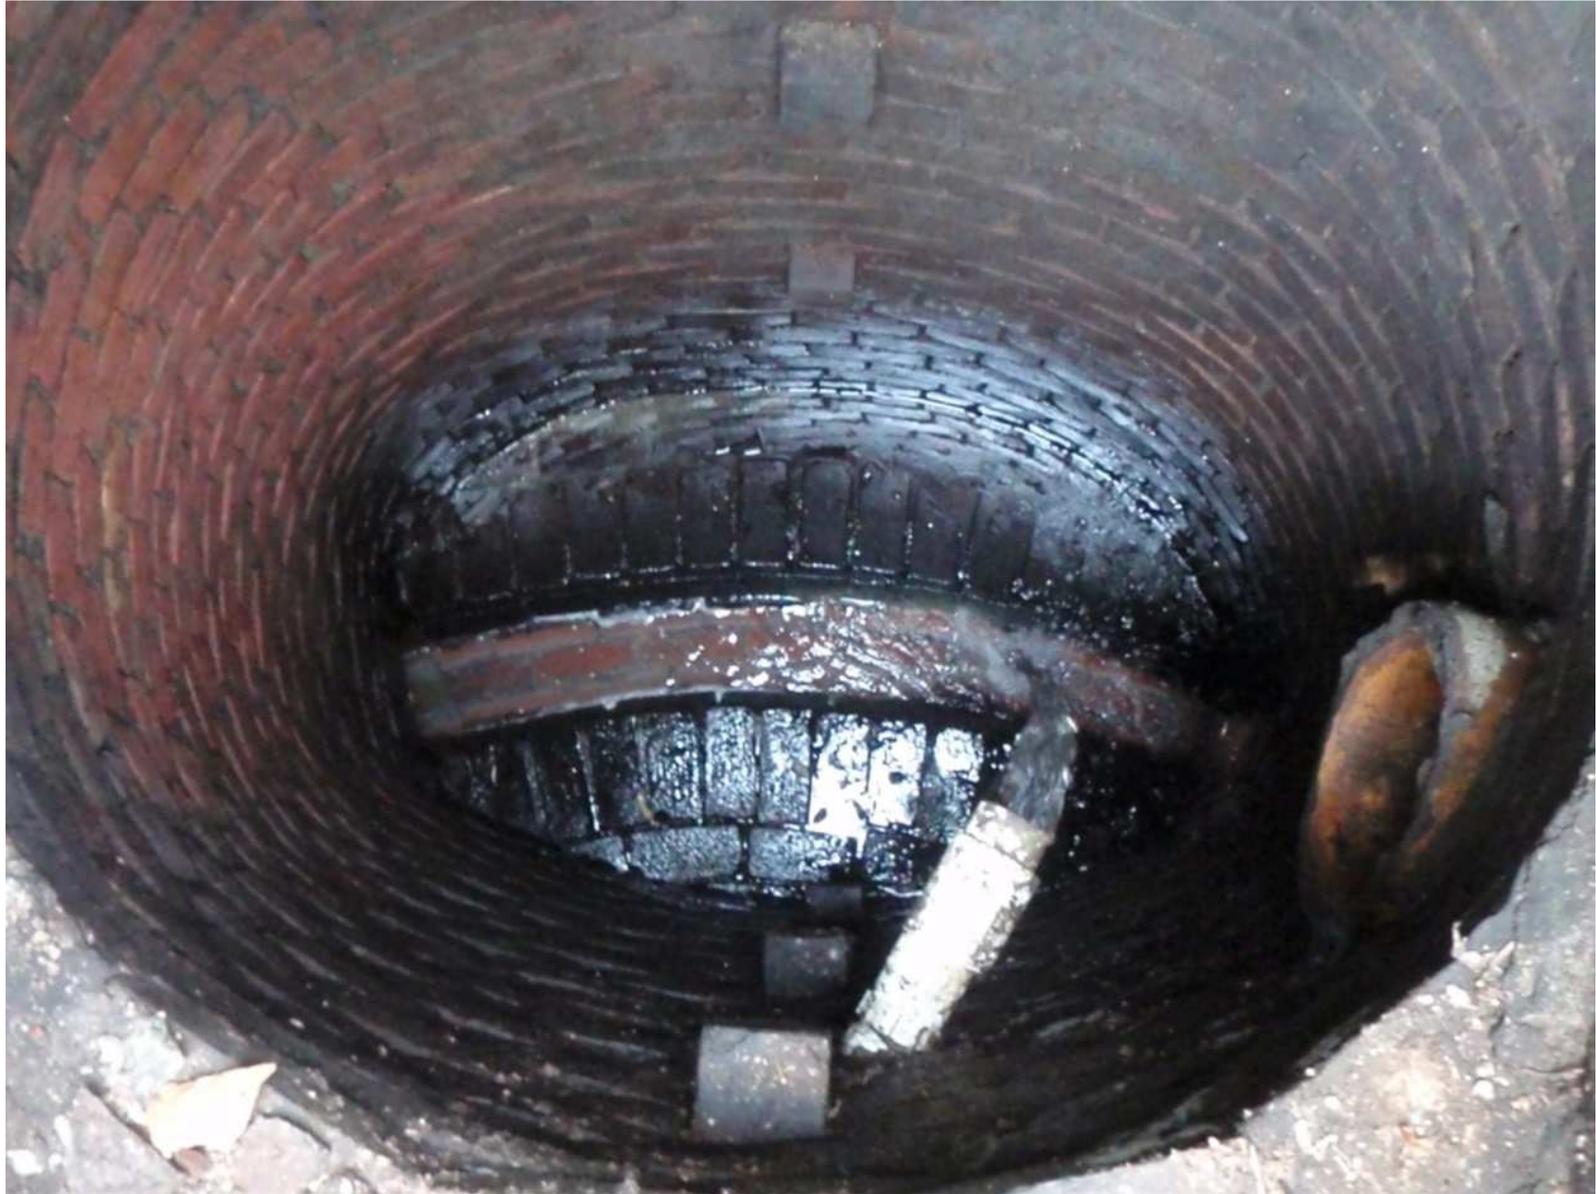
Photo 21, Diversion pipe in M-3337 from 31-5015
