REPORT

IDDE Drainage Areas 7, 9 and 31
Investigations

May 3, 2018

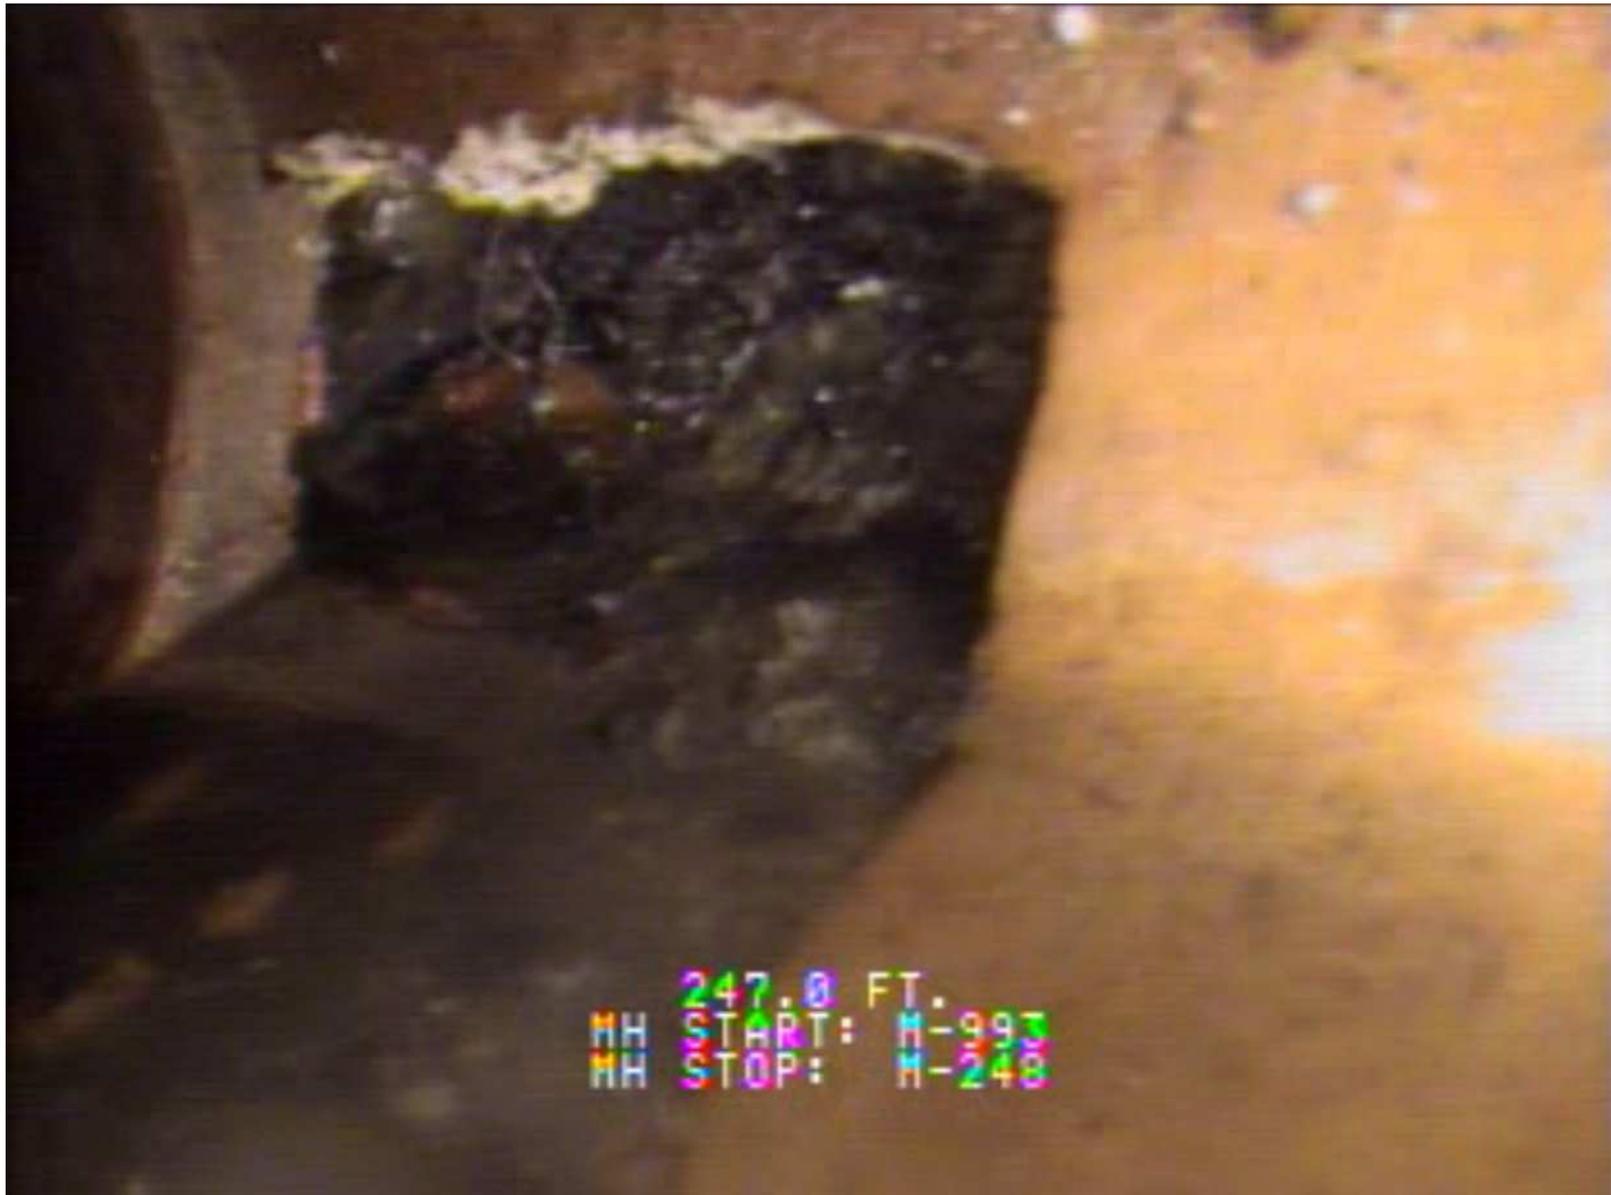
The Boston Avenue underdrain is below sewer segment M-393 to M-248, which has multiple sections of broken pipe; many of which are along the invert of the pipe (Appendix B, Photo 22). In addition, there is a large hole in the invert of SMH M-248 (Appendix B, Photo 23). It is likely that sewage exfiltration from this sewer segment is migrating to the underdrain and is the source of the contamination in the storm drain. Weston & Sampson recommends television inspection of the remaining sewer on Boston Avenue. Dye tests should be performed on

Photo 22, large hole in invert of sewer from M-393 to M-248

adjacent buildings, as necessary, to confirm that all sewer services are connected to the sewer (and not the underdrain). Once additional investigations are complete, Weston & Sampson recommends lining sewers that are over underdrains on Boston Avenue and sealing SMH M-248 to prevent further sewage exfiltration into the underdrain.
