TO: Jessica Fosbrook, PE, Project Manager, City of Somerville
FROM: Rachel Burckardt, PE, WSP
Jason Bobowski, PLA, Hatch
**SUBJECT: Somerville Avenue Utility and Streetscape Improvements
Tree Removals**
DATE: May 17, 2018

SOMERVILLE AVENUE UTILITY & STREETScape IMPROVEMENTS

SITE PREPARATION & DEMOLITION PLAN

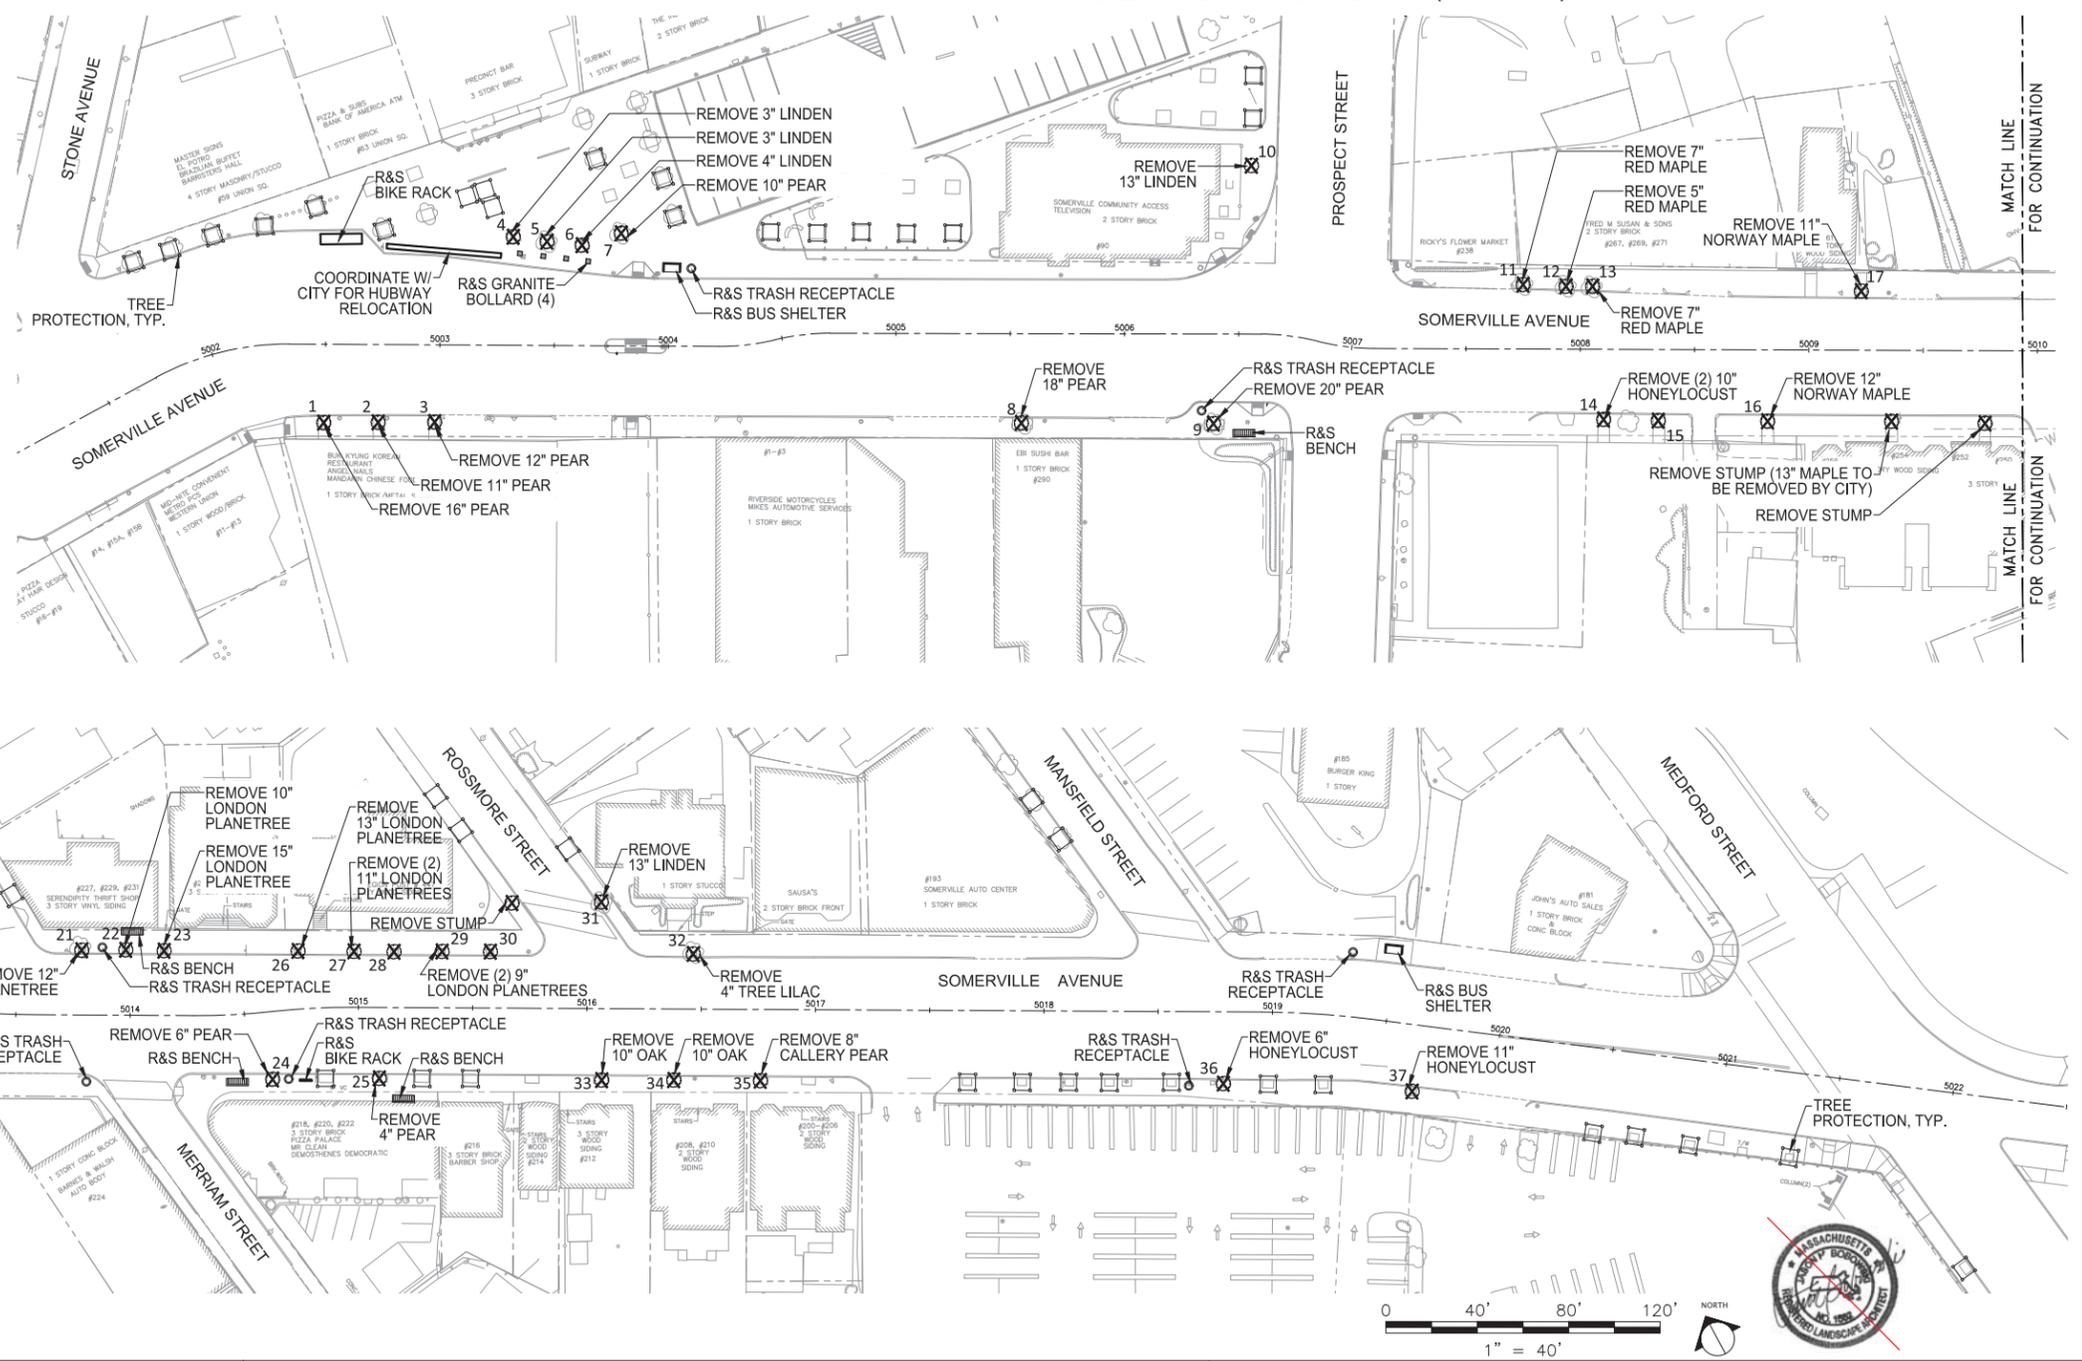
The scope of this project includes new major storm drainage facilities, water main replacement and improvements, sewer relocations, sewer lining, a new communications duct bank, and street restoration including new sidewalks, separated cycle tracks, curb, crosswalks and wheelchair ramps, green stormwater facilities, street furniture, planters, and 51 new trees with tree cells. The project also includes the removal of 37 street trees while preserving 40 street trees along Somerville Avenue from Union Square to Medford Street. The trees proposed to be removed include some for health reasons and others whose health will be jeopardized by the proposed construction, including some that are simply in conflict with the required locations of the new infrastructure improvements. Following are descriptions of each tree to be removed, with street location, DBH (namely, the tree diameter measured at 4.5 feet above the ground), species and the reason(s) for removal. See attached plan for locations of the trees to be removed.

The project design team has considered each existing street tree within the project area with the aim of preserving as many as possible. A total of 40 of the 77 street trees will be retained and protected during construction. The 37 trees proposed to be removed include some for health reasons and others whose health will be jeopardized by the proposed construction, including some that are simply in conflict with the required locations of the new infrastructure improvements.
