2014 ACCESSIBLE PEDESTRIAN SIGNAL SUPPLEMENTAL STUDY

Somerville, Massachusetts

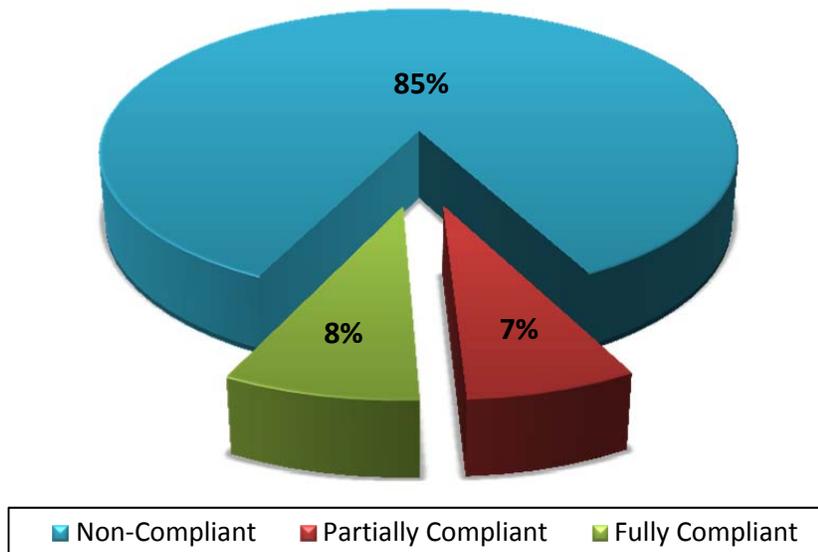
Figure 1
APS Compliance Distribution

A total of 309 APS were inventoried throughout the City of Somerville. The compliance of each APS was determined by the guidelines set by MUTCD (2003) and Draft PROWAG (2005). If all elements of the APS met the guidelines it was considered compliant. If the APS had either a tack tile arrow or audible tone, but failed to meet other guidelines it was considered partially compliant. If none of the guidelines were met (no tack tile arrow or audible tone), it was considered non-compliant. The breakdown of the compliance of the APS is shown below. As can be seen, the majority of the APS in Somerville are non-compliant (85%), while 7% are partially compliant, and 8% fully compliant.

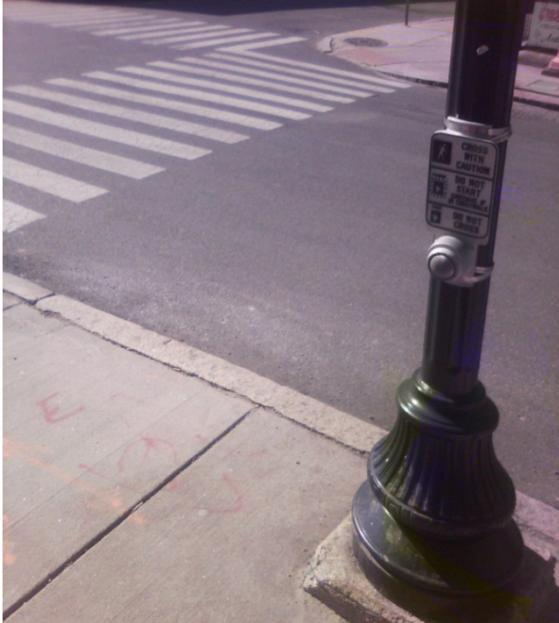
Central Street @ Highland Ave

NOT COMPLIANT- 85%

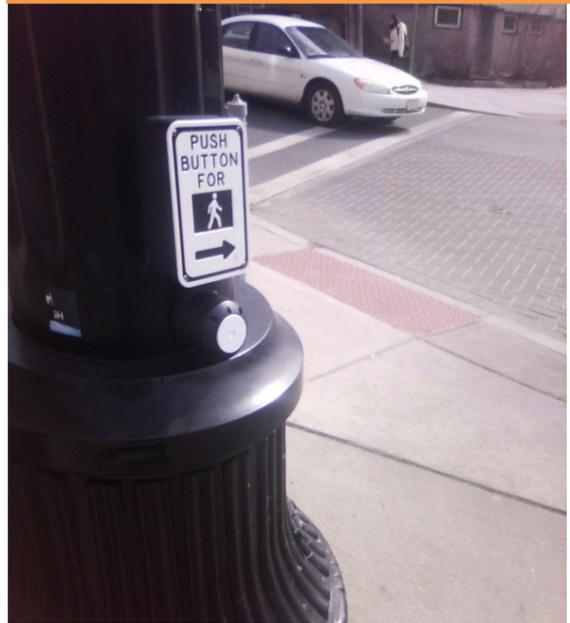
Somerville Ave @ Mossland St

PARTIAL COMPLIANCE- 7%

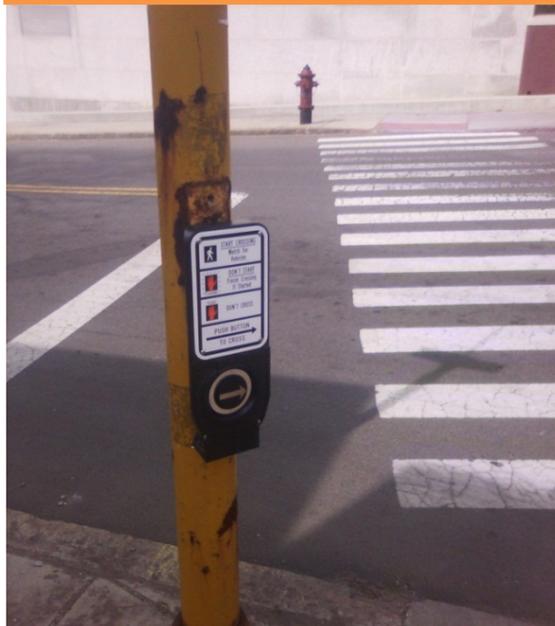
School Street @ Broadway

FULL COMPLIANCE- 8%

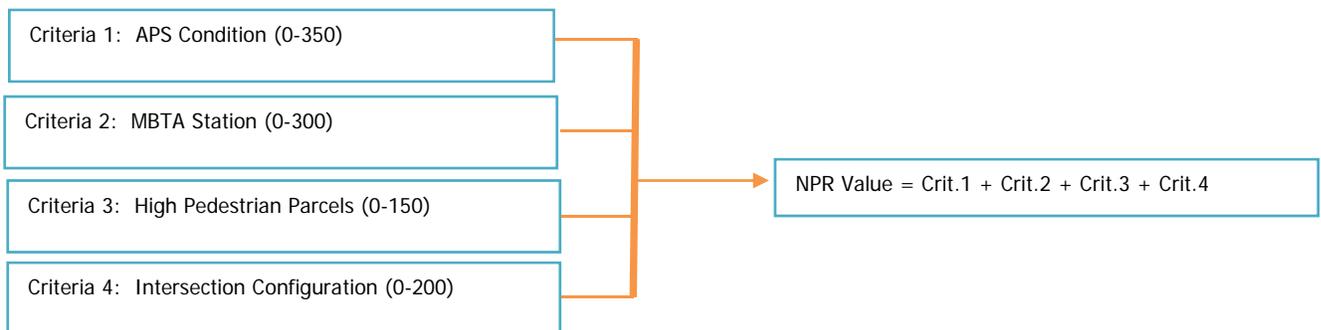
Figure 3
APS NPR Calculation Flowchart

The NPR formula adds the rankings for each criterion together to get a composite number ranking for each APS in the data set. Figure 3 below shows a flowchart of the method:

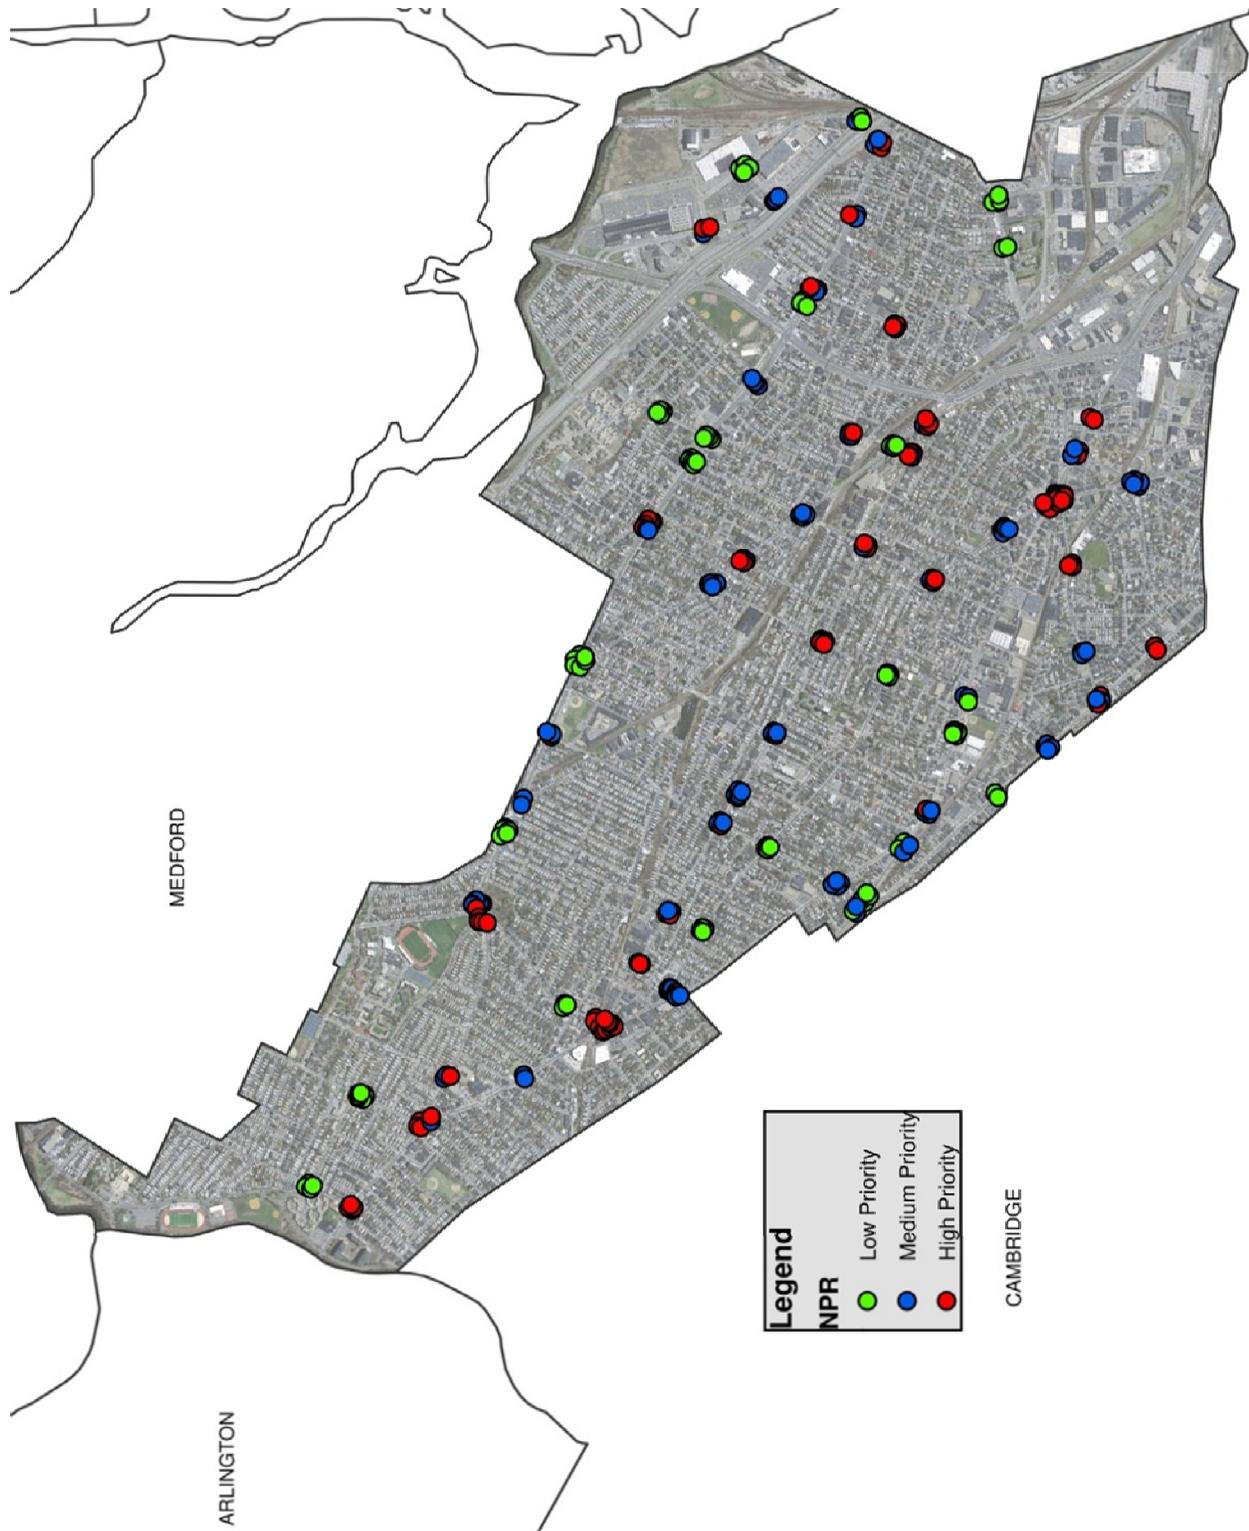
Figure 4
NPR Priority Map

Once the final NPR values were summed for all APS, they were distributed into three categories based on a geometric split. Figure 4 shows the priority levels for APS in the City of Somerville.

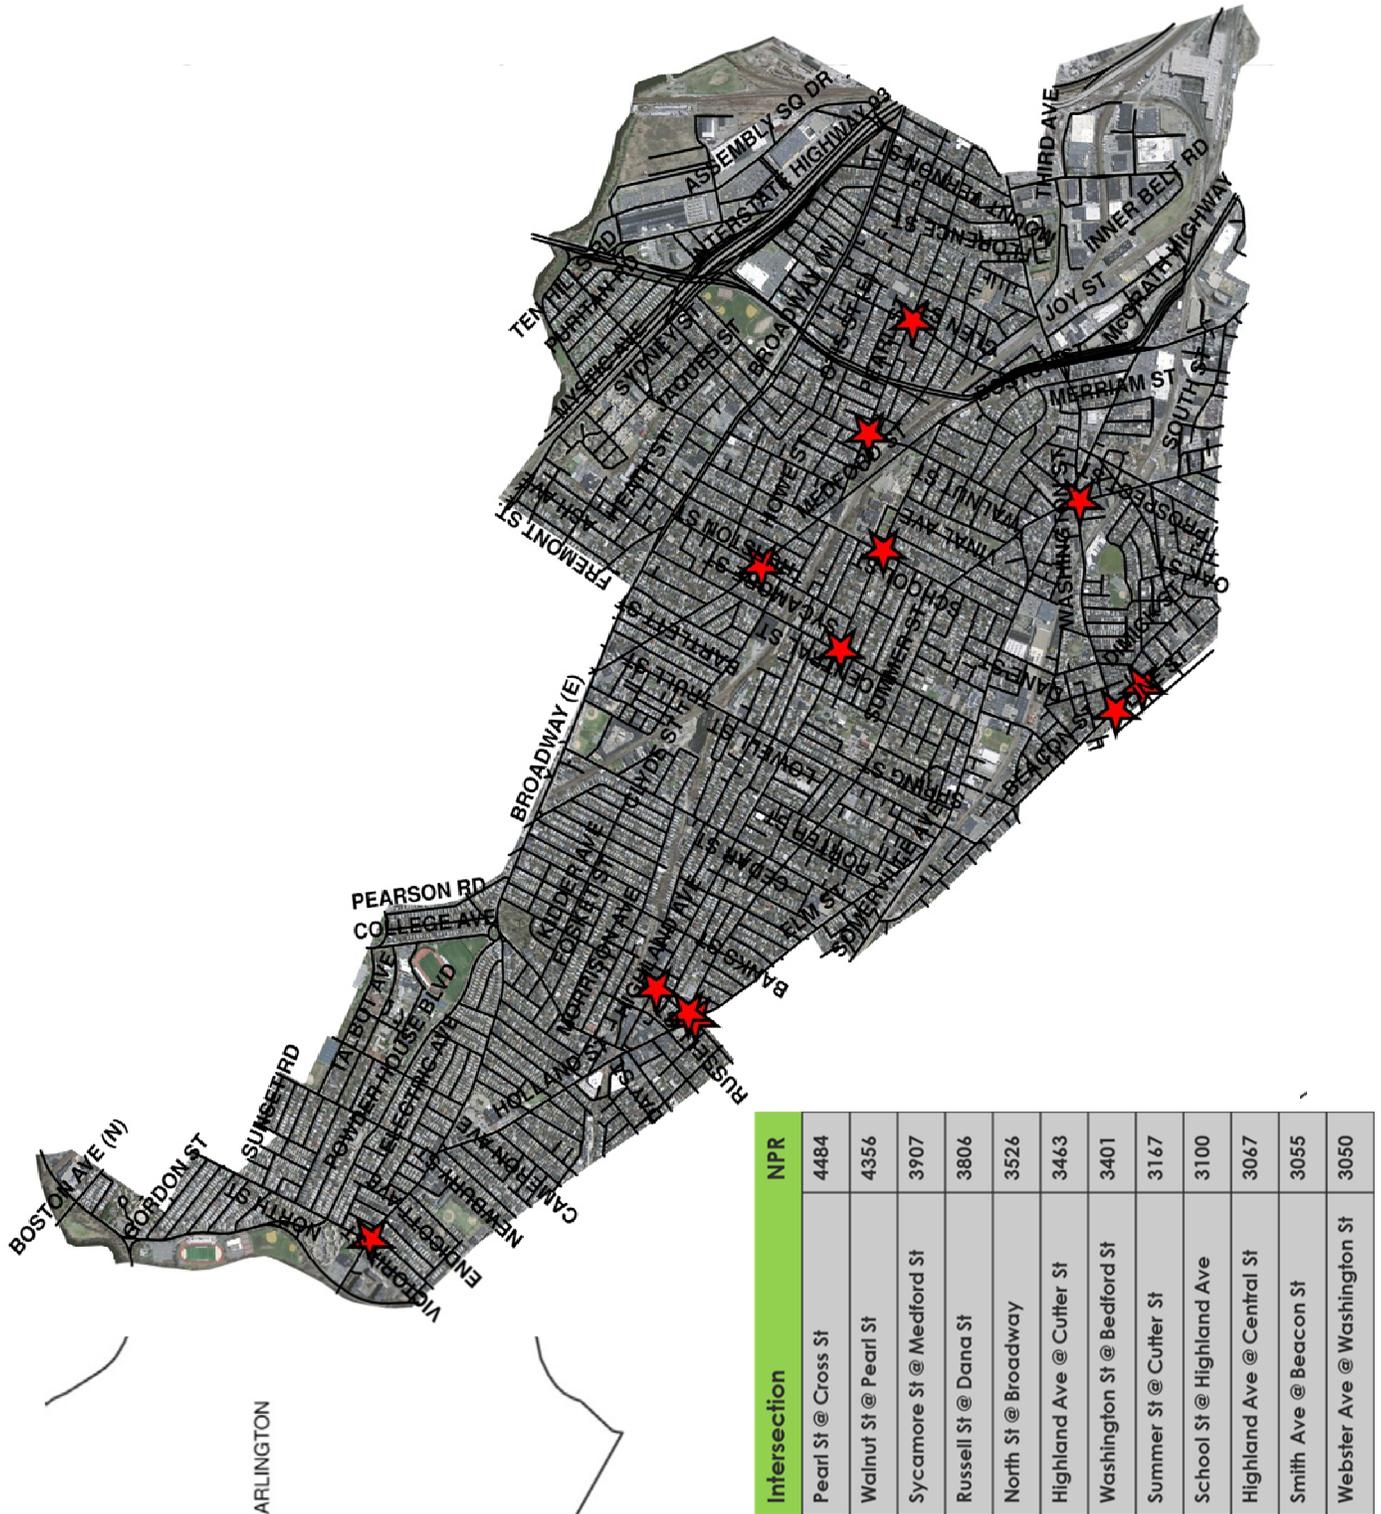
Figure 5
Cumulative Pedestrian Accessibility Intersection NPR

After the new NPR scores were calculated for all individual assets, they were summed for each intersection. Figure 5 on the next page shows the highest priority intersections for cumulative pedestrian accessibility.

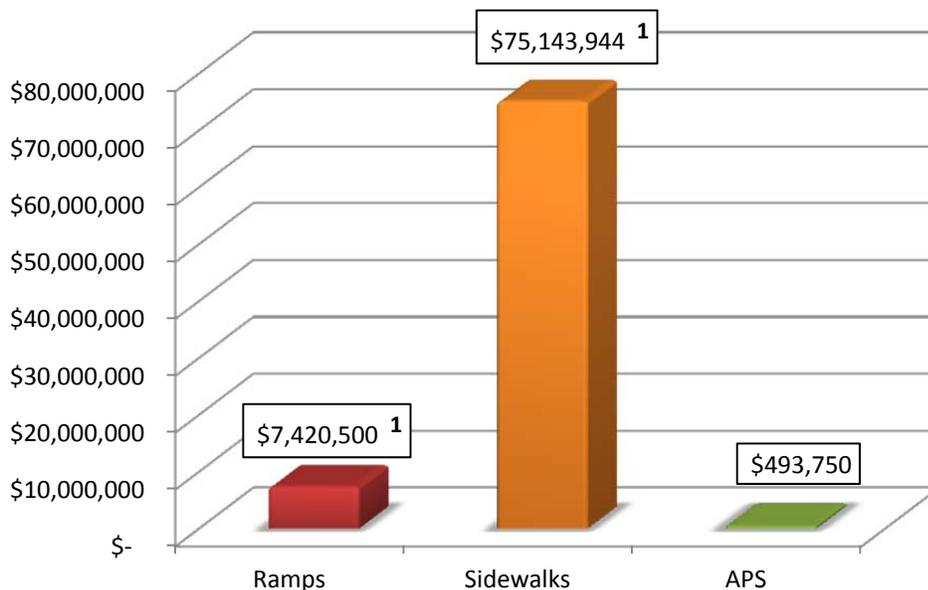
Figure 6
Cumulative Pedestrian Accessibility Backlog

In relative to the other two pedestrian accessibility assets, the repair costs for the APS is miniscule, but within a limited budget can make a difference. The Figure below shows the backlog of all three pedestrian accessibility assets, which total \$83,058,194.

Now that the City has a comprehensive understanding of its pedestrian accessibility assets, it is vital to take action and addressing the growing backlog. Currently, between sidewalk, ramps, and APS, the backlog totals to \$83,058,194. Somerville needs to increase future funding levels for all pedestrian accessibility assets. Based on this existing backlog collectively, **\$2,300,000 annually should be spent to improve the City's sidewalks, ramps, and APS.** The City should consider utilizing the cumulative multi-asset NPR approach, and focus on repairing all three assets on high priority intersections. This approach focuses on high pedestrian volume regions which are in immediate need of repair.
