PROJECT NAME: 31-33 1/2 Union Square

**CITY OF SOMERVILLE, MASSACHUSETTS
COMMUNITY PRESERVATION COMMITTEE
FY16 FUNDING CYCLE
APPLICATION COVER PAGE**

EBERLE BUILDING - FACADE RESTORATION PROPOSAL

Summary of Existing Conditions

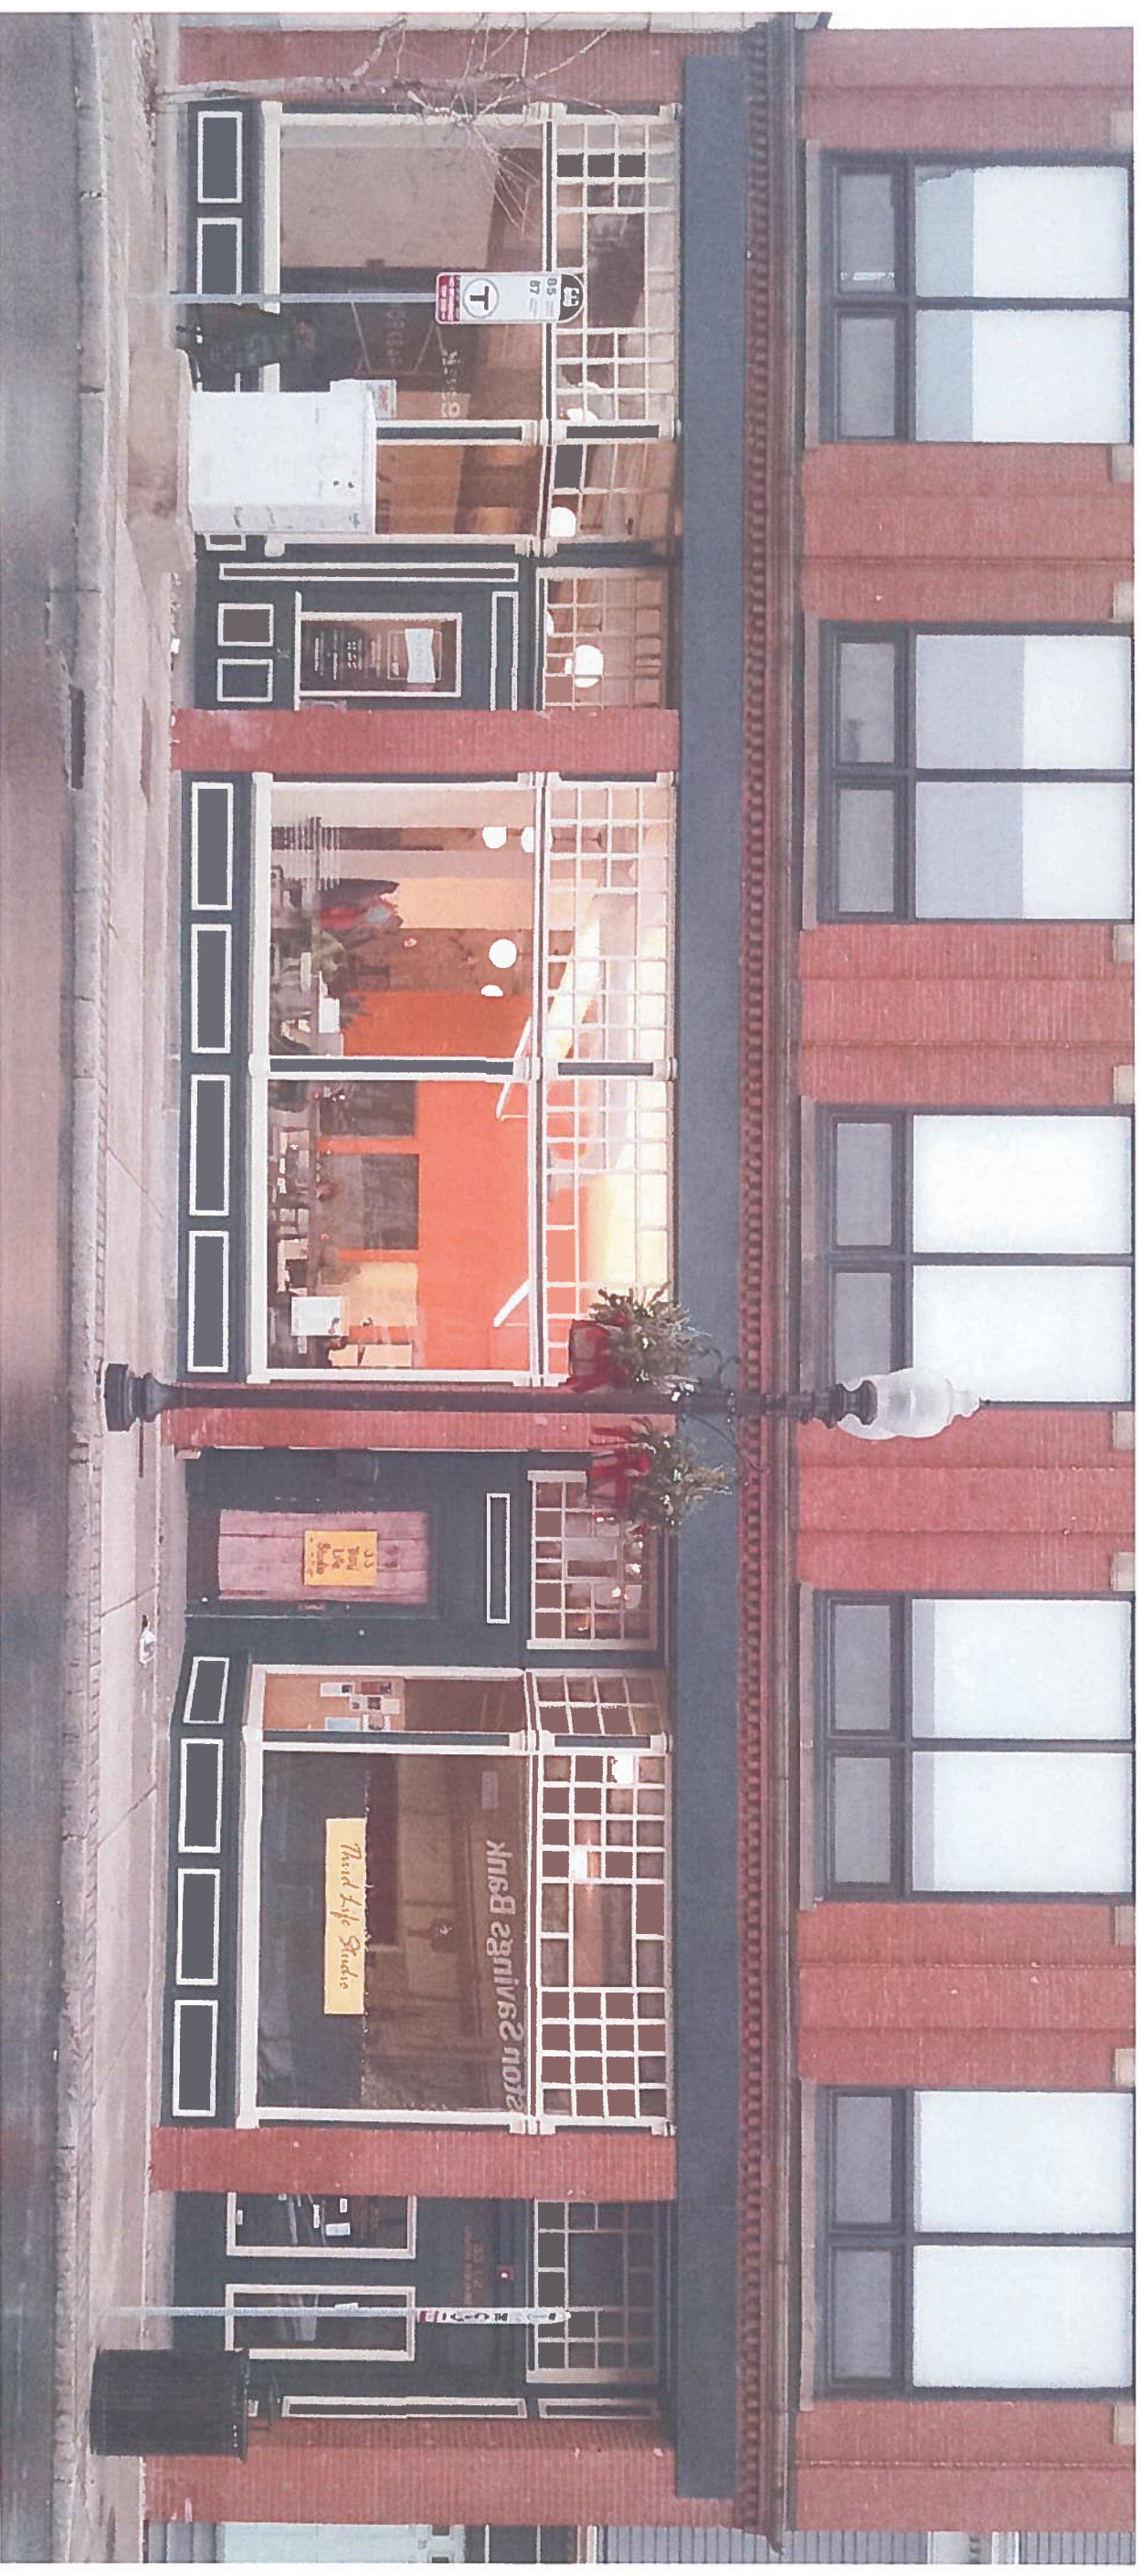
WOOD DETAILS AND CLADDING
TO BE REPAIRED WHERE REQUIRED
VERTICAL AND HORIZONTAL STEEL
STIFFENERS TO BE INSTALLED AT
INTERIOR OF STOREFRONT AS
REQUIRED FOR ADDITIONAL SUPPORT

EXISTING WOOD STOREFRONT AND CLADDING TO BE REPAIRED, WHERE REQUIRED, TO THE GREATEST EXTENT POSSIBLE. WHERE RESTORATION IS NOT POSSIBLE AND REPLACEMENT OF ITEM IS REQUIRED, REPLACEMENT WITH THE SAME MATERIALS AND DETAILS IS REQUIRED. REFINISH WITH PROPOSED PAINT COLORS

FOR IMPROVED ENERGY EFFICIENCY: ALL PLATE GLASS AT LOWER PORTION OF STOREFRONT TO BE REPLACED WITH 1" THICK INSULATING SAFETY GLASS
AT UPPER PORTION OF STOREFRONT, GLASS AND WOOD DETAIL IS TO REMAIN AND INTERIOR STORM WINDOWS ARE TO BE INSTALLED

CLEAN / REPAIR EXISTING BRICK AS REQUIRED

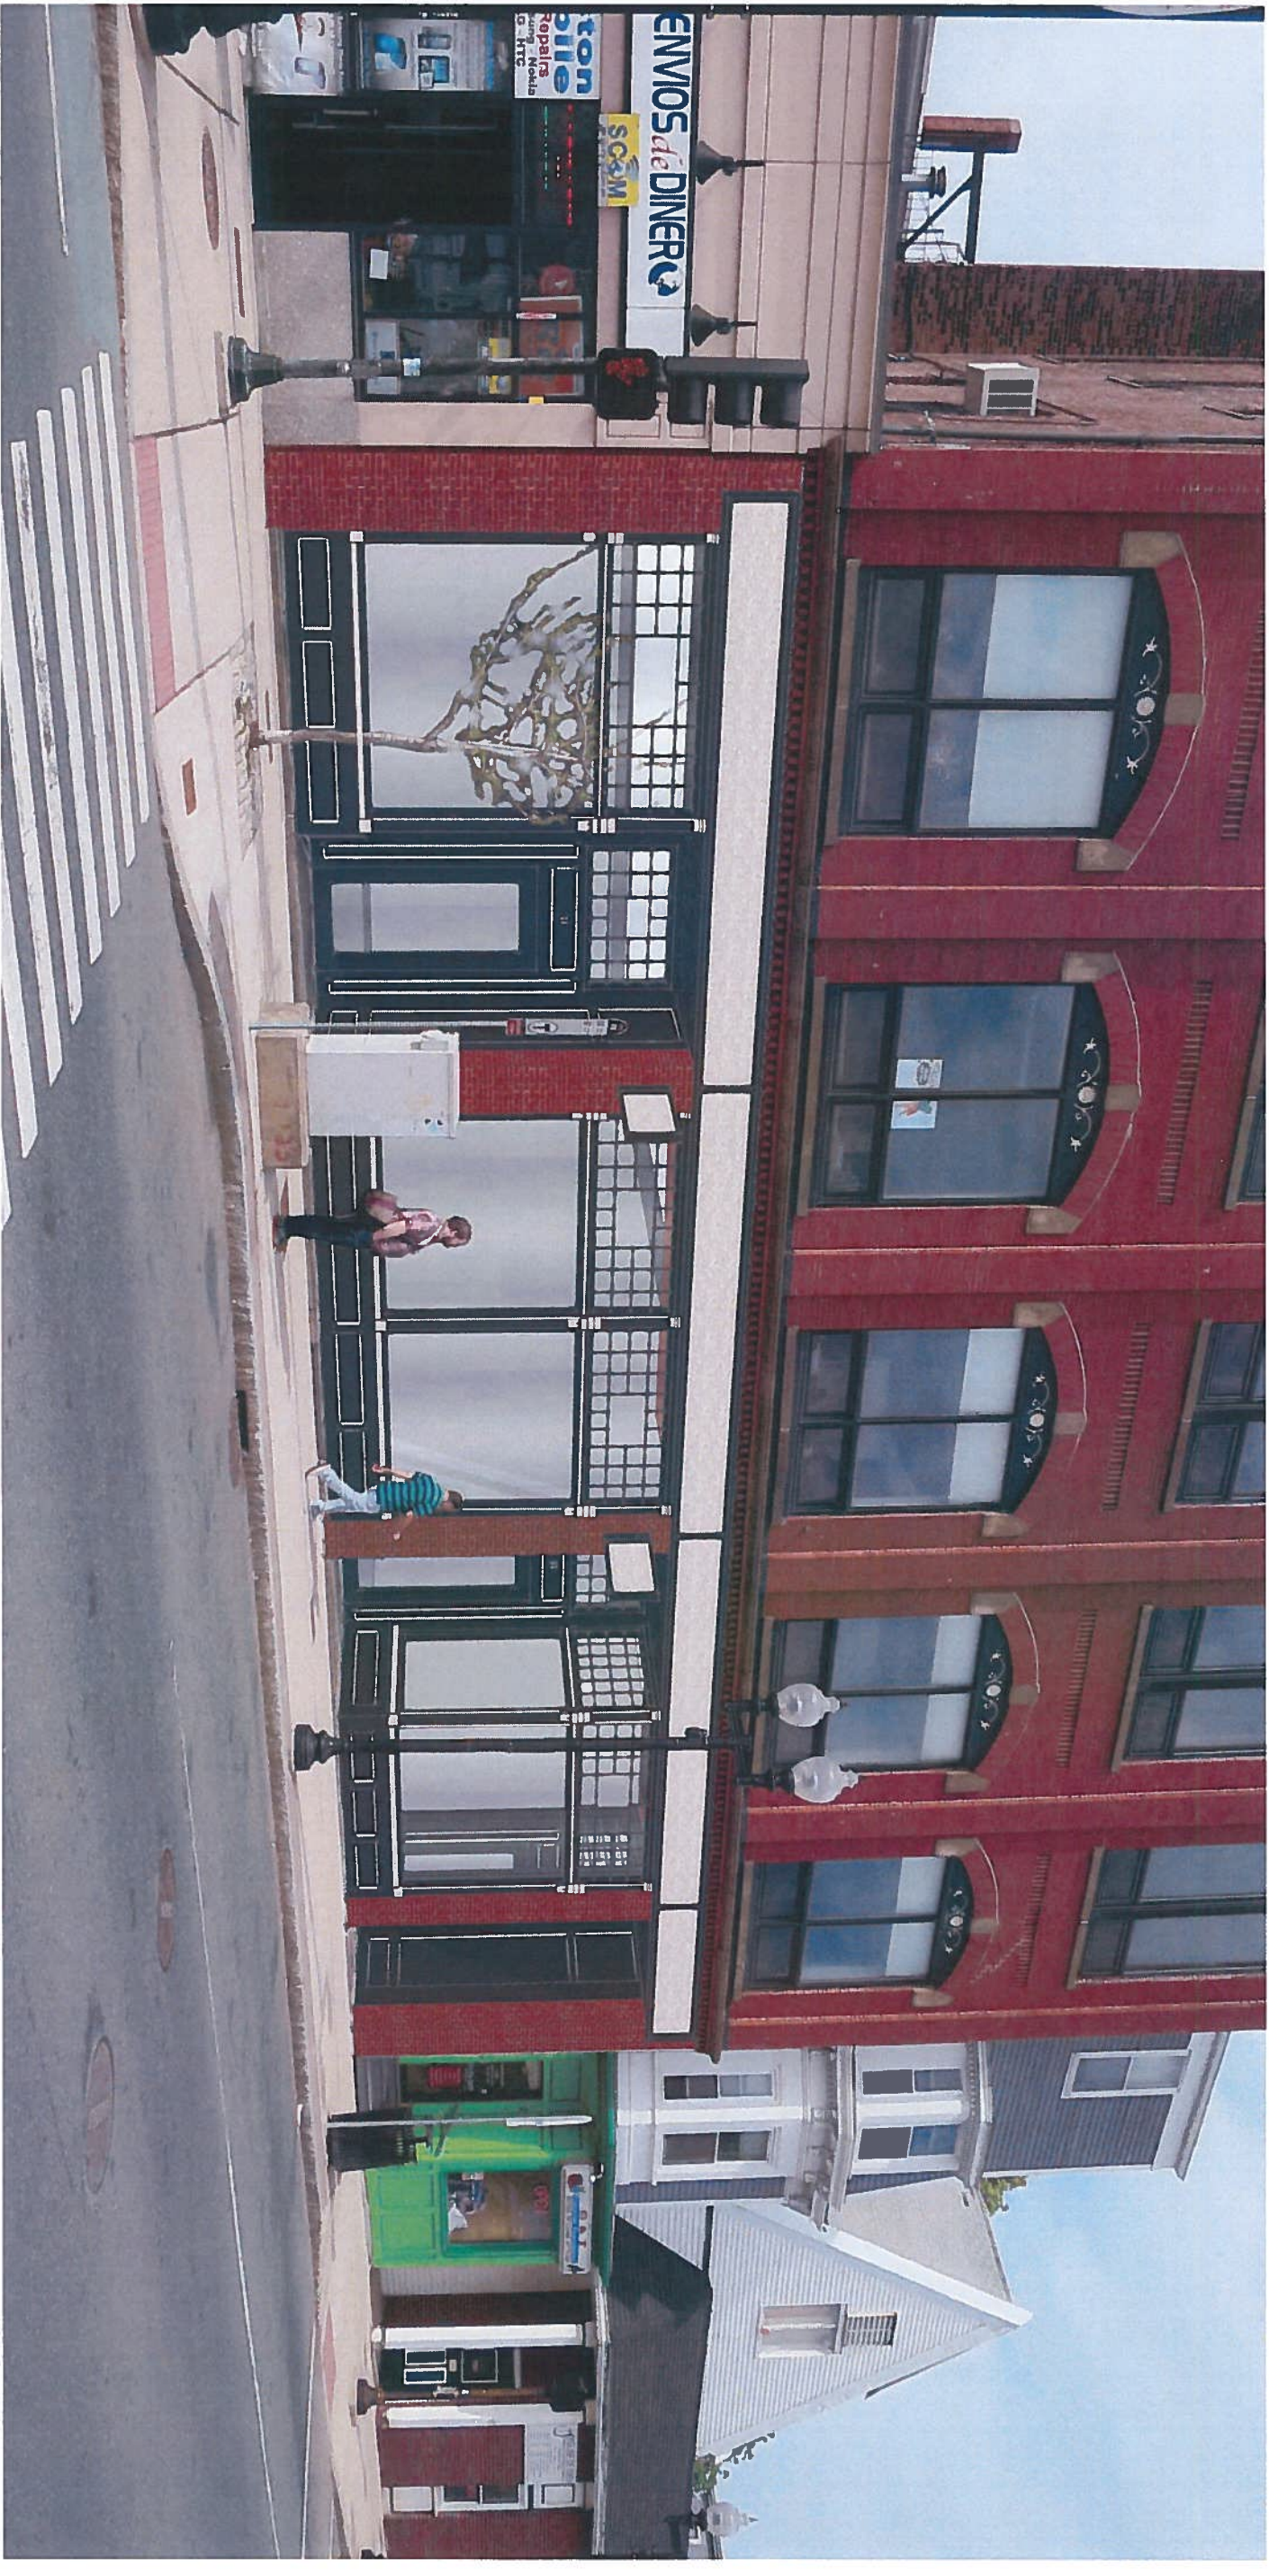
PROPOSED STOREFRONT

PROPOSED COLOR - 2128-10 BLACK BEAUTY (BENJAMIN MOORE)

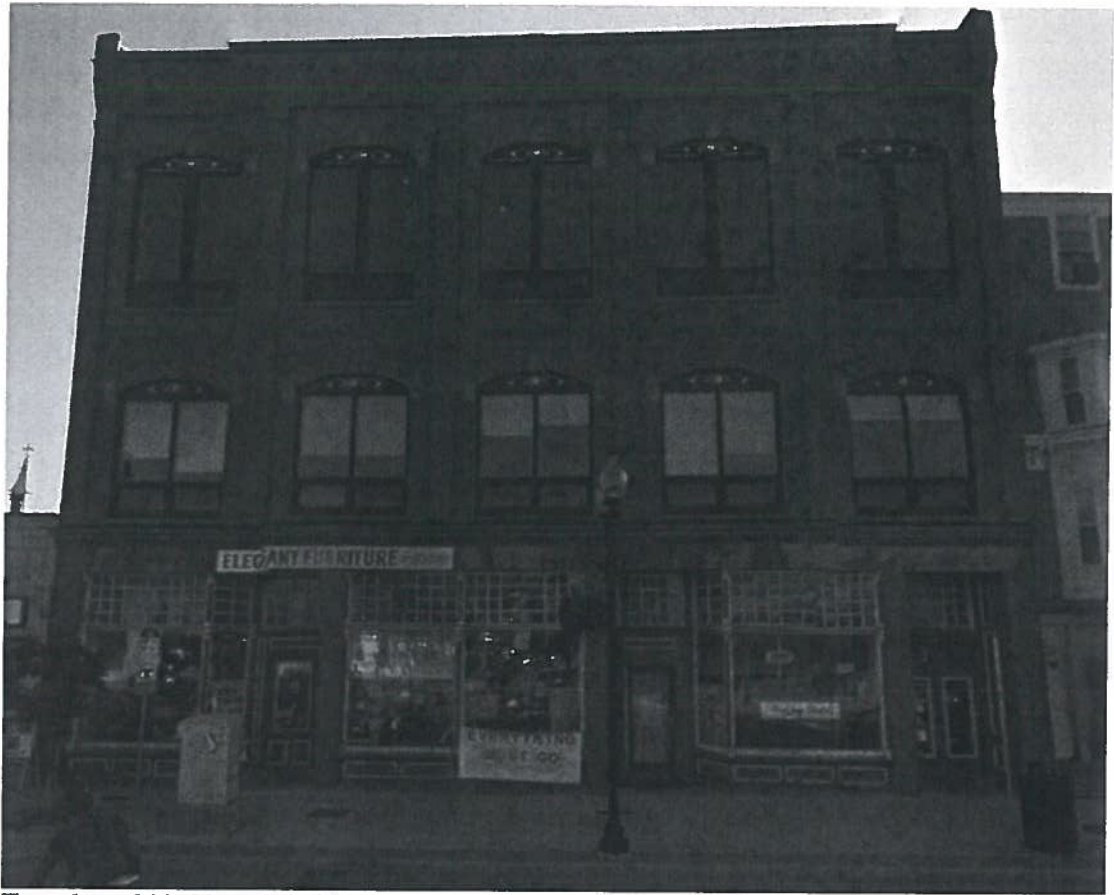
Facades of 31, 33 and 33 ½ Union Square Facing Somerville Avenue in Somerville, MA

The three-story exterior masonry and wood-framed building facing Somerville Avenue at 31, 33 and 33 ½ Union Square in Somerville has an existing storefront that appears to be composed of a wood-stud and plywood sheathed base, approximately 24 inches high, lower and upper glazing surrounded by light wood vertical posts and horizontal narrow intermediate wood girts and heavier wood sills.

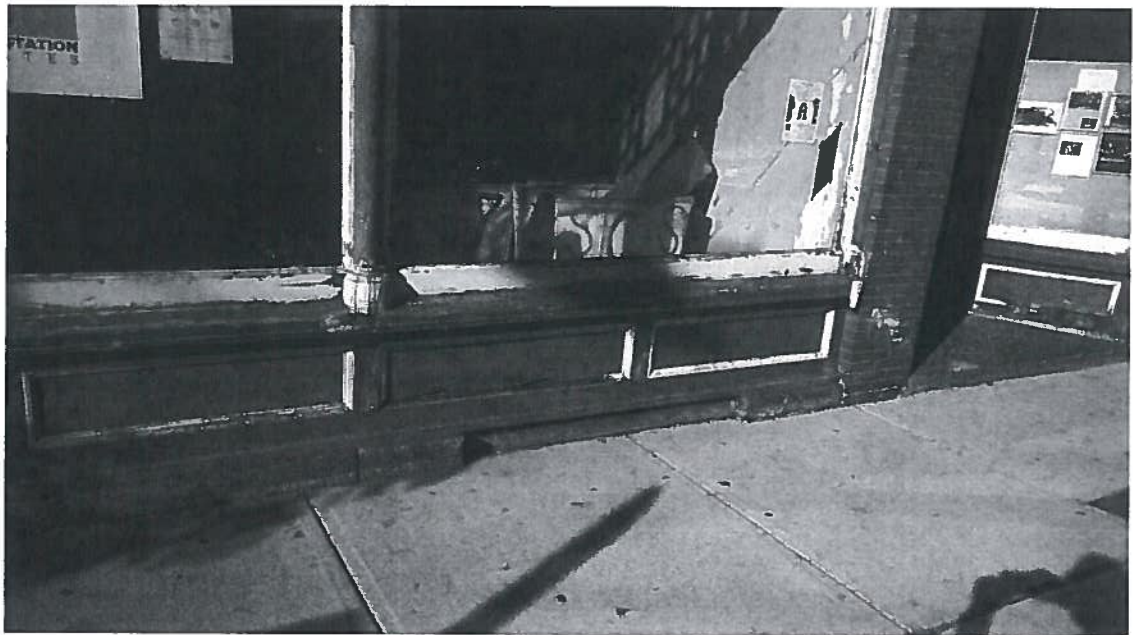
Plywood-Sheathed and Wood-Stud Base, Sill, Center and End Decorative Wood Posts, and Brick Column at Lower Glazing of Storefront Construction

- The panels between brick masonry piers appear to bow outward noticeably at the center. The thin decorative posts do not appear to be structurally adequate to span 10'-4" under even moderate lateral loads. The base spans from the foundation walls to the wood sills, which must span long distances, as wall girts, between masonry piers.

It is our professional opinion that the existing storefront is in poor structural condition. In order to restore the storefront to a structurally adequate condition, we recommend that the framing be dismantled and reconstructed using new, structurally sound framing elements and glazing that replicate the desired historic conditions while meeting the minimum requirements for structural safety and serviceability of the Massachusetts State Building Code.

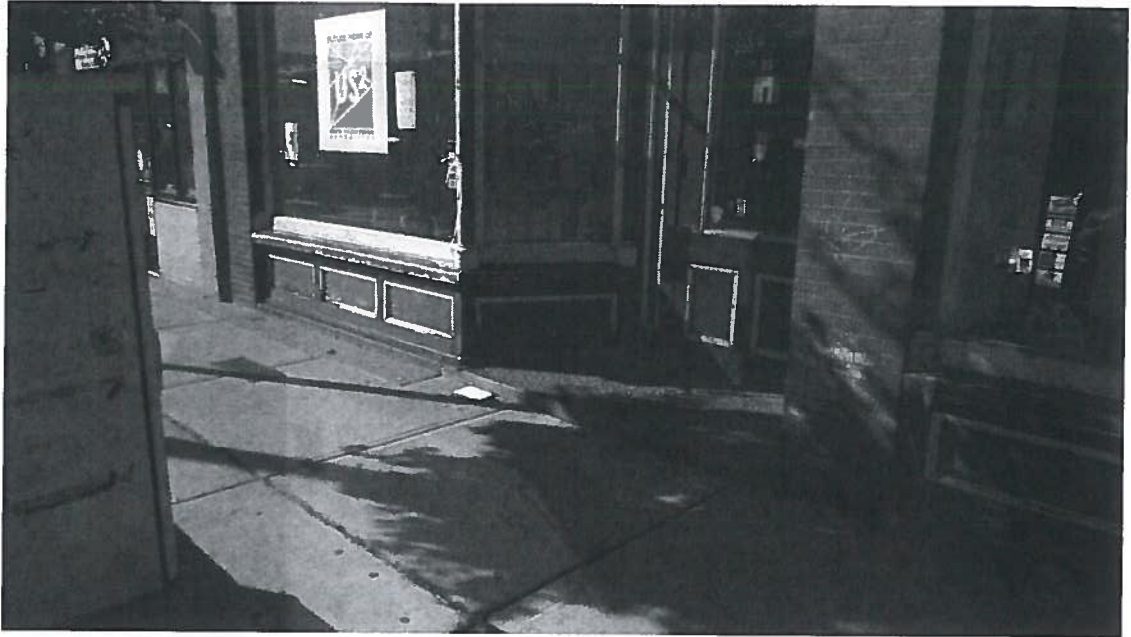
Lower Storefront at Entry to 31 Union Square

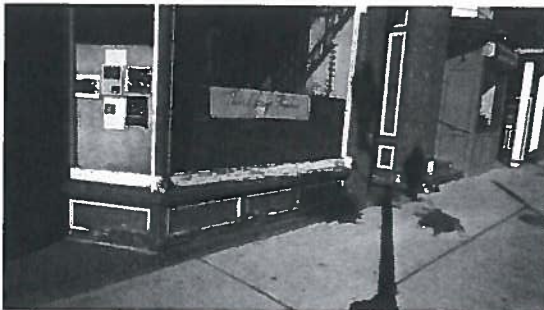
Deteriorated Plywood Base Sheathing

- The plywood at the base has deteriorated to the point where it can be crushed by hand.
- Some of the lower trim has disintegrated and disappeared.
- The vertical decorative wood posts have not been maintained and are cracked. One post includes two replacement “Dutchman” repairs.
- The upper glazing panel wood mullions and the narrow intermediate wood girts appear to have sagged and separated from their supports. Some mullions are desiccated and no longer appear to absorb and hold paint.

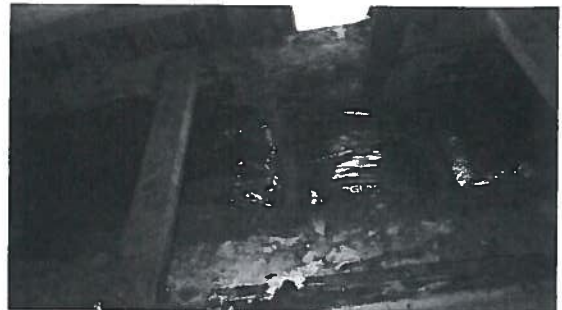
- The covering on the podium beams appears to have been replaced with plywood within the past 20 to 30 years (plywood was not used when the building was reportedly constructed).
- The sheathing and decorative trim on the base appears to have been replaced with painted plywood and ordinary wood molding trim within the past 20 to 30 years.
- The wood stud framing, or at least some of the stud framing, of the base appears to have been replaced with more modern wood studs (see photograph below).
- The 1/4" plate glass lights in the lower glazing also appear to be relatively modern, as such glazing did not exist in the 1880s.

Modern Base Wood Studs
