**CITY OF SOMERVILLE, MASSACHUSETTS**  
**COMMUNITY PRESERVATION COMMITTEE**  
**FY21 FUNDING CYCLE**  
**APPLICATION COVER PAGE**

PROJECT NAME: Grace Baptist Church

PROJECT LOCATION: 59 Cross Street, Somerville, MA 02145

ONE SENTENCE DESCRIPTION OF PROJECT: Repair of existing slate roof & replacement of related flashing & gutters; repointing of brick masonry; replacement of entry doors & hardware; new accessible exterior entry ramp to lower level.

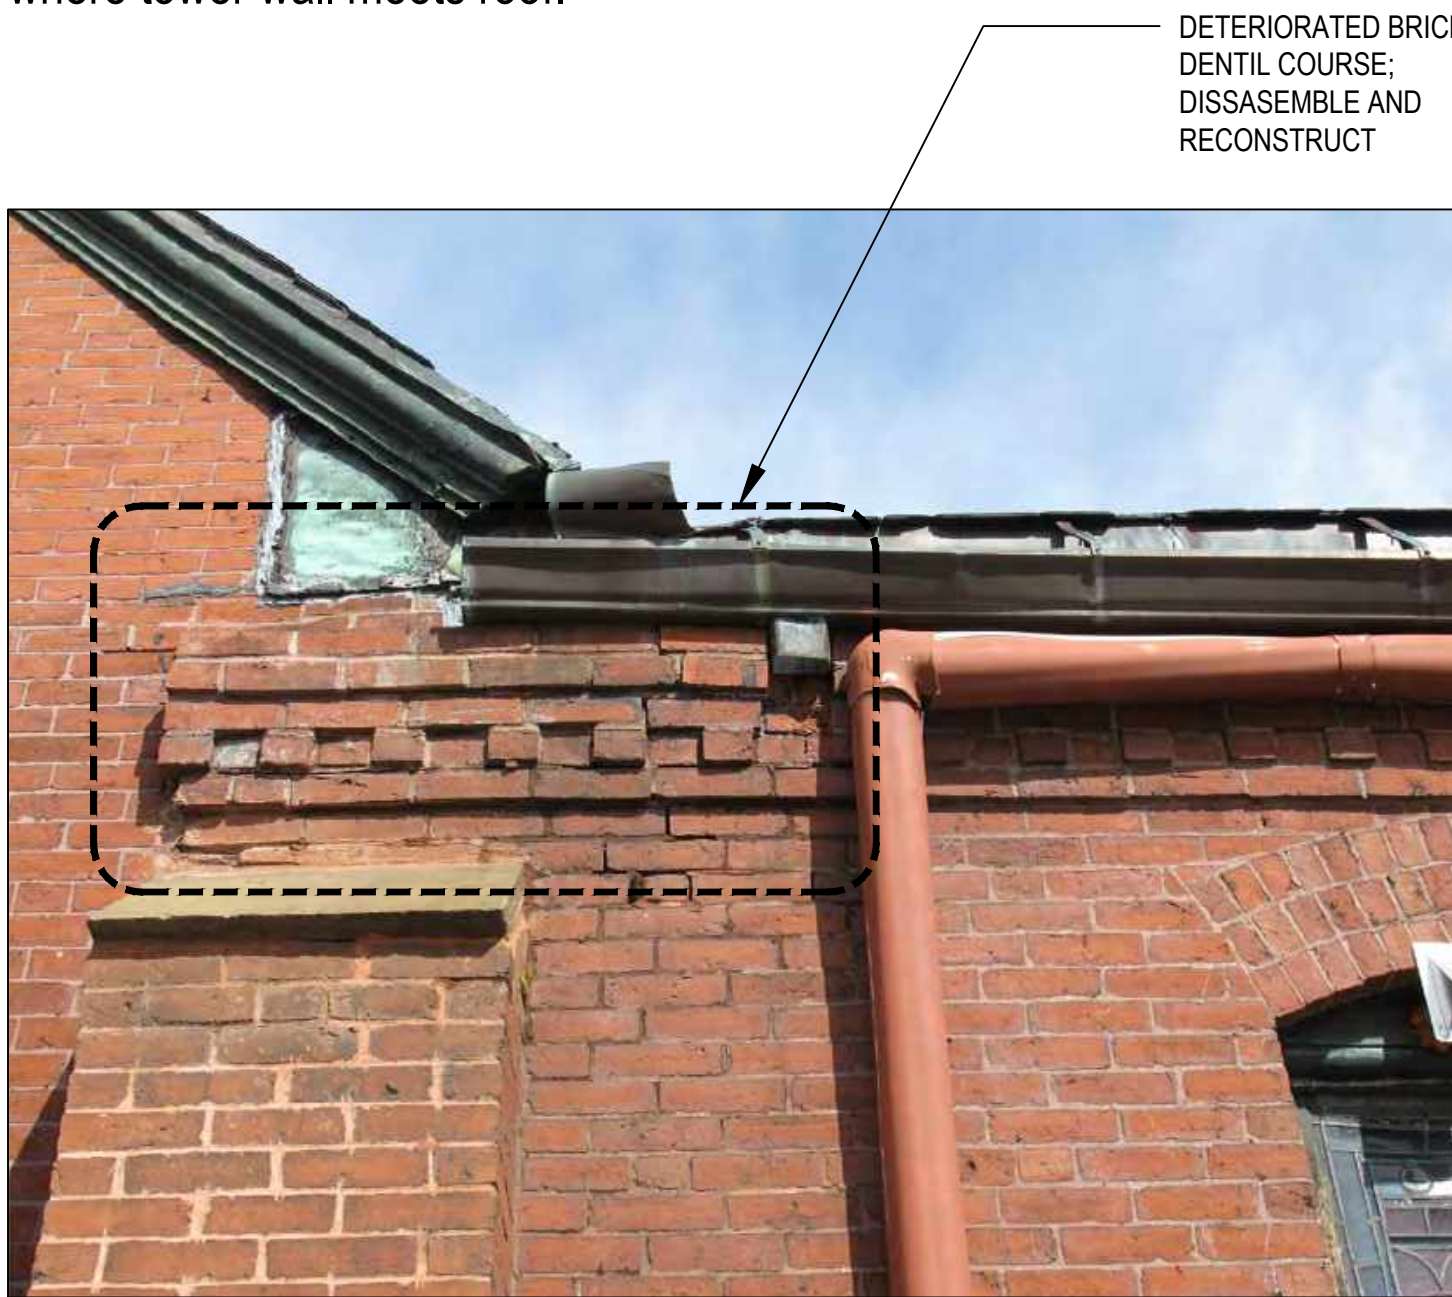
3 4.1 SOUTH ELEVATION - BRICK DENTIL DETERIORATION  
Scale: 1/8"=1'-0" @ 24 X 36 PRINT

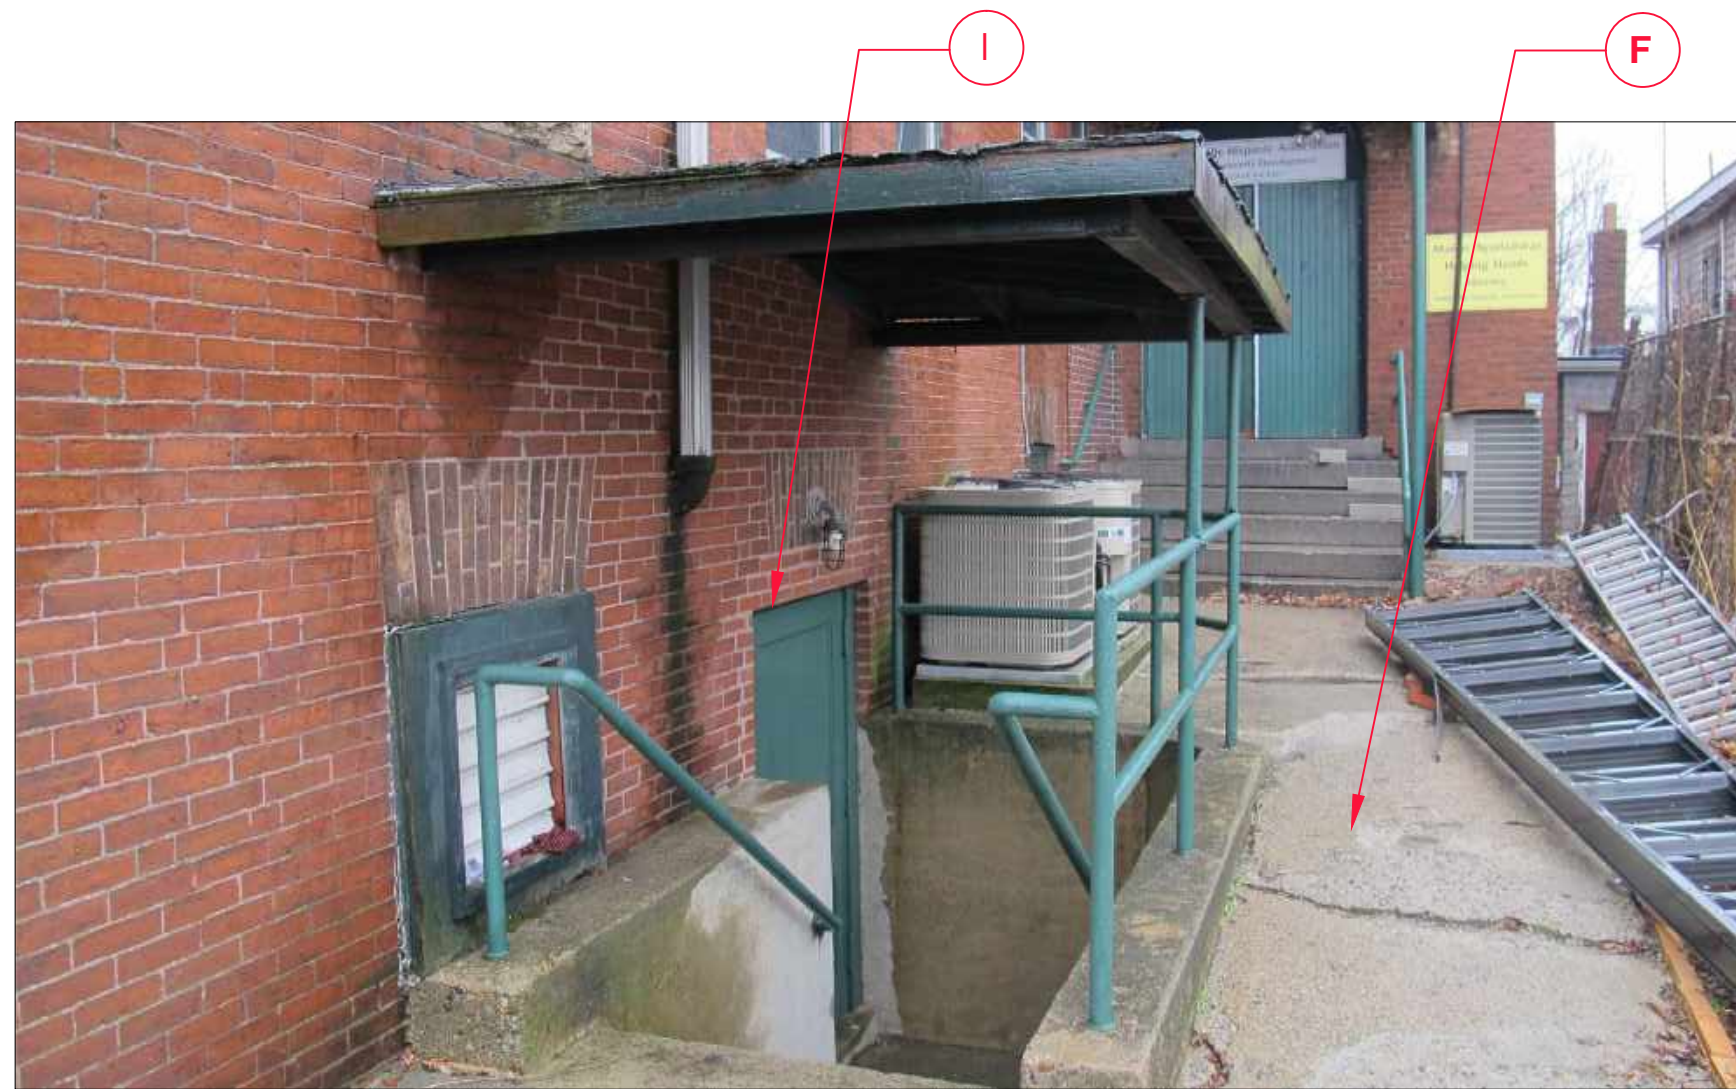
PHOTO 1: Existing stair where new accessible entrance is to be located. Note: stairs up to Sanctuary beyond.

3. See Photos #3 and #4 on Sheet A-202 for existing double doors at south entry.
4. See Photos #1, #2, #3, #4, #5 and #6 on Sheet A-500 for existing entry to lower level Social Hall and existing stairs to northwest tower; also, for interior photos of existing conditions within lower level Social Hall.

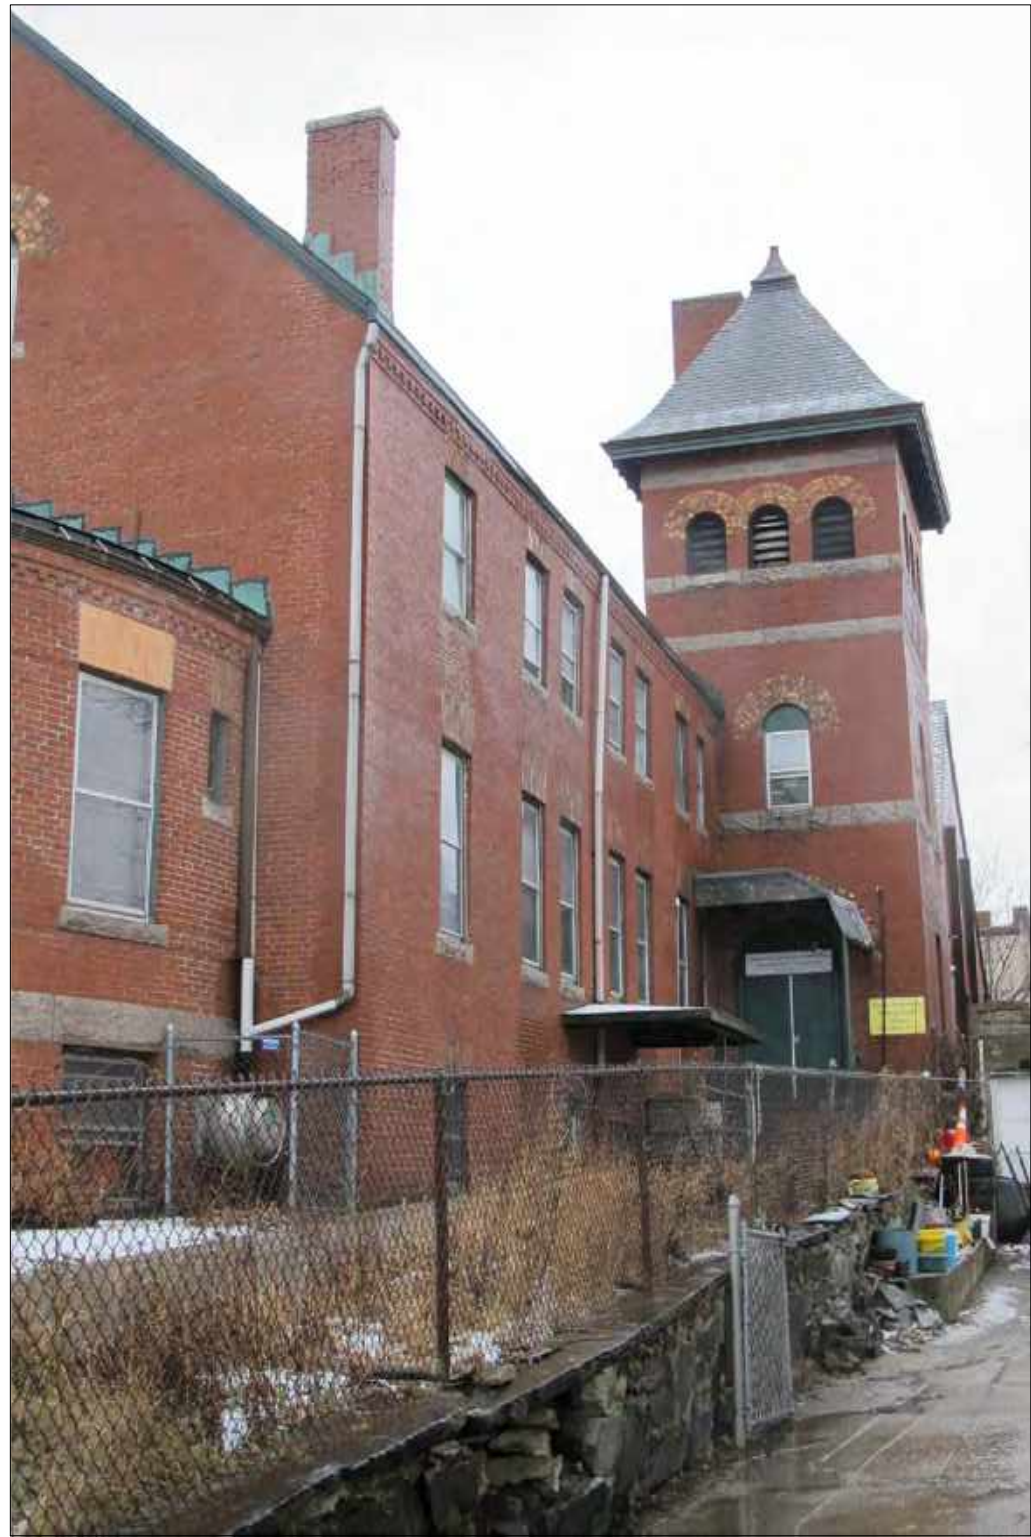
PHOTO 4: Existing area between Somerville Hispanic Church and neighbor's property. Note: new walkway and accessible entrance to be built at this location.

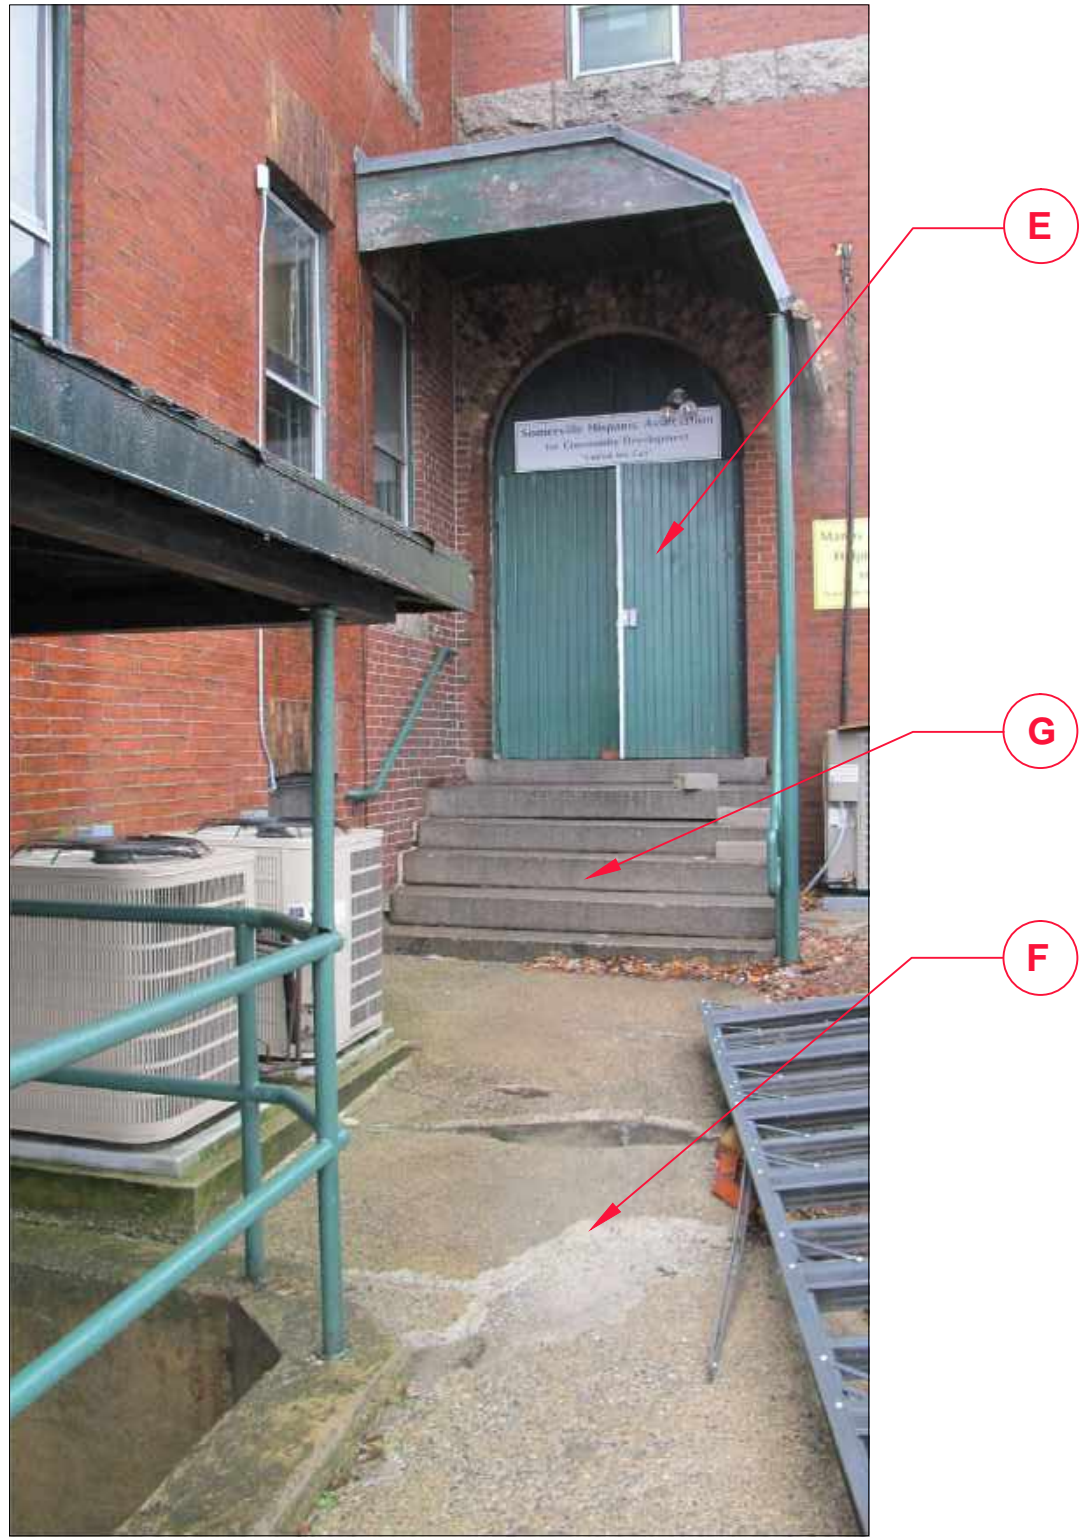
PHOTO 5: Existing door and stairs at Sanctuary entrance.

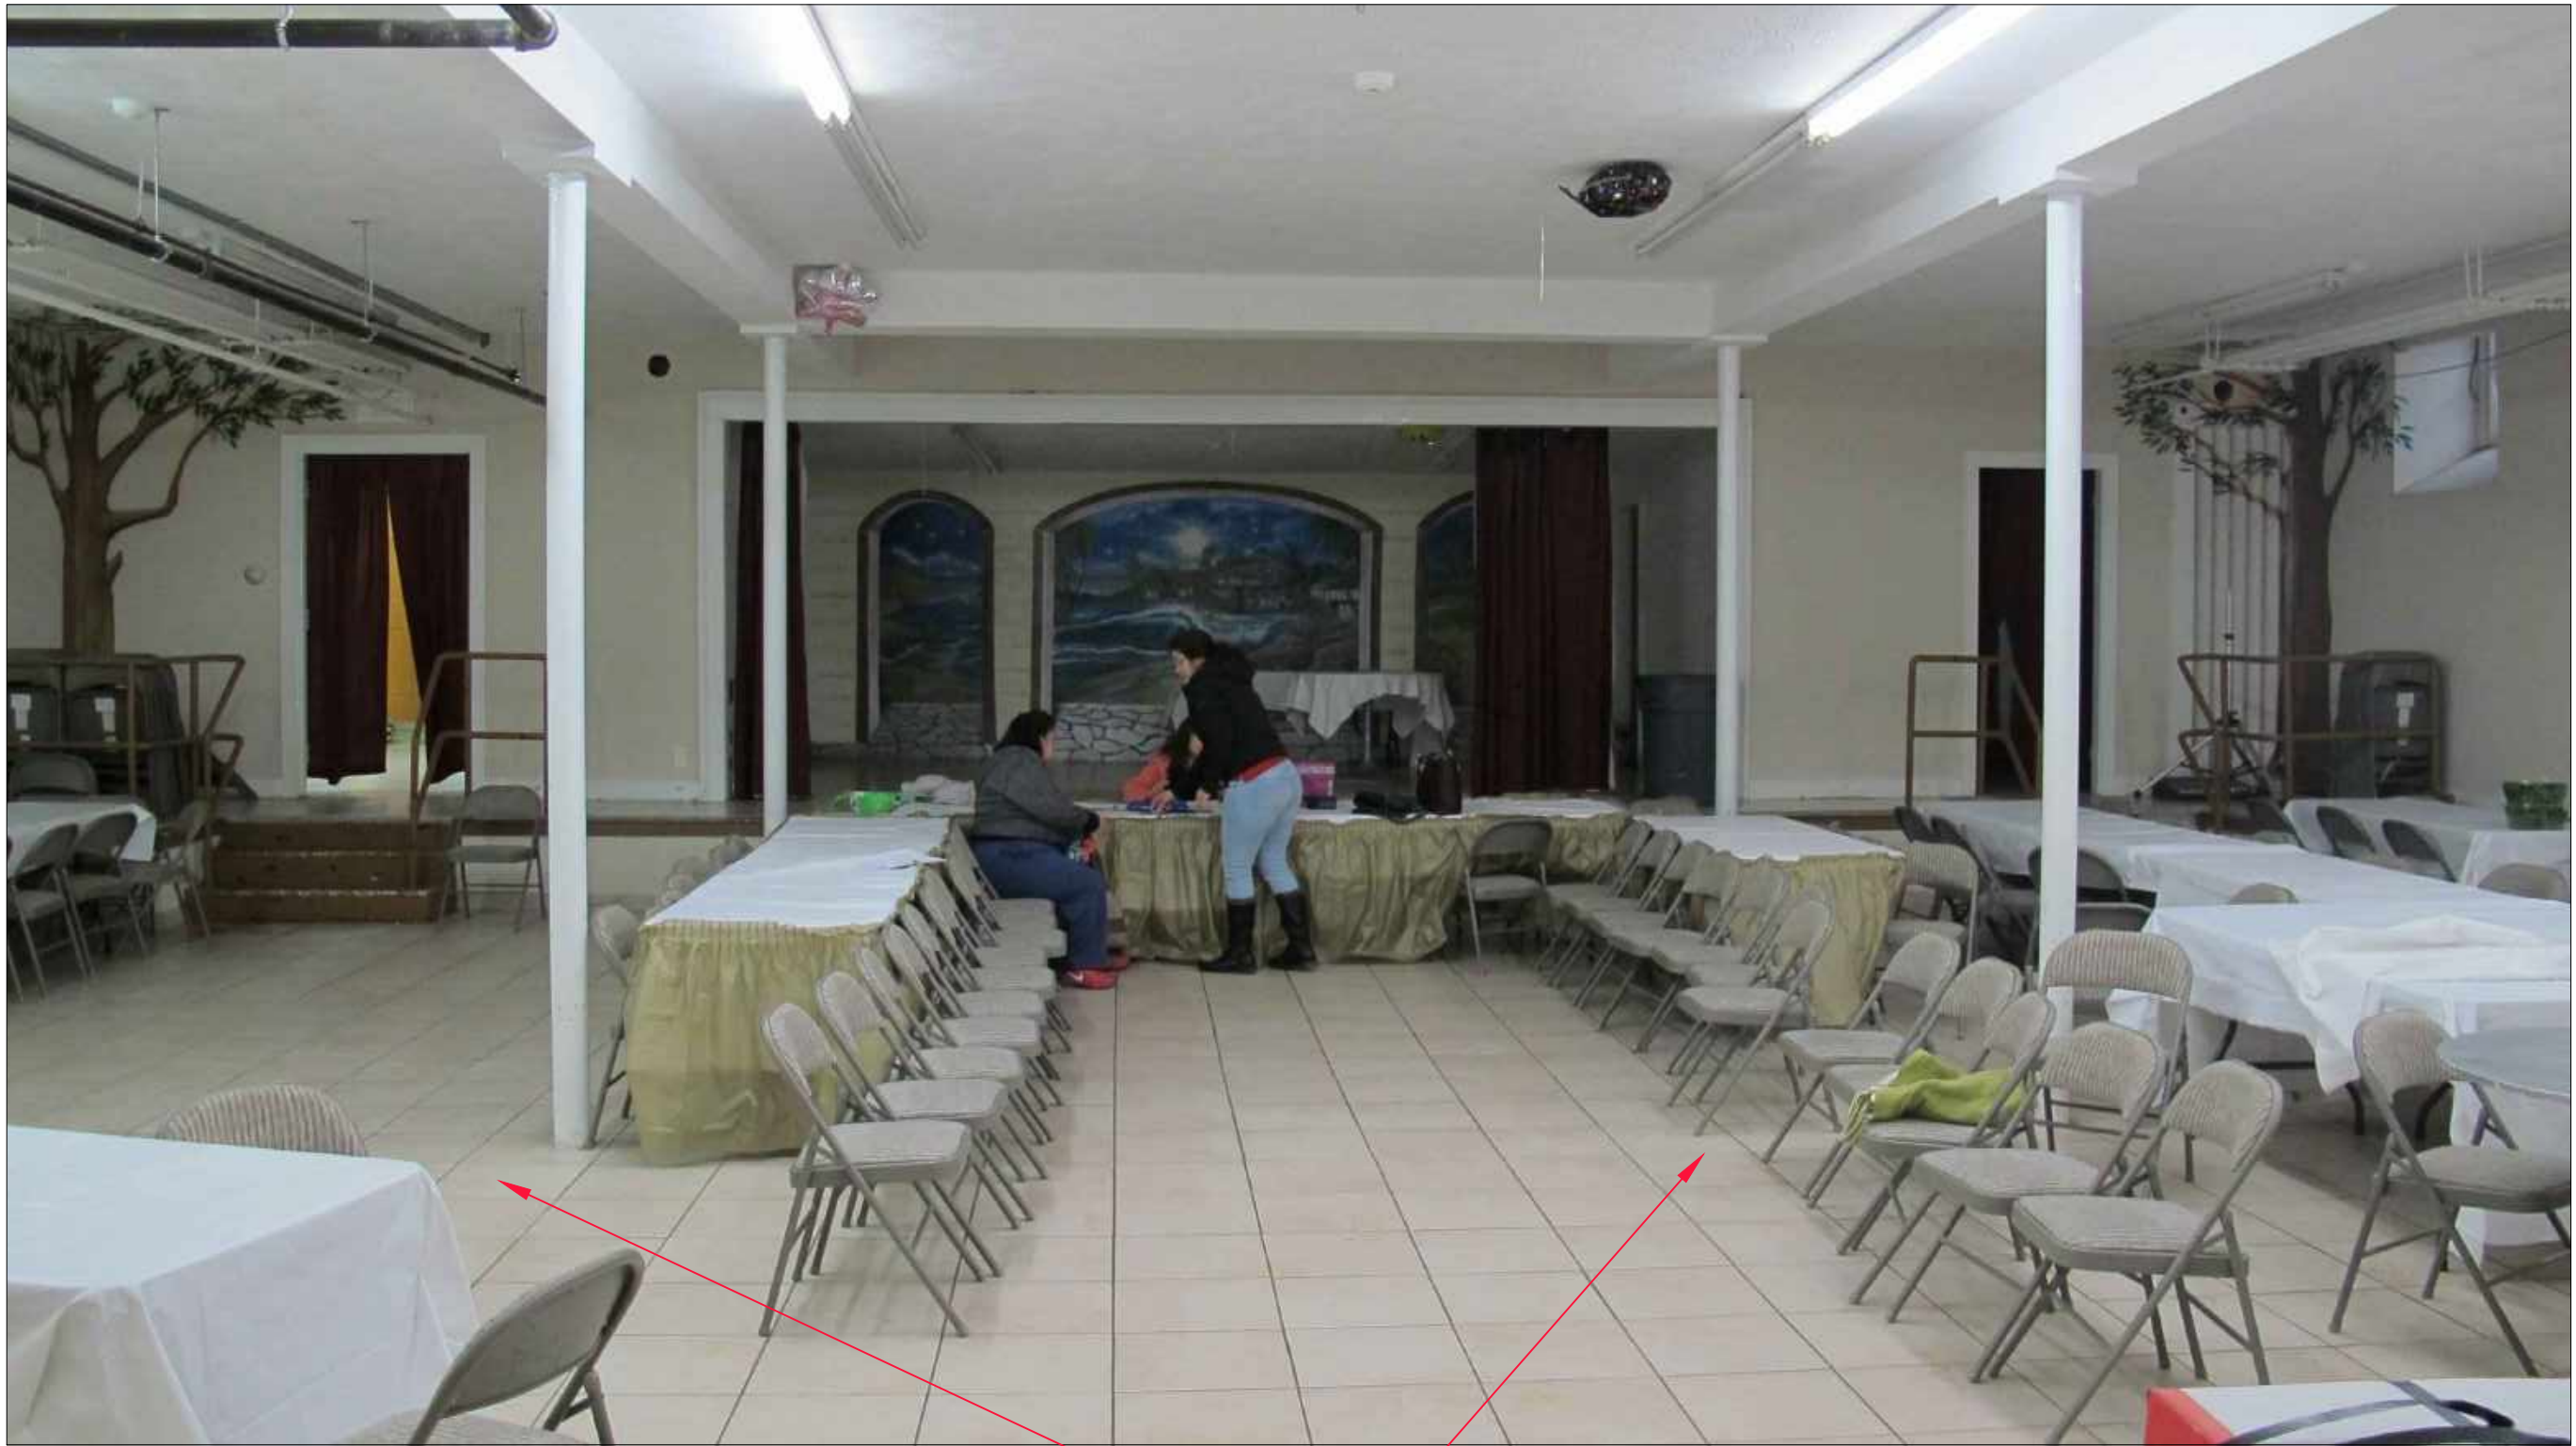
PHOTO 6: Existing Social / Dining room in basement. Floor to be raised to match the elevation of the stage area beyond.
