# Orientation - Overview Photographs | Primary Approach Sightline

Branch: Somerville Broadway
Address: 125 Broadway
Date: 7/16/2013
Page: 13

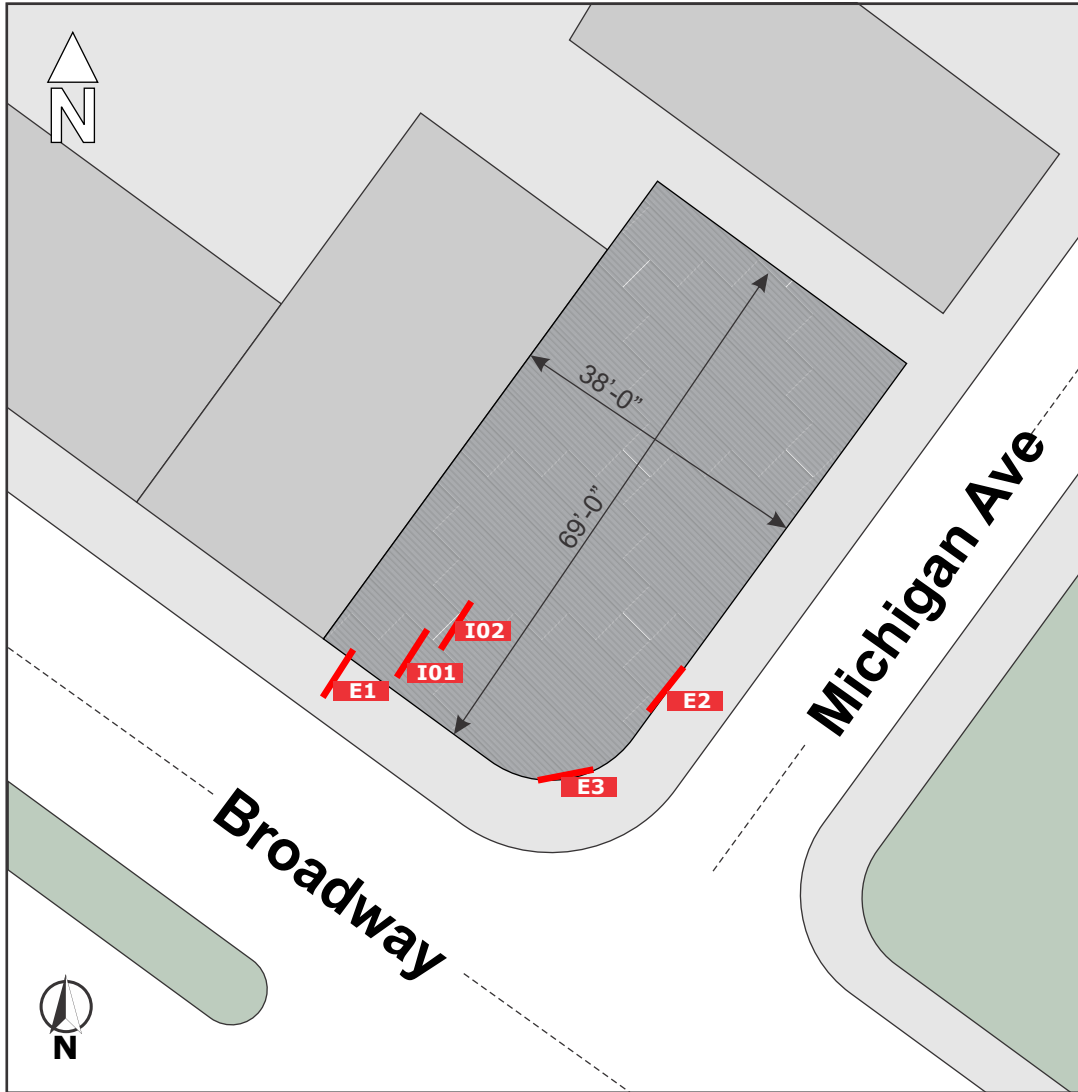
# Orientation - Existing Signage Distribution Map

Key	Sign	Sq.ft.
E01	D/F Blade Sign	43.75
E02	Wall Cabinet	56
E03	Door Vinyl	N/A
I01	ATM Header	N/A
I02	ATM Header	N/A

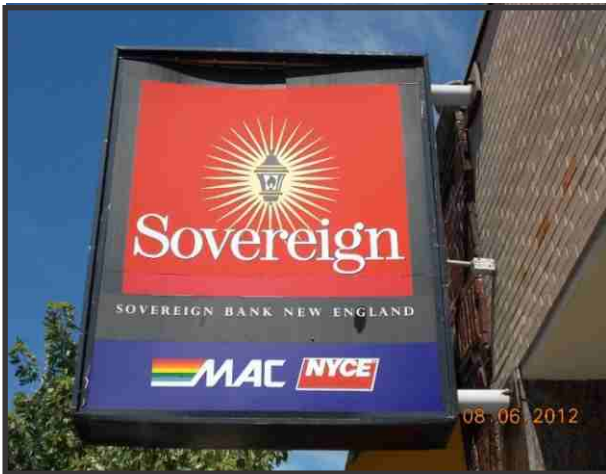
Sign #	E01
Photo #	1
Sign Type	D/F Blade Sign
Sign Measurement	87.5" x 72"
Total SQ.FT.	43.75
Sign Material	Aluminum
Illuminated	Yes-Internal
Quantity	1
Etc.	N/A

# Recommendation: E01 – Plate Letters On ACM

Recommended Action: Remove Blade/Replace

Sign Type: Plate Letters On ACM Panel

Mode#: W-PLH-18 On ACM

Signage Copy: Santander

Comments: Center on Fascia Areas

\*Restore Walls As Needed

\*Signs To Be Externally Illuminated By  
Gooseneck Lighting (At Least 5 Per Sign)

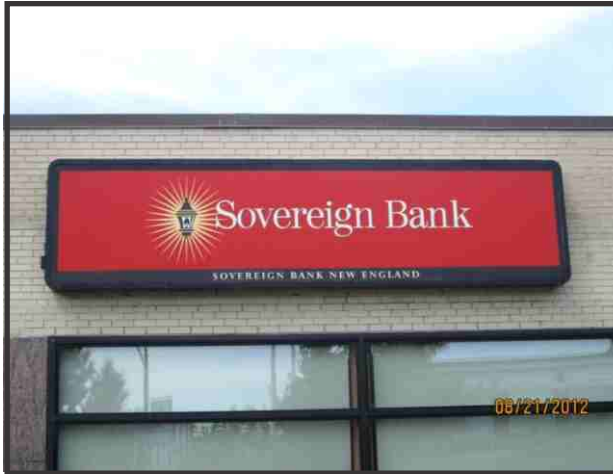
Sign #	E02
Photo #	2
Sign Type	Wall Cabinet
Sign Measurement	48" x 168"
Total SQ.FT.	56
Sign Material	Aluminum
Illuminated	Yes-Internal
Quantity	1
Etc.	N/A

Removal Only

Recommended Action: Removal Only

Sign Type: S/F Wall Sign

Sign Type Description: Int. Illum. Wall Sign

Signage Copy: Sovereign Bank

**\*Existing Sign To Be Removed & Replaced By SB-2 Sign Band (See E01)**

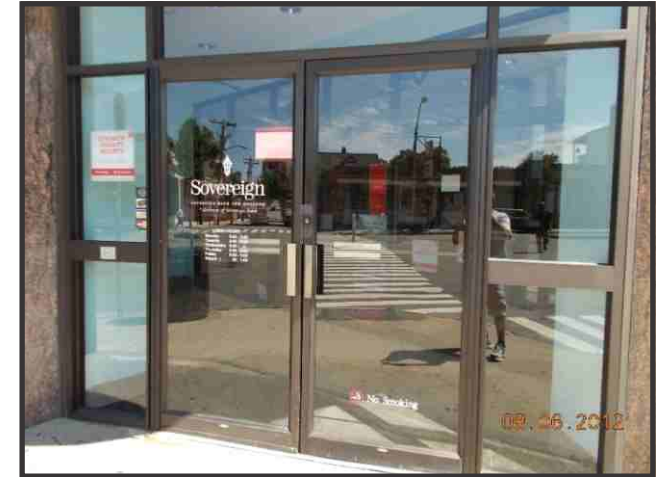
Sign #	E03
Photo #	3
Sign Type	Door Vinyl
Sign Measurement	24" x 24"
Total SQ.FT.	4
Sign Material	Vinyl
Illuminated	No
Quantity	1
Etc.	N/A

# Recommendation: E03 – Door/Window Vinyl

Recommended Action: Remove & Replace  
 Sign Type: Double Door Entry Vinyl w/ Sidelight  
 Sign Material: Vinyl

Confirm Hours Info W/ Santander

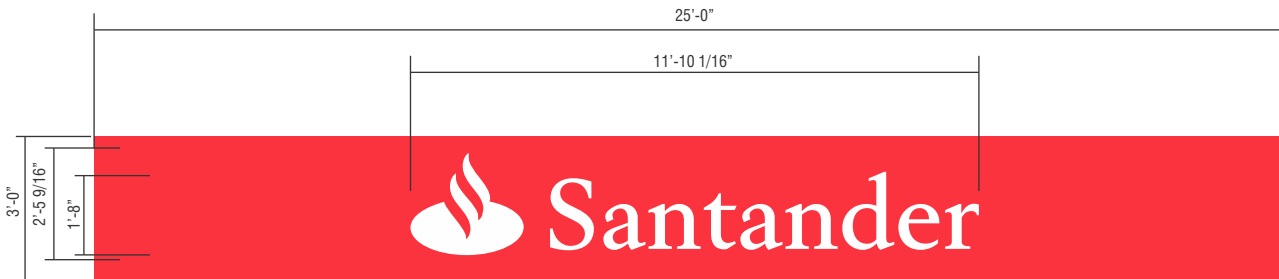
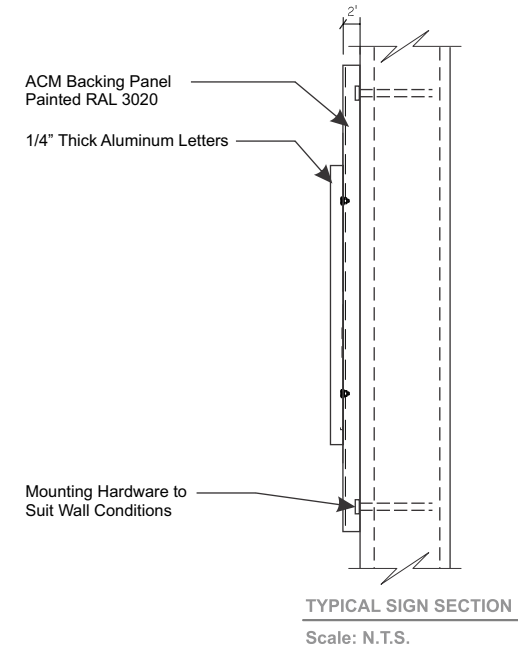
**W-PLH-18 Plate Letters On ACM Background** *25.2 Square Feet*  
Scale: 1/4" = 1'-0"
