HAZARDOUS MATERIALS INSPECTION REPORT

90 Washington Street
Somerville, MA 02143

September 2019

TRC Project No: 308710.0000.0000

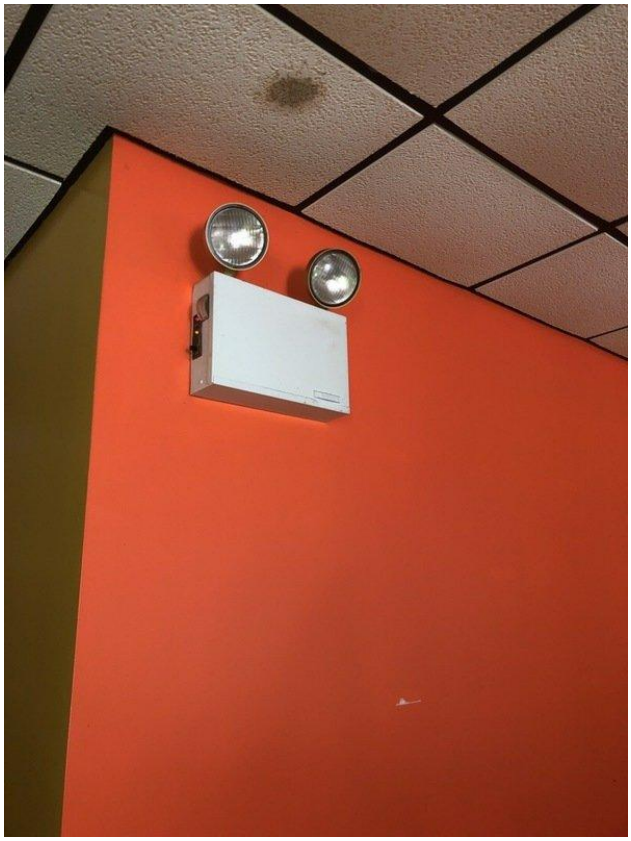
HAZMAT Item Description	Heavy Metal Containing Devices, Emergency Lighting System Batteries
HAZMAT Item Quantity	2

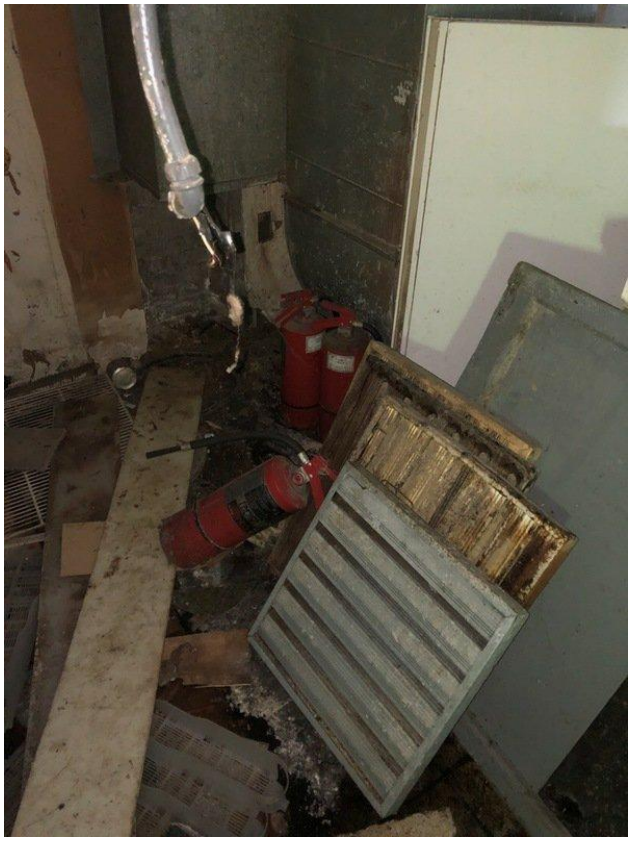
HAZMAT Item Description	Refrigerants, Fire Extinguisher
HAZMAT Item Quantity	5
HAZMAT Item Photo

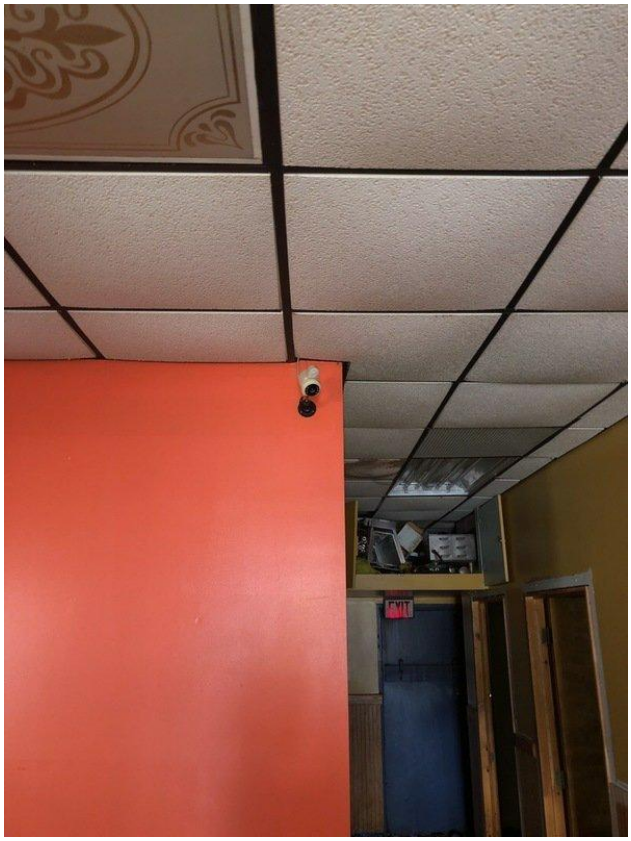
HAZMAT Item Description	Heavy Metal Containing Devices, Security System and Alarm Batteries
HAZMAT Item Quantity	2

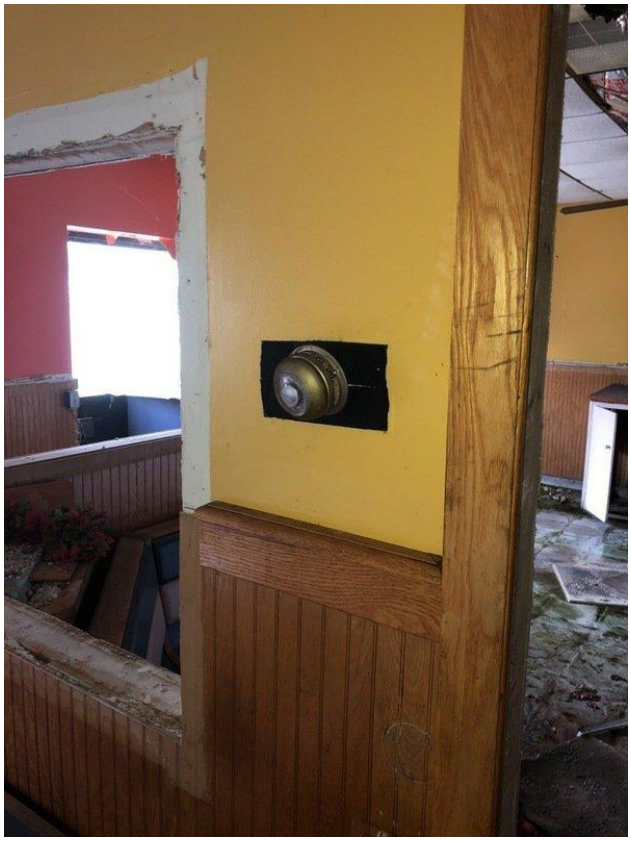
HAZMAT Item Description	Heavy Metal Containing Devices, Thermostats
HAZMAT Item Quantity	1

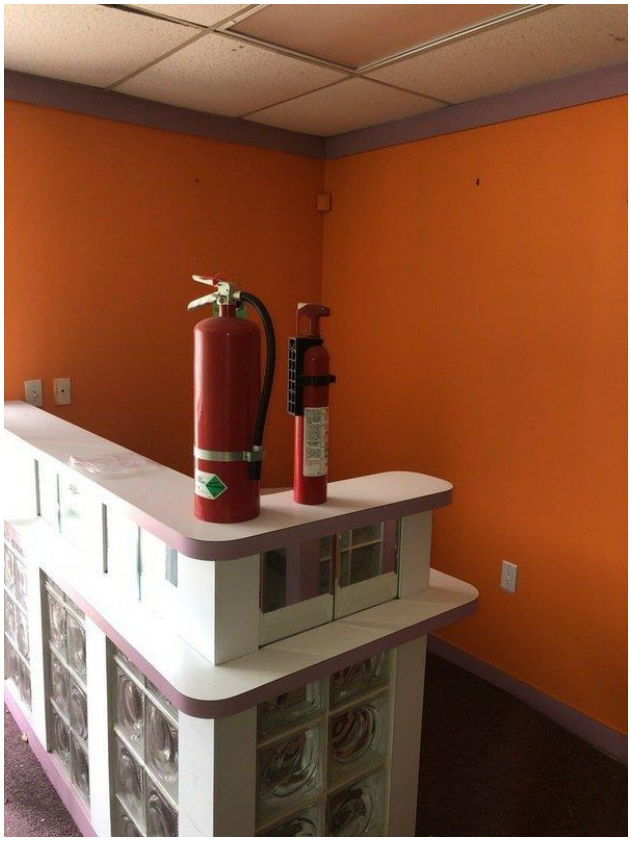
HAZMAT Item Description	Refrigerants, Fire Extinguisher
HAZMAT Item Quantity	2

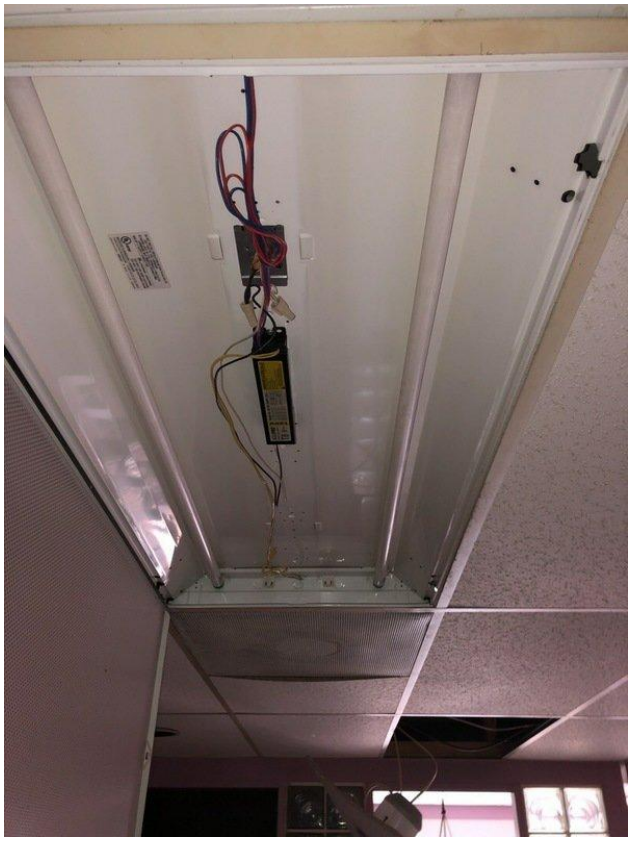
HAZMAT Item Description	Heavy Metal Containing D vices, Fluorescent (Green Tip)
HAZMAT Item Quantity	36

2. Fluorescent lamps should be disposed at an authorized lamp recycler, hazardous waste transporter, or other universal waste handler within one year of the date marked on the storage containers.

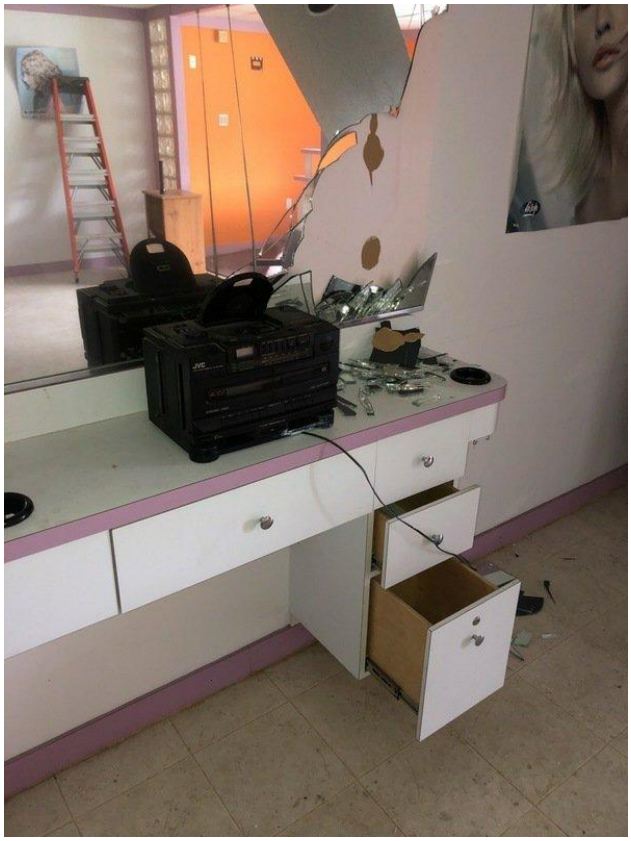
HAZMAT Item Description	Miscellaneous, Other Electronic Recyclables
HAZMAT Item Quantity	4
HAZMAT Item Note	1 stereo and 1 sanitizer 2 salon items
HAZMAT Item Photo

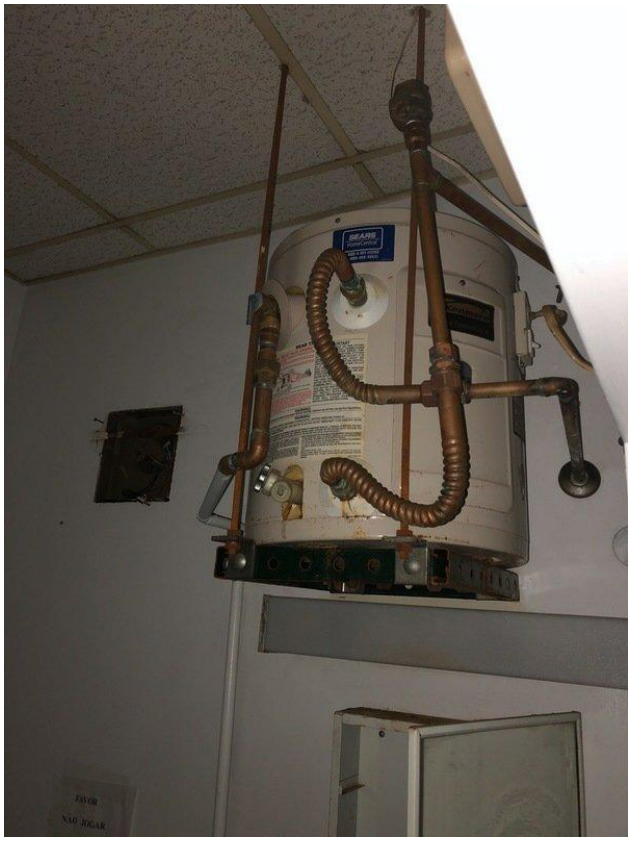
HAZMAT Item Description	Water heater
HAZMAT Item Quantity	1

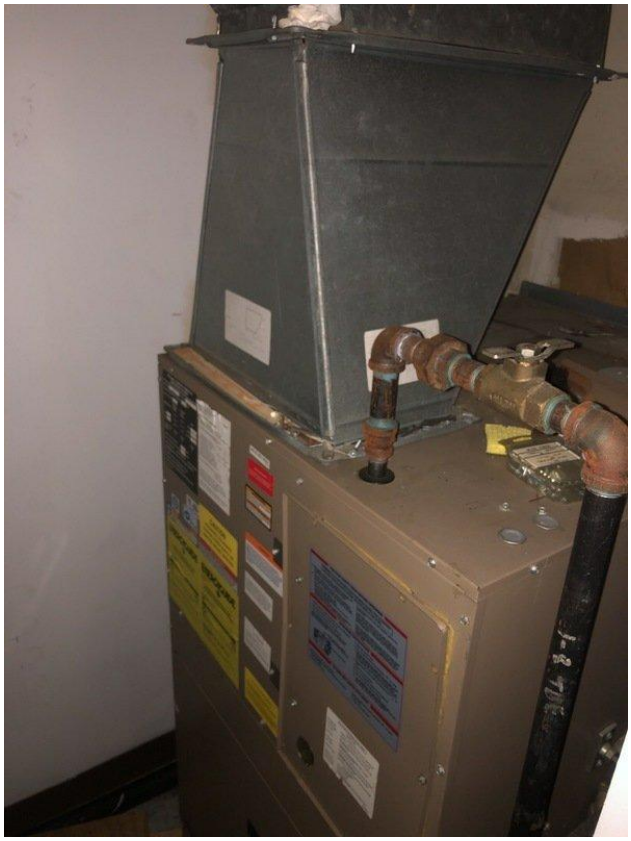
HAZMAT Item Description	Refrigerants, HVAC
HAZMAT Item Quantity	1

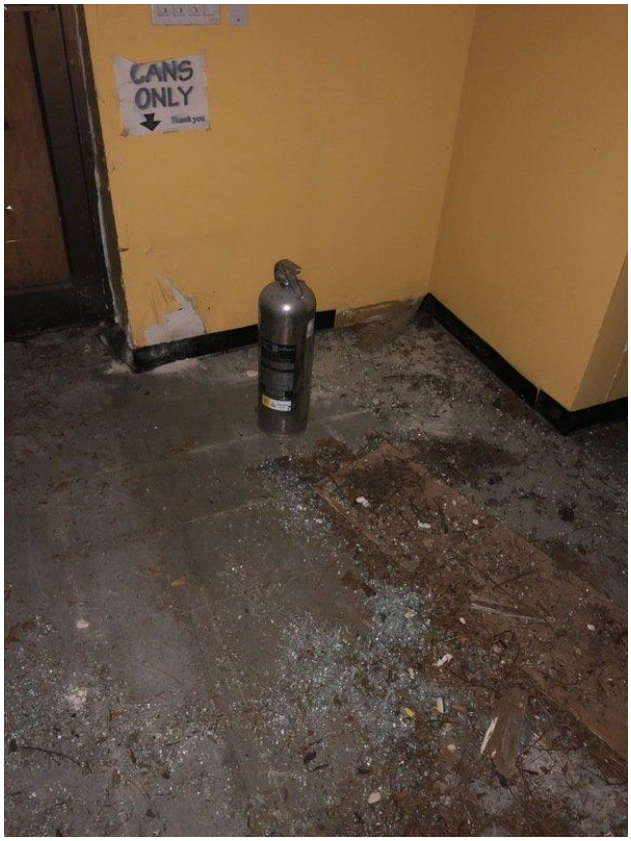
HAZMAT Item Description	Refrigerants, Fire Extinguisher
HAZMAT Item Quantity	3

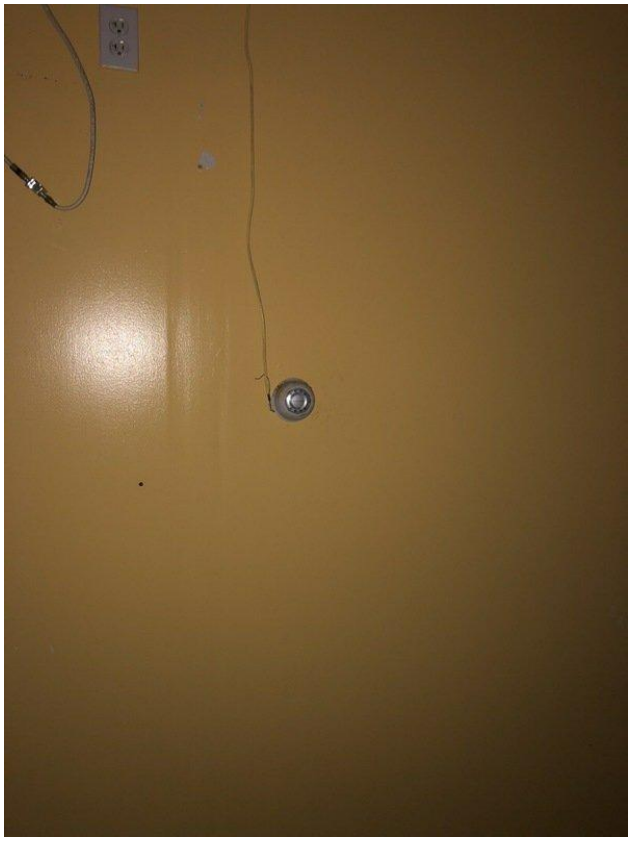
HAZMAT Item Description	Heavy Metal Containing Devices, Thermostats
HAZMAT Item Quantity	3

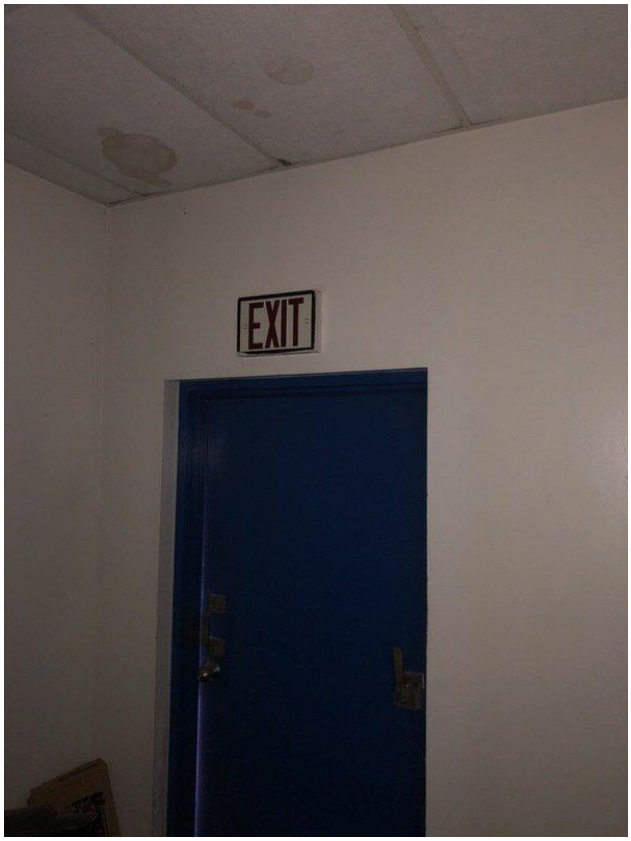
HAZMAT Item Description	Heavy Metal Containing Devices, Exit Sign Batteries
HAZMAT Item Quantity	2

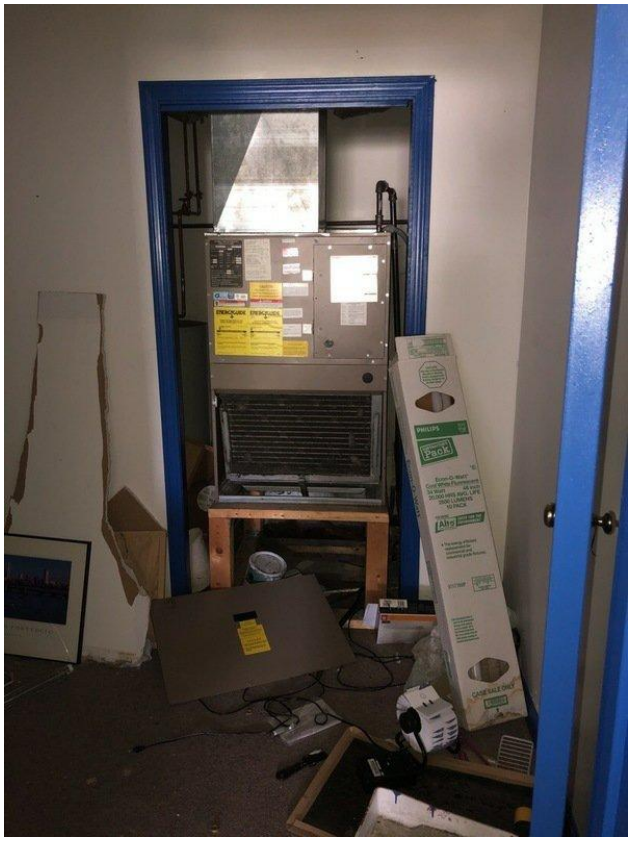
HAZMAT Item Description	Refrigerants, HVAC
HAZMAT Item Quantity	1
