Building Renovation & Department Relocation Master Plan

BROWN SCHOOL - FINAL REPORT VOL. II APPENDICES

MARCH 25, 2022

**HAZARDOUS BUILDING MATERIALS SURVEY REPORT
BROWN SCHOOL BUILDING
201 WILLOW AVENUE, SOMERVILLE, MA**

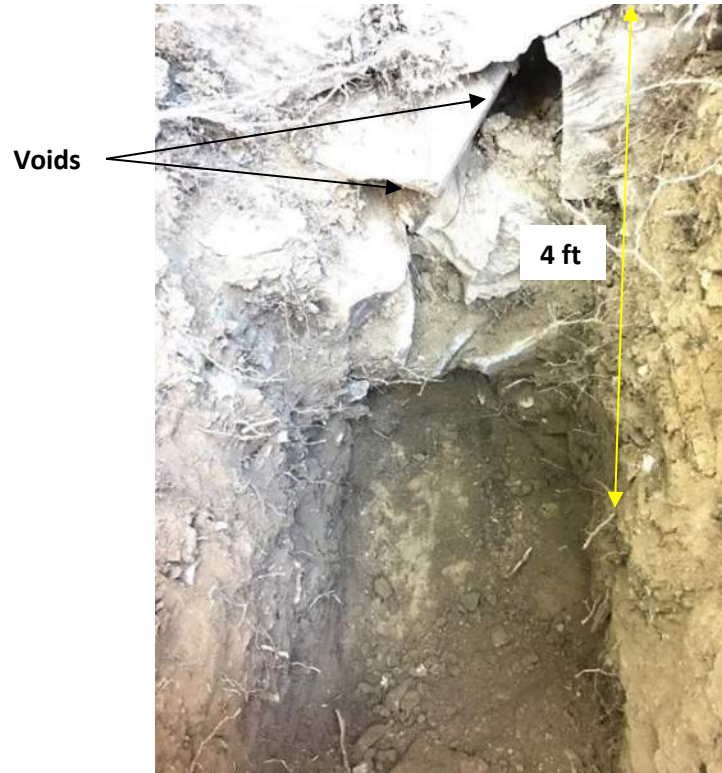
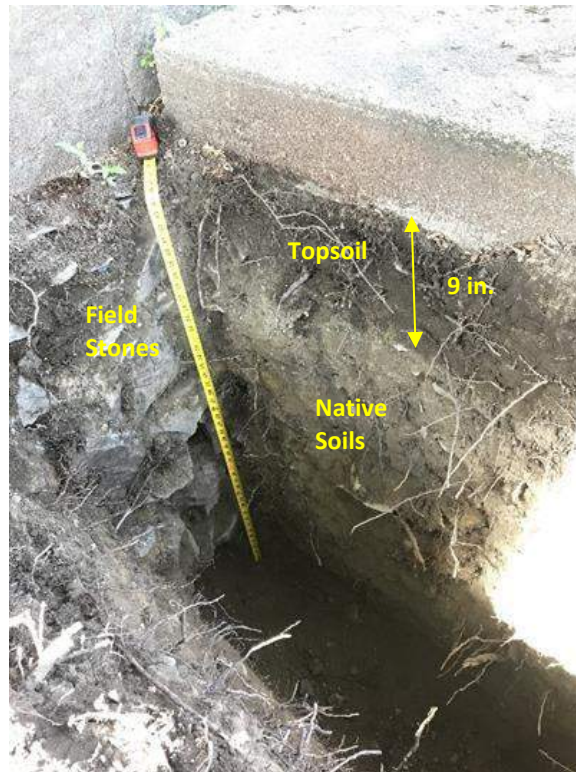
Test Pit 4 (TP-4)

The test pit encountered an approximately 9-in.-thick layer of dark brown topsoil at the ground surface. Roots and rootlets were noted in the topsoil layer. The topsoil is underlain by an approximately 0.5-ft-thick layer of light gray cohesive sandy silty clay fill. The fill contains pockets of light brown (orange) fine sand. The fill is underlain by natural soils consisting of brown sandy lean clay to silty sand and extending to the test pit termination depth (approximately 4 ft).

Groundwater was not encountered in the test pit, and soils were noted to be generally dry to moist.

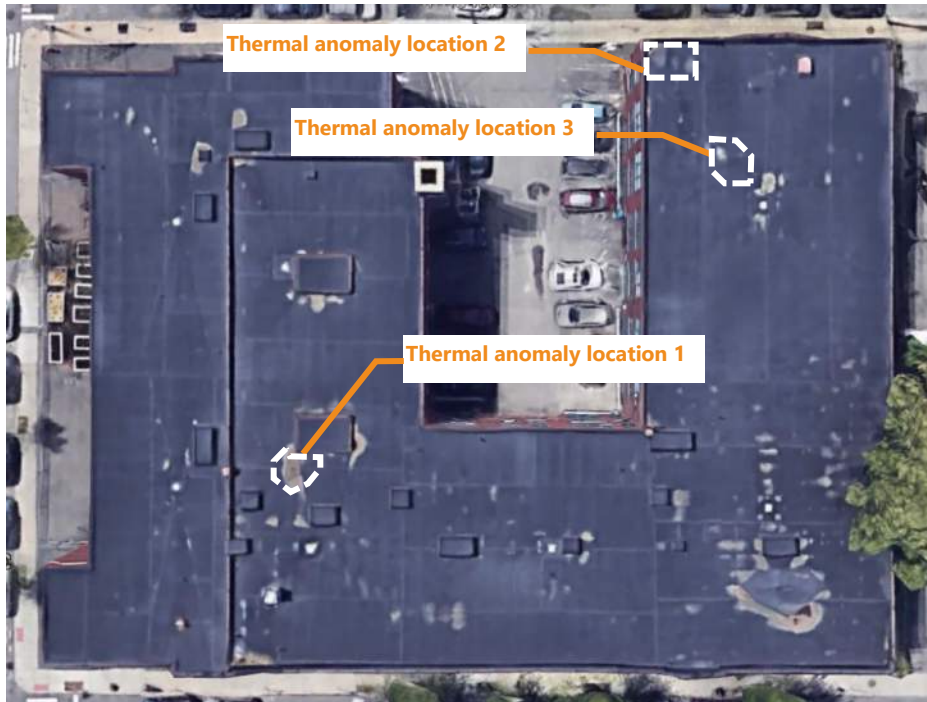
- Location 1 - There is a thermal anomaly (approximately 9 square feet) at the northeast corner of one roof curb (Figure 6).
- Location 2 - There is a thermal anomaly (approximately 16 square feet) at the southeast corner of the west wing (Figure 7).
- Location 3 - There is a thermal anomaly (approximately 9 square feet) in the field of the roof in the south half of the west wing (Figure 8).

An overall photo showing the locations of the thermal anomalies at 33 Cross Street is included (Figure 9).

Figure 9. Thermal anomaly locations at the Edgerly Center.

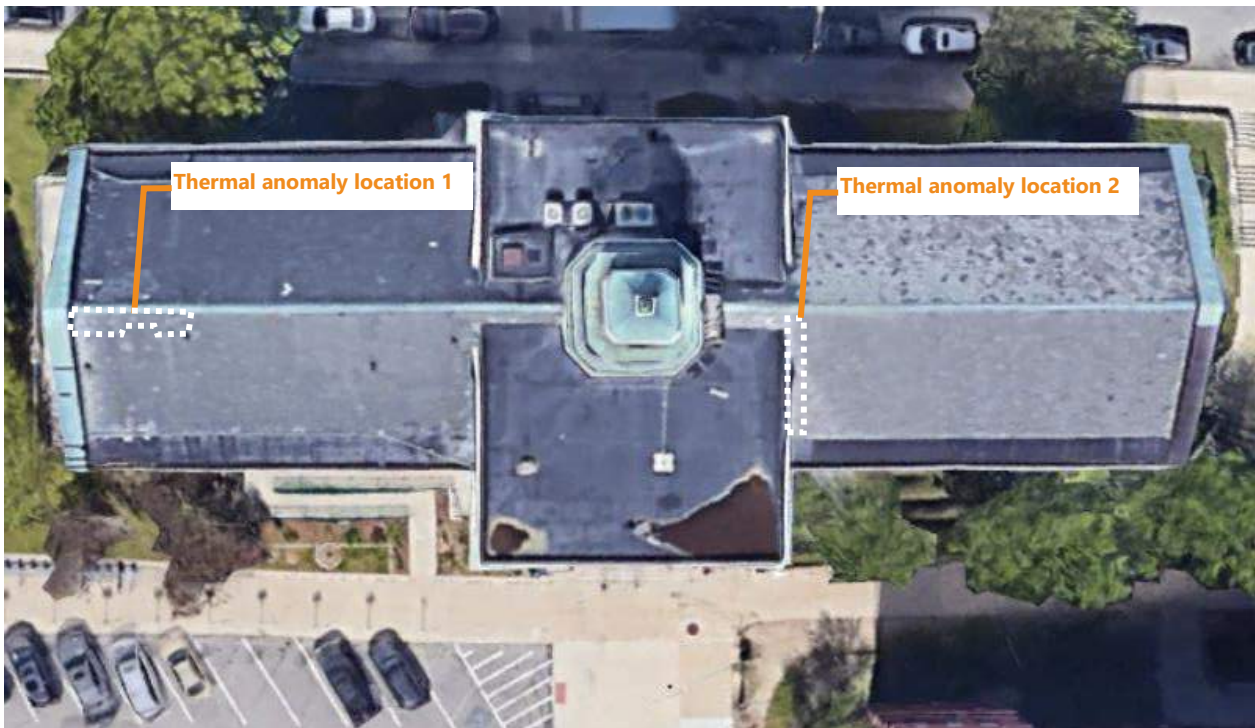
- Location 1 - There is an area of thermal anomaly (approximately 30 square feet) at the south end of the south slate roof adjacent to the roof ridge (Figure 10).
- Location 2 - There is an area of thermal anomaly (approximately 50 square feet) at the north slate roof adjacent the stepped flashing at the rising brick wall (Figure 11).

An overall photo showing the locations of the thermal anomalies at 93 Highland Avenue (City Hall) is included (Figure 12).

Figure 12. Thermal anomaly locations at City Hall.

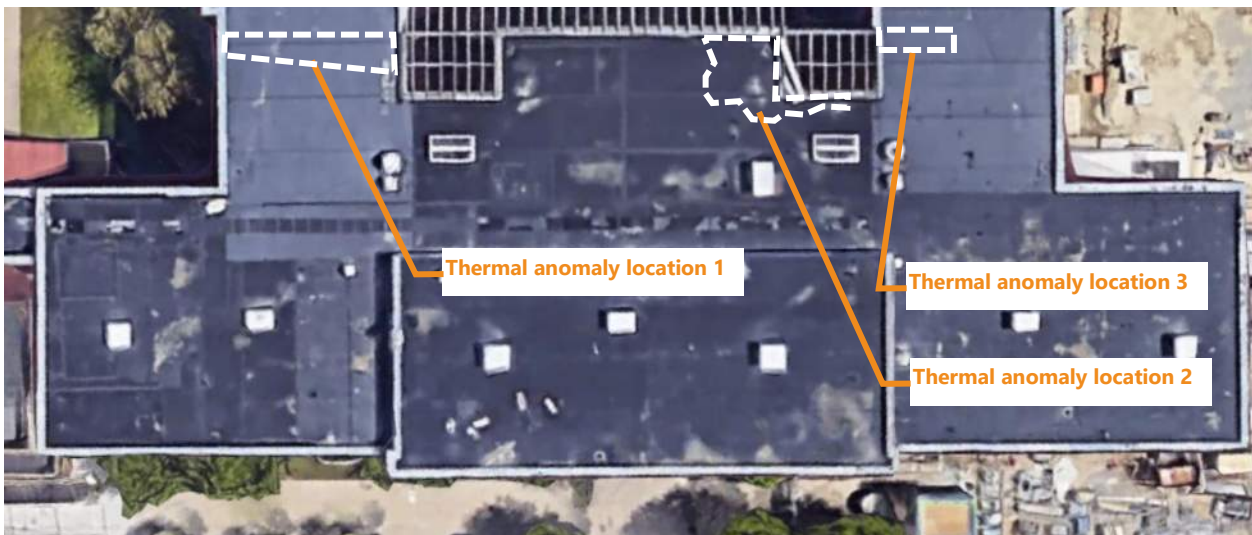
- Location 1 - There is an area of thermal anomaly near the demolished building edge where the roofing membrane is loose/peeled back and the insulation is exposed (Figure 13).
- Location 2 - There is an area of thermal anomaly surrounding one of the drains near the demolished building at the north edge of the roof (Figure 14).
- Location 3 - There is an area of thermal anomaly near the demolished building edge where the roof membrane is loose/peeled back and the insulation is exposed (Figure 14).

An overall photo showing the locations of the thermal anomalies at 81 Highland Avenue (High School) is included (Figure 15).

Figure 15. Thermal anomaly locations at the High School.

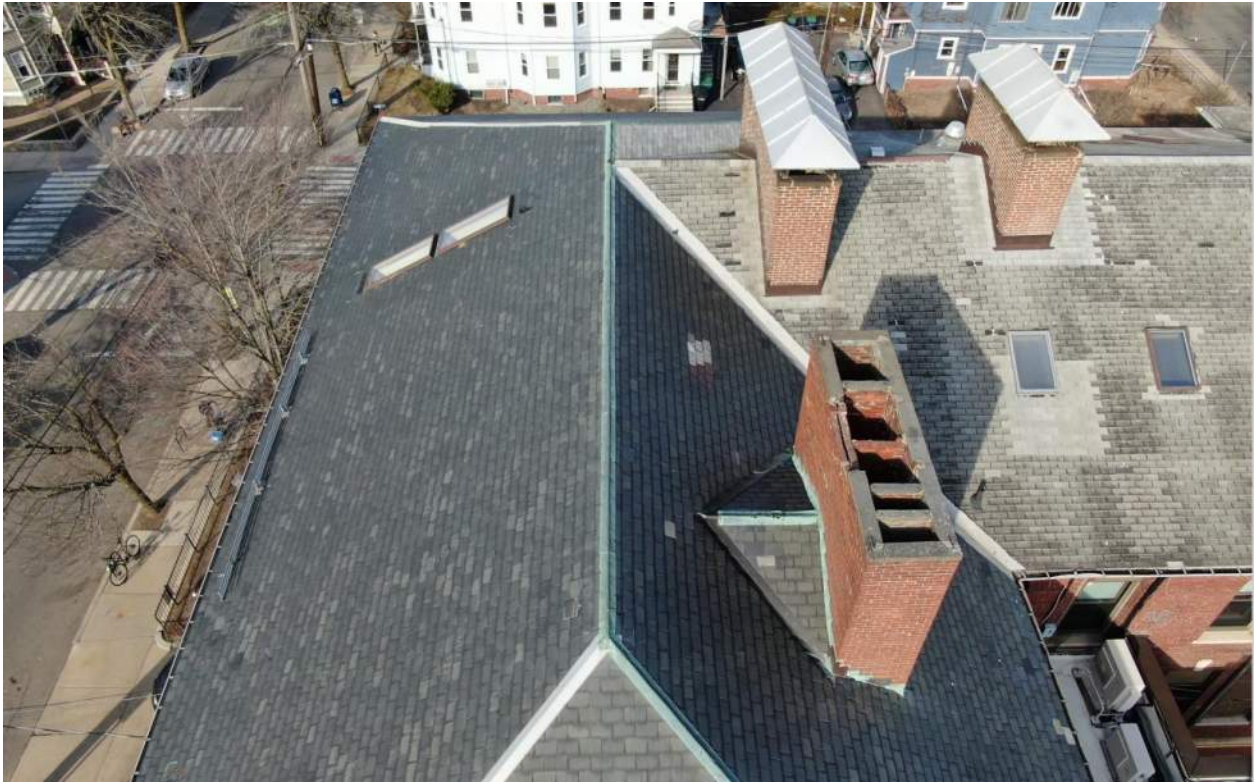
No thermal anomalies were noted at the Brown School. Refer to Figure 16 through Figure 18 for overall photos of the roof.

Figure 16. Overall view of the Brown School (west side)

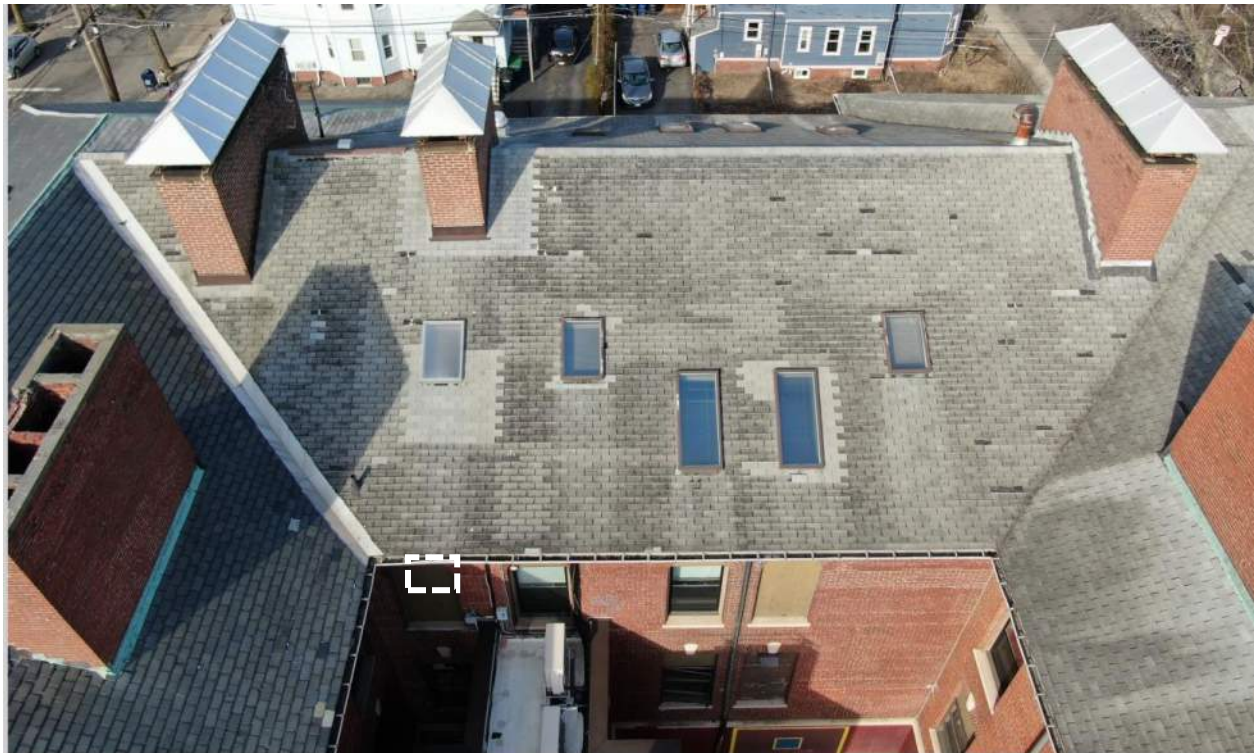
Figure 17. Overall view of the Brown School (central portion)

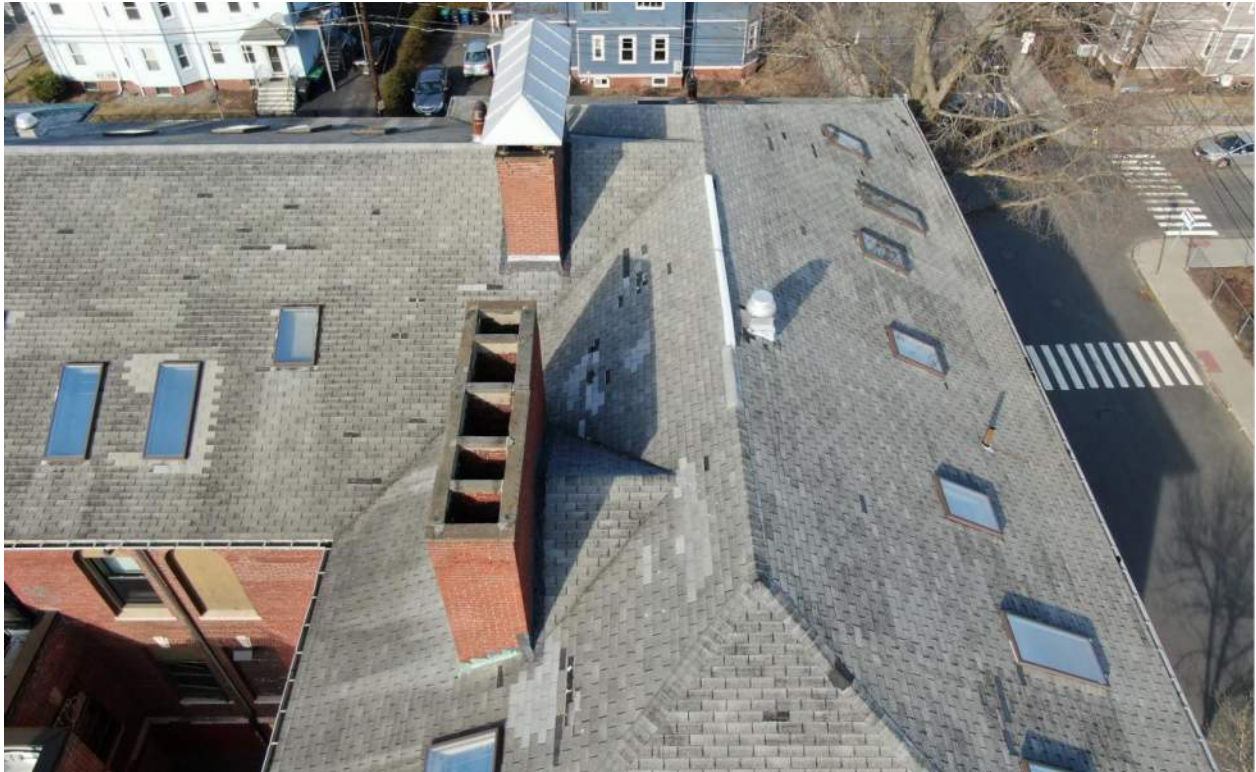
Figure 18. Overall view of the Brown School (east end)

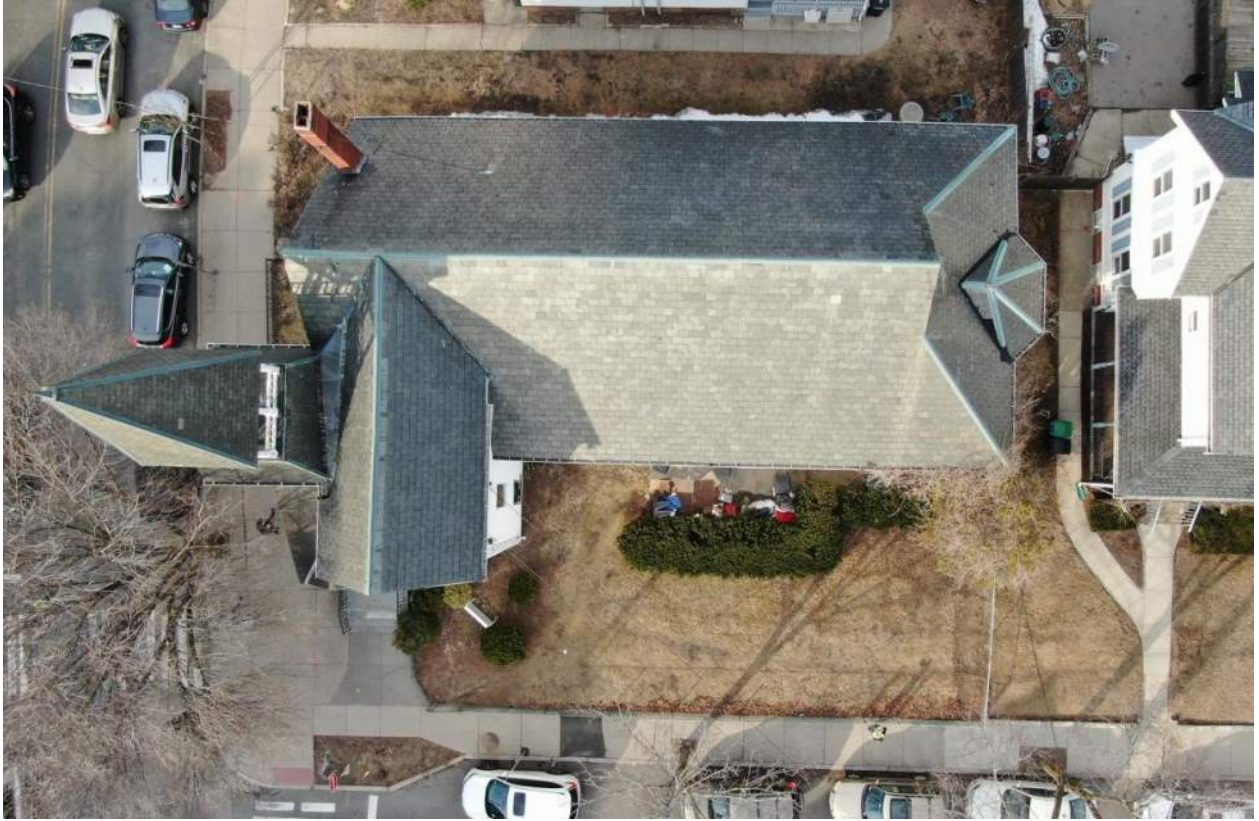
No thermal anomalies were noted at the Church building. Refer to Figure 19 for an overall photo of the roof.

Figure 19. Overall view of the Church
