Community Services and Activities Master Plan

VOLUME I - FINAL REPORT

NOVEMBER 24, 2021

**BEYER
BLINDER
BELLE**

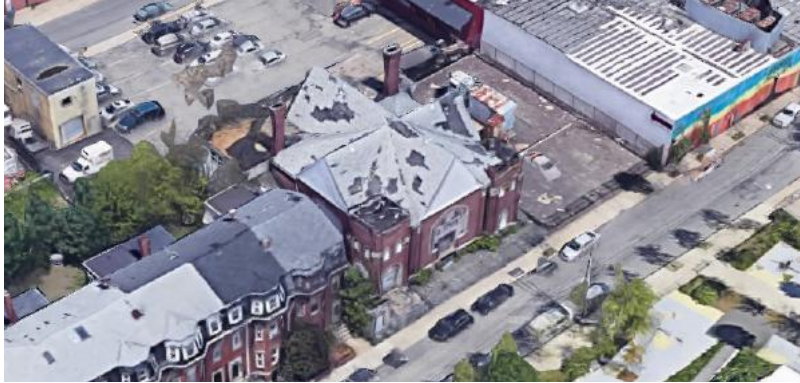
ZONING ENVELOPE - SECTION

24 CROSS STREET EAST - POTENTIAL FOR 3+ STORIES

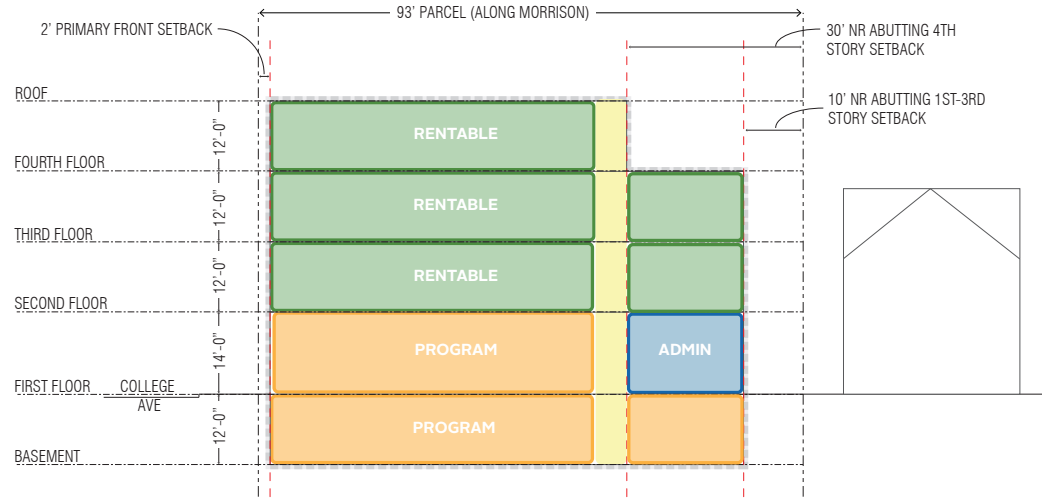
SECTION

Space Use	SF
All Rentable SF, Floors 2-4 (-5%)*	7,600
Exclude: COA Admin on 2nd Fl.	1,400
RENT - NET TENANT USABLE	6,200
<i>*Demising; does not include prorated amenity or common space</i>	
GROSS SF AS SHOWN	20,800

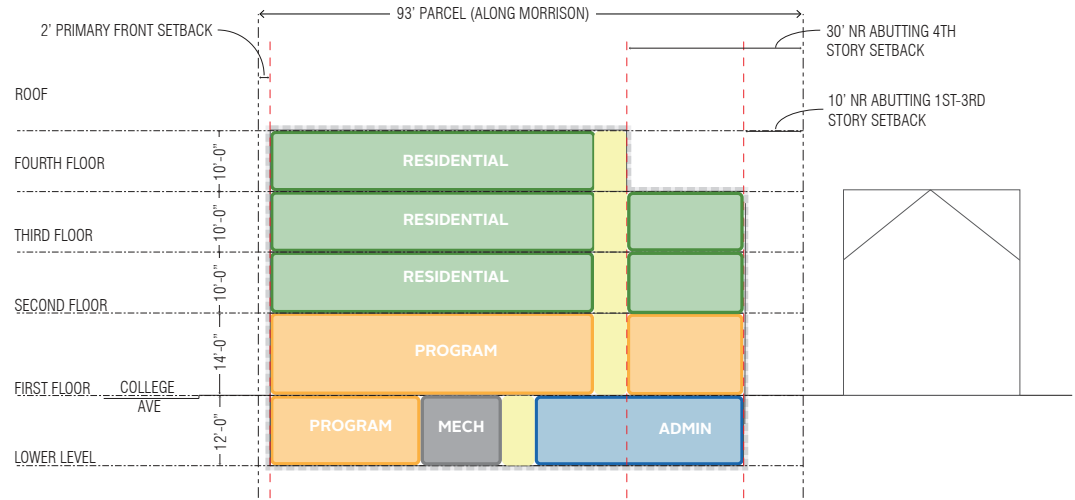
SECTION

NEW BUILD OPTION 2 - COUNCIL ON AGING + RESIDENTIAL

A second option was also developed to test-fit residential use for floors 2-4 above the community and Council on Aging programs. In this version, the COA admin space has been located on the Lower Level in order to maintain separation between the various building uses. Note that given the compact site footprint, only one elevator is planned. However, this would require residential occupants sharing the elevator with staff and visitors taking the elevator to the Lower Level. The conceptual unit mix is provided in a table on the facing page.

Space Use	SF
All Rentable SF, Floors 2-4 (-5%)*	7,600
<i>*Demising; does not include prorated amenity or common space</i>	
GROSS SF AS SHOWN	20,800

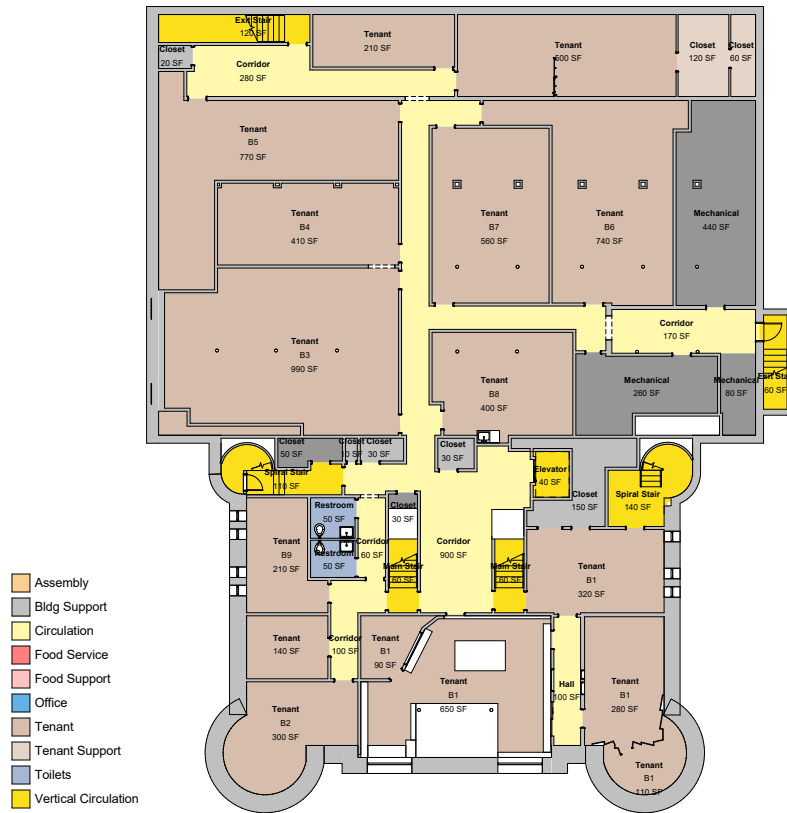
191 HIGHLAND BASEMENT - EXISTING BY USE

NOTE: Areas rounded to nearest 10 SF

SCALE: 1/32" = 1'-0"

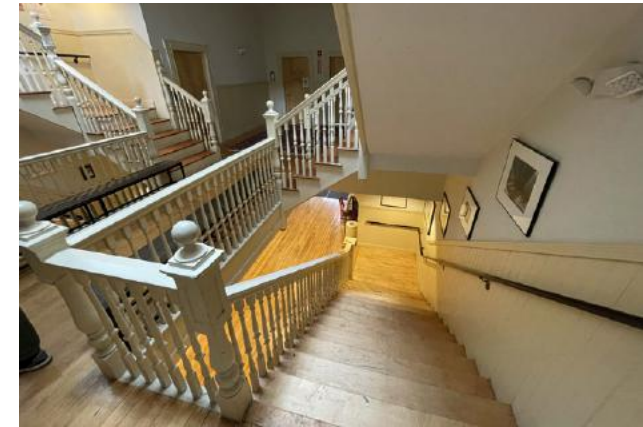
Second Floor Landing, Main Stair

- While the communal / open areas at the second and third floor landings of the grand stairs are

primarily for circulation, such areas are also part of the means of egress for occupants of such floors. These areas have some wall art, paintings, etc. but should be kept clear of any displays or items that would obstruct the means of egress or significantly increase the combustible load of the space.

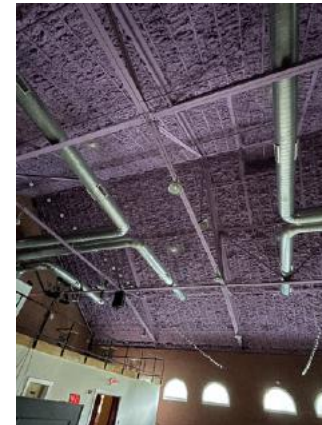
Ceiling of Drill Hall with roof trusses; NE corner "chimney" brick displacement

and southeast corners. These assemblies are in poor condition and should be wholesale replaced. Because of the large cricket upstream, a tremendous amount of water volume is channeled to these short gutters and downspouts. There is also an issue with the flashing details at each of the adjacent corner "chimneys," which is causing deterioration to the masonry and stucco.

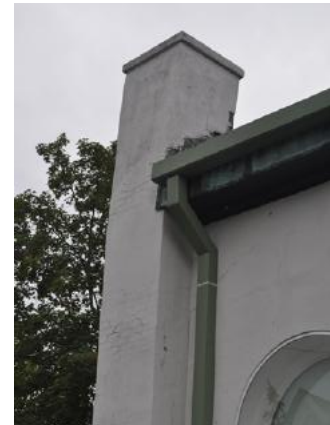
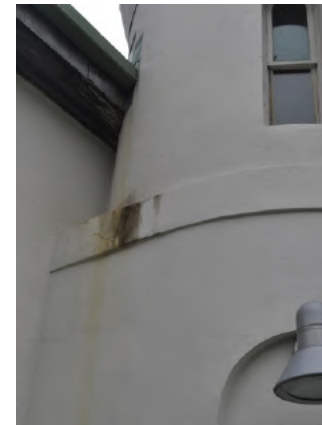
Damaged soffit and runoff staining; delamination of paint coating on stucco

different issues which are being explored further as part of the work about to commence. There is surface-level crazing, spalling, and delamination of the coating in numerous areas which may indicate issues with the paint breathability. Deeper cracks and water damage in the stucco may require re-stuccoing in several localized areas including the full east elevation of the drill hall. In addition, indicated conditions of opening brick joints in a number of areas are telegraphing through the stucco, which will necessitate brick stitching and repointing. Further, a few specific areas like the top of the northeast corner buttress need full brick reconstruction. Lastly, staining is present on most facades from secondary runoff carrying oxidation from metal flashings, also subject to investigation.

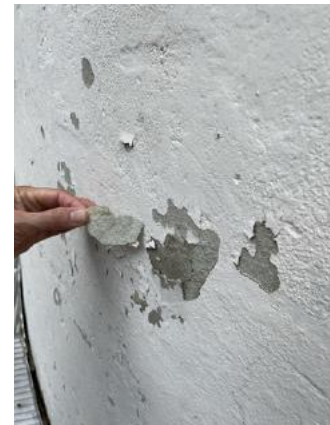
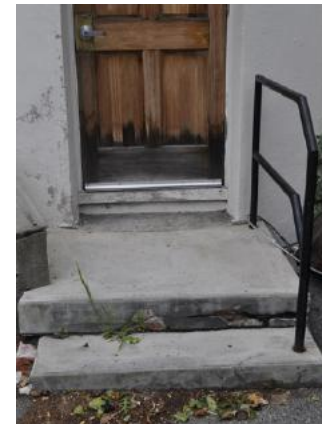
Stoop and egress door deterioration; window grate deterioration

In general, the door stoops are cast-in-place concrete and in fair condition, but will require localized patching and/or grinding typically due to metal rust jacking. 100% of painted metal handrails/guardrails will need replacement due to poor condition or non-compliance with building and accessibility codes. The main entry lacks a landing at the top of the ramp, and the ramp appears to be steeply sloped. If work is proposed for the building, it should be paired with a site grading study to address this issue and the relationship of the adjacent sidewalk to the curb.

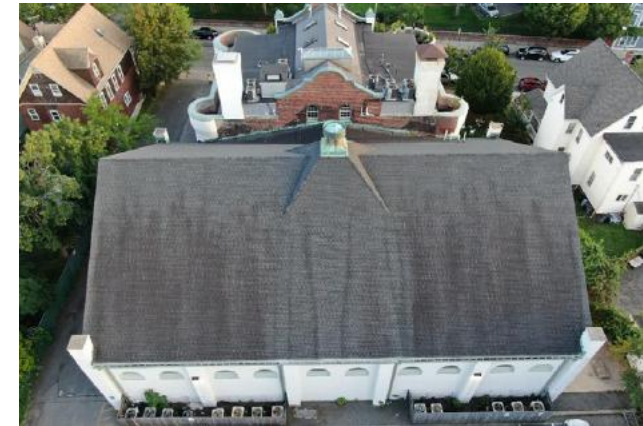
Drone photograph of Armory roof

The drill hall roof is a pitched roof with a single ridge oriented east-west. A copper ventilation cupola with hipped roof planes emerges from the center. All roofing surfaces are asphalt shingle with the exception of a large roof cricket, surfaced with membrane, which negotiates the geometry between the drill hall and head house. The drill hall has external aluminum gutters at the eaves, connected to aluminum leaders. The eaves, fascia, gutters and soffits are in good condition with the exception of the short runs of eave at the southwest

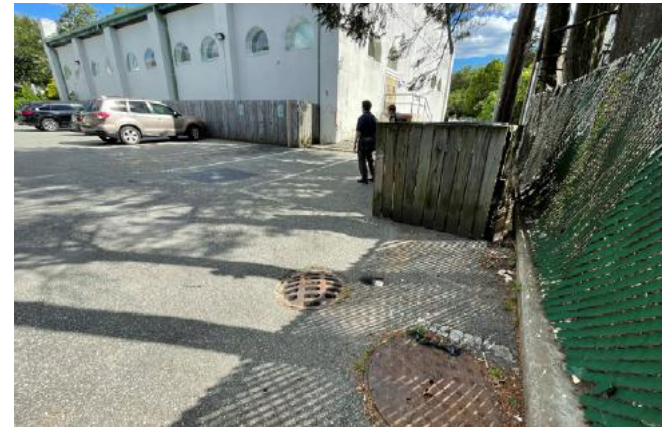
Catch basin and sewer manhole at west end of parking lot

Sewer manholes were observed in Highland Ave and the sidewalk adjacent to Hudson Street.

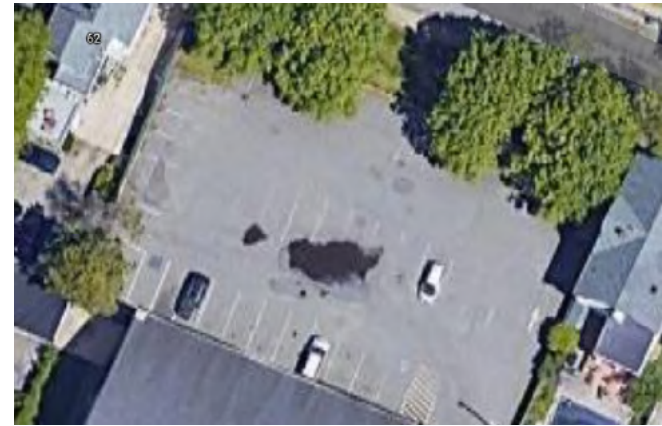
Google Earth aerial of ponding occurring in parking lot

The parking lot and access drive pavement is in fair condition with some cracking and significant drainage and ponding issues. Six catch basins are located in the parking lot at the perimeter; ponding has been observed in the middle of the lot. The walkway pavement is in fairly good condition with some cracking; no drainage issues were observed in dry weather. Along Highland Avenue, the public sidewalk was raised from the curb to improve accessibility in 2009 but erosion has created a steep drop. The long term recommendation to address the City's stormwater mitigation goals is to resurface the entire parking area and replace all drainage infrastructure while also increasing amount of bio-retention landscape areas. On Highland Avenue, accessibility should be addressed by reconfigured sloped paths and the sidewalk should be returned to the curb height.

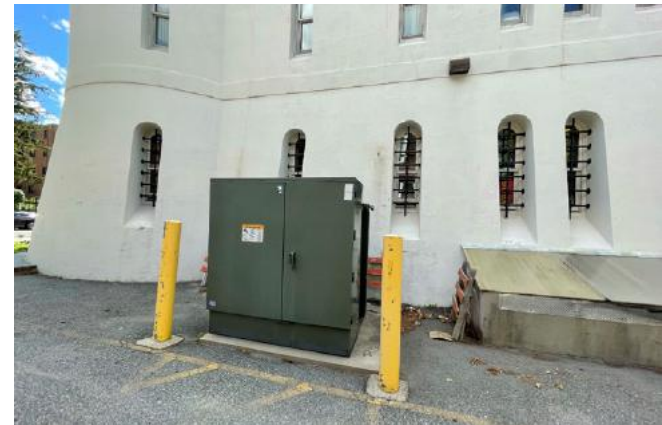
Pad-mounted transformer and plastic areaway cover at southeast corner

Transformer was observed at the southeast corner of the building. There are overhead electrical wires in the vicinity that do not connect to the building.

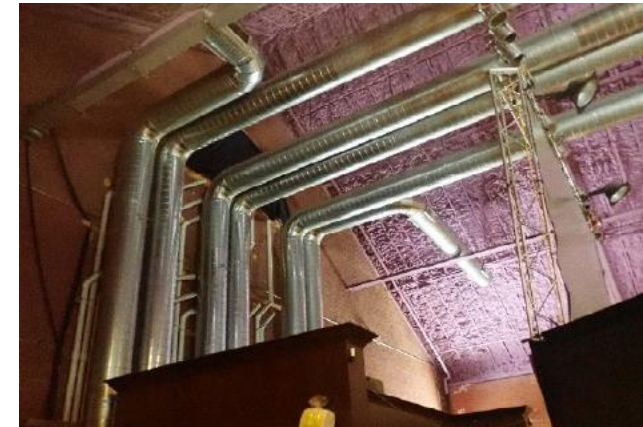
Ductwork (dating to 2009) in the Drill Hall

The main performance/event space is heated and cooled by ten (10) individual Carrier split AHUs with condensing gas heat and DX cooling. Most AHUs were manufactured in 2006. They are in fair condition and are near the end of their expected service life. Some appear to have had various repairs already. Overhead ductwork is in good condition. Outdoor condensing units are of varying type and age, and also appear to be in fair condition and near the end of their service life. Each AHU serves a single supply duct and thermostat. Staff report general dissatisfaction with the HVAC system and in particular that some AHUs are not used due to disruptive noise during events; these thermostats are labeled "Loud" and remain off. We anticipate the split AC systems will need to be replaced soon, and recommend converting to a centralized system with more robust heating and cooling components, including energy recovery and heat pump heating, and a centralized controller. Some ductwork can likely be reused when replacing the system, however thorough duct cleaning is recommended throughout the building in this case.

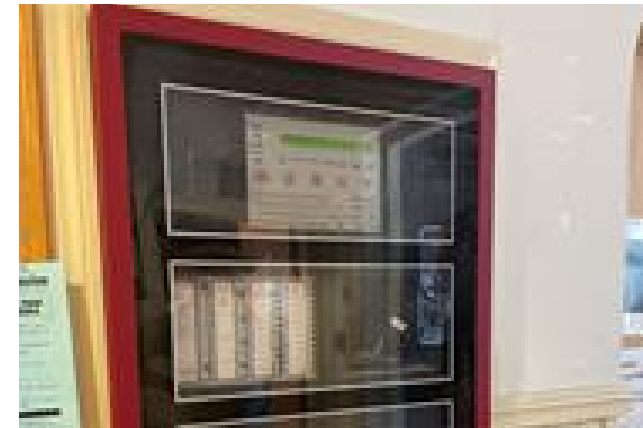
Notifier Fire Alarm Panel

The building is protected throughout by an automatic sprinkler system and a Class I standpipe system with hose connections located at stairways and Performance Hall mezzanine. A fire alarm system with emergency voice/announcement capability is also installed that appears to provide coverage throughout the building. The fire alarm system appears to be comprised of smoke detector and manual pull station initiating devices and combination audible/visual notification appliances. Emergency lighting and exit signage were also observed.

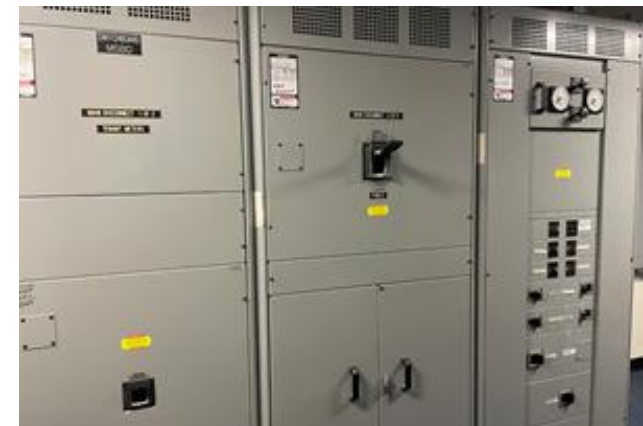
Main electrical service switchgear

The main electrical service and distribution equipment was manufactured in 2007 and is in good working condition. There are multiple electric meters. Equipment was inspected visually but was not evaluated for capacity during the site visit. There is a Notifier fire alarm system, which is of unknown age and appears to be in good condition.

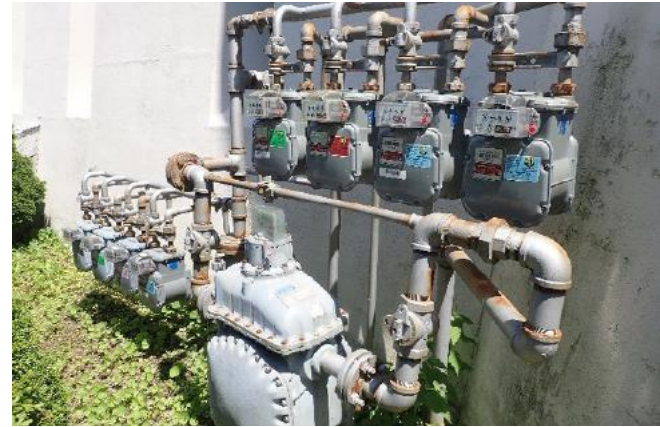
Gas meters on west side of building

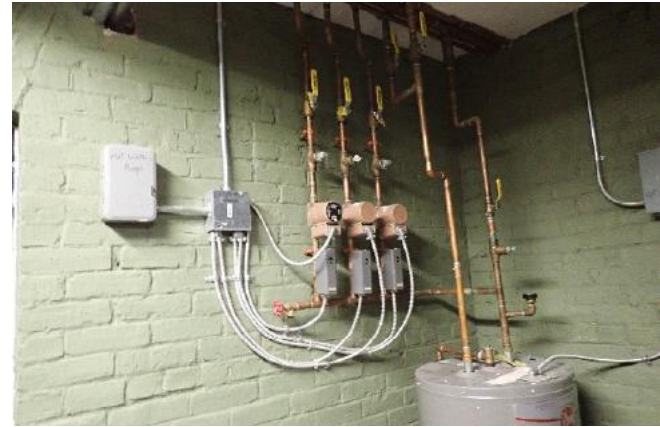
Domestic hot water heater and recirculating pumps

The building is served by a 1-1/2 inch water service and 6-inch fire protection. The building is fully sprinklered. Domestic hot water is served by an electric storage heater with three (3) recirculation loops. The water heater was manufactured in 2019 and is in good condition. Other water heaters may exist in tenant or live/work areas of the building but were not observed during the site visit. Fixtures appear to be in good condition. The lower mechanical room contains a sump pump that appears to be in good condition. No reports or observations were made on drainage systems. Based on building age, scoping of the lines and destructive testing on select interior drainage piping is recommended to determine integrity of piping.

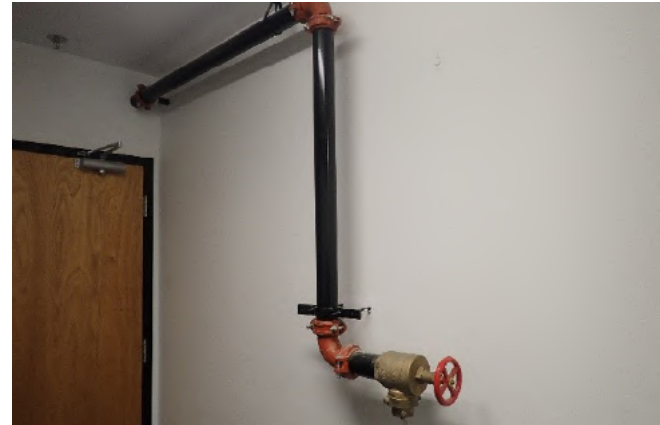
Sprinkler control valve assembly

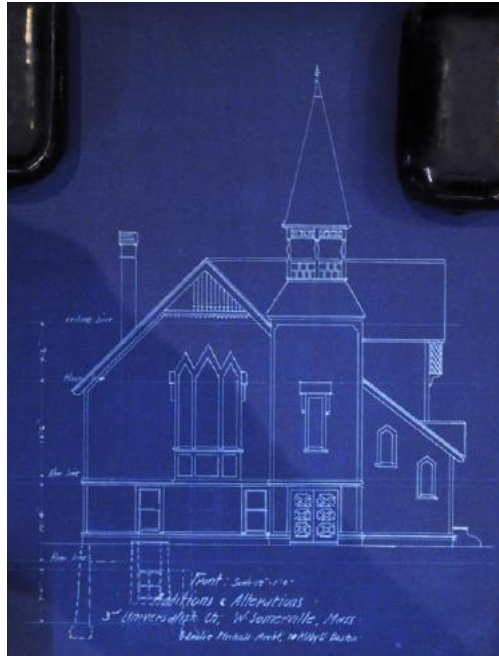
Front Elevation

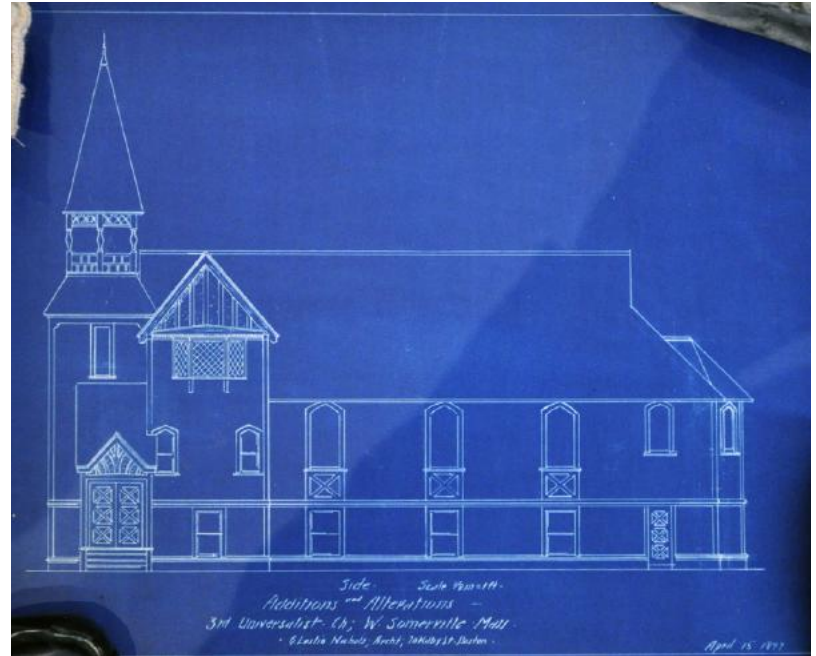
Side (South) Elevation

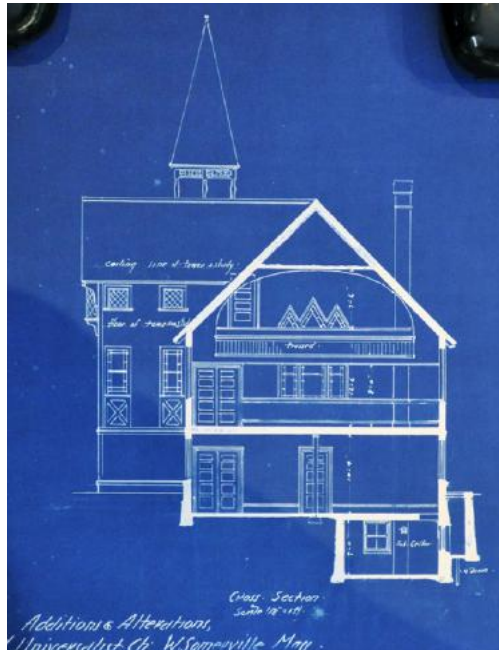
Cross Section

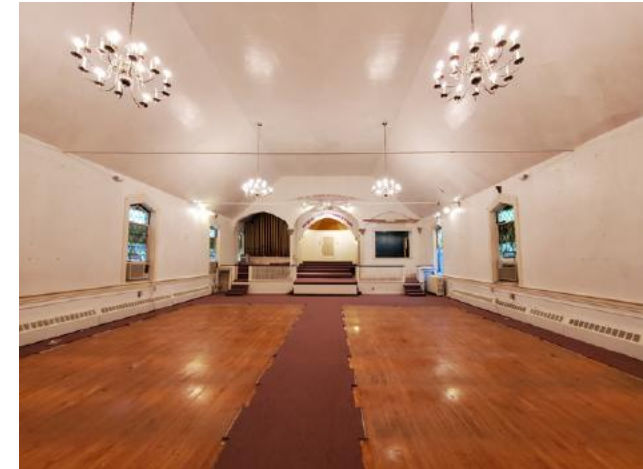
Sanctuary, with uneven flooring, cracked plaster ceiling

The sanctuary floor has a range of deflection/settlement of about 4", while the balcony has approx. 3.5" of deflection across the span. More investigation is needed to confirm if elements of the structure are overstressed or deteriorating due to some other environmental condition.

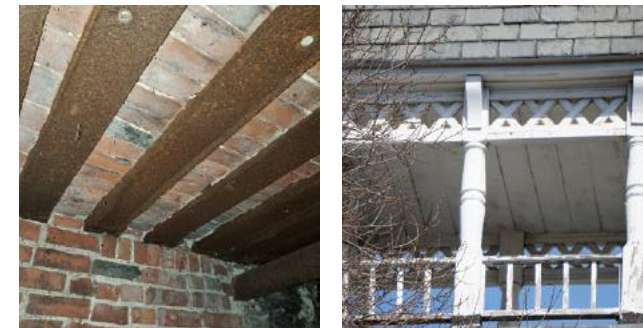
Evidence of moisture in the Sub-basement, open steeple belfry

The foundation walls are exposed brick down to grade; these require 100% repointing at minimum and wholesale replacement of the face brick is recommended due to extensive salt and water damage. The foundation is rubble below the level of grade and is in poor condition where visible in the sub-basement. The sub-basement has evident dampness issues.

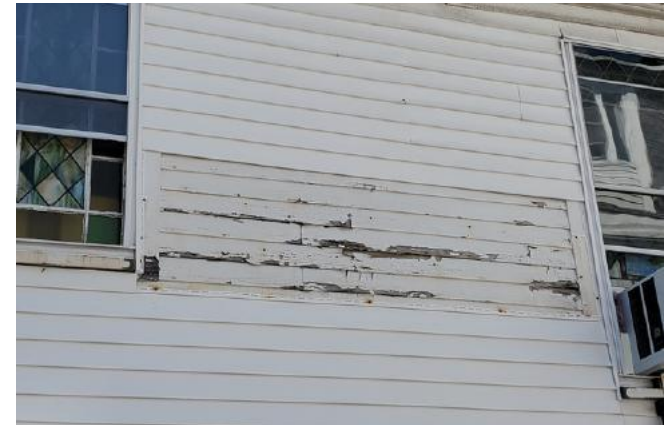
Area of prior vinyl siding loss or removal; wood clapboards exposed

The building is fully clad with vinyl clapboard siding. Limited areas of missing/lost vinyl panels show exposed underlying wood clapboard and wood trim in poor condition, but the extent of these conditions are unknown.

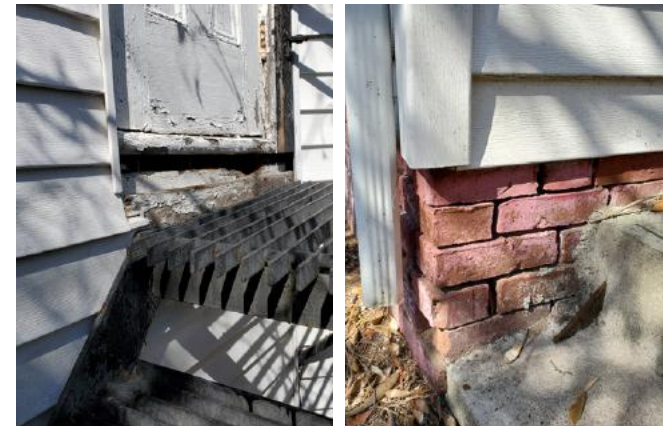
Rear entry door sill deterioration, condition of masonry foundation

The exterior doors are low-quality non-original replacements in extremely poor condition and require 100% replacement. The stoop at the main sanctuary entry is in poor repair and requires the full replacement of stoop and railings.

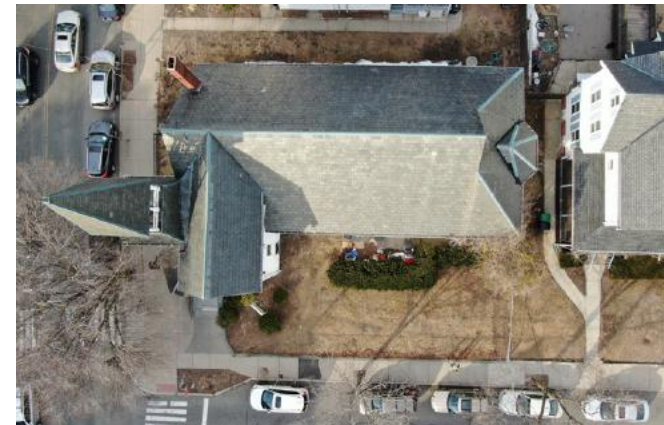
Drone photograph of church roof

The roofs are steep-slope with a primary ridge oriented east-west. The roofs were surveyed using drone photography and on-site observation. The slate on primary roof planes is in fair condition overall with some missing and displaced slate tiles, others with cracks and exfoliation. Localized unevenness and distortion of the roof planes may indicate overstepping of roof trusses. In numerous locations older copper flashings have been top-coated with flashing cement, suggesting past or

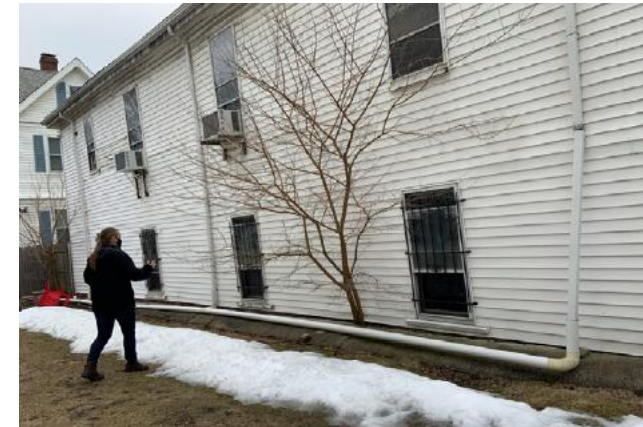
External downspout drainage at the north elevation

The existing roof drains are exterior and piped externally around the building to discharge at-grade along the east side of the building. Runoff from these downspouts and the south side of the site appears to flow overland towards Morrison Ave. Catch basins and drain manholes were observed within Morrison Avenue.

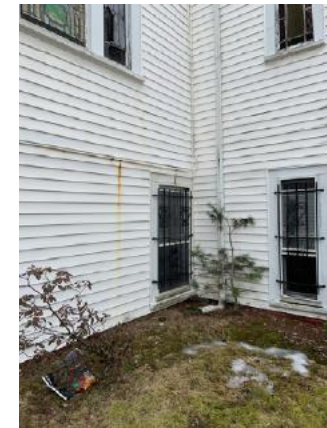
External downspout to planted area

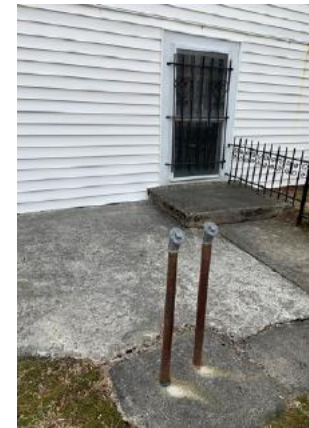
Oil fills

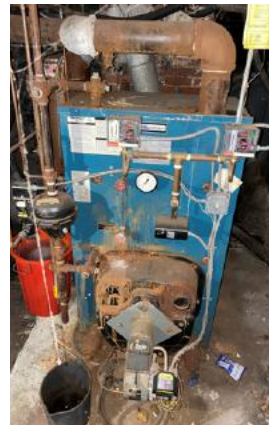
Oil-fired boiler and oil tanks, Sub-Basement

The Baptist Church is currently used for storage and contains only temporary heat from an electric unit heater in the kitchen. The oil-fired boiler and tanks are in poor condition and have been abandoned in the basement.

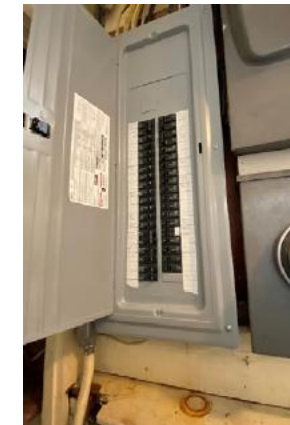
Main electrical distribution panel

The electrical service and distribution panel are older and in fair condition. No central fire alarm system was observed.

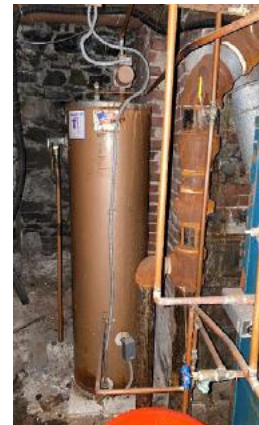
Electric hot water tank

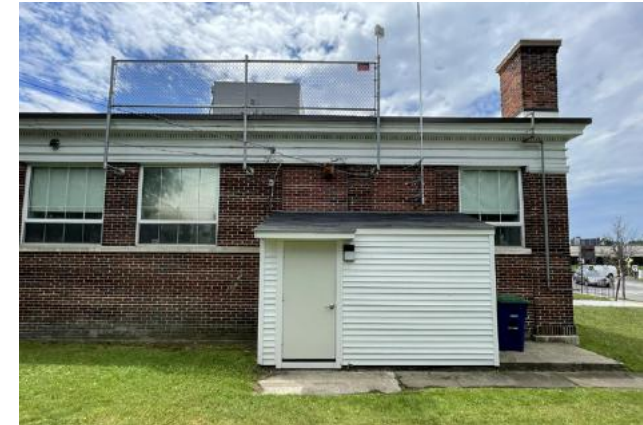
Rear addition over basement stair with second exit

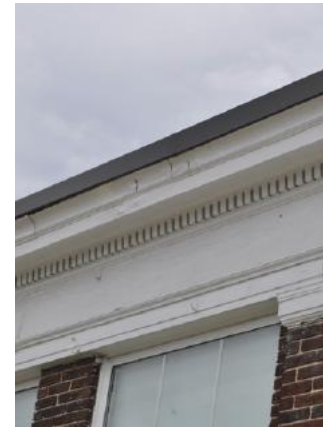
Deteriorated paint at the cornice; unsympathetic brick infill at window

The facades and exterior envelope of the East Branch Library are in good condition. However, the building is in need of routine preventative maintenance work, including scrape, prime, and paint of the exterior millwork; replacing sealant at windows; and some localized repointing of the brick. Grading at the site appears to encourage positive drainage.

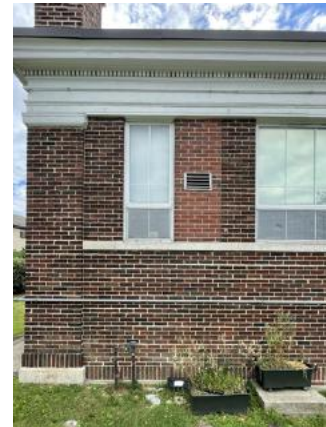
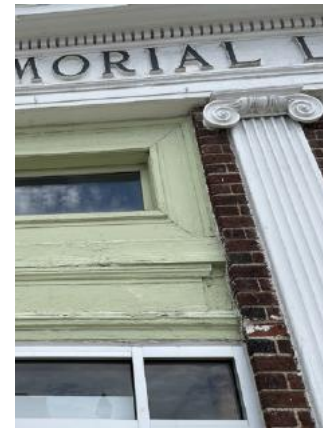
Weathering of exterior millwork; original half-pilaster detail

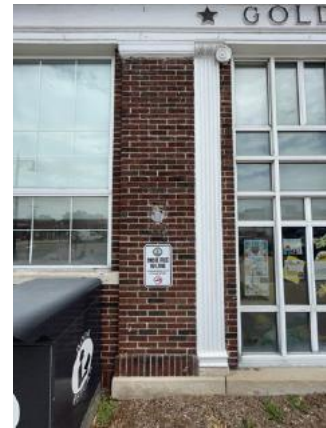
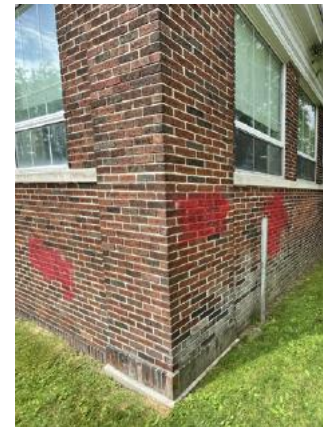
Graffiti paint-over and efflorescence; Broadway Plaza seating

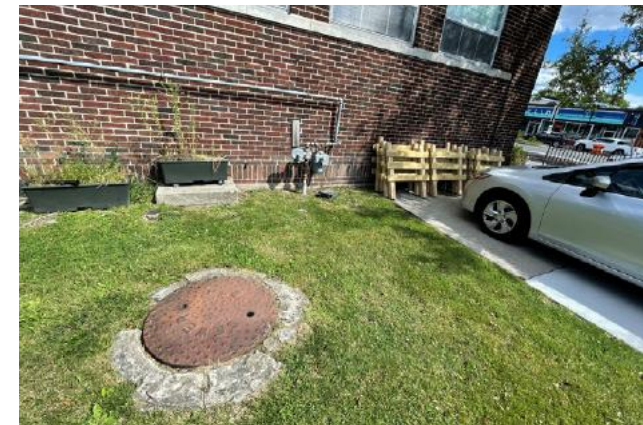
Sewer manhole west of building

Based on the City of Somerville Stormwater Management Plan, dated June 15, 2020, the library site is located within a portion of the City served by combined sewers. A sanitary sewer manhole was observed onsite adjacent to the vehicle access. The location of the building service is not known.

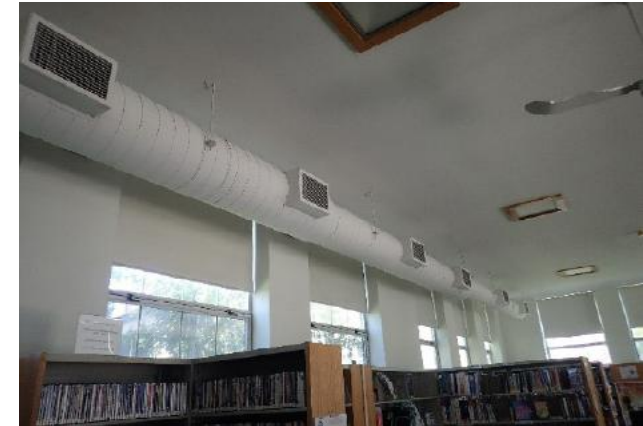
Exposed ductwork fed from rooftop air handling unit

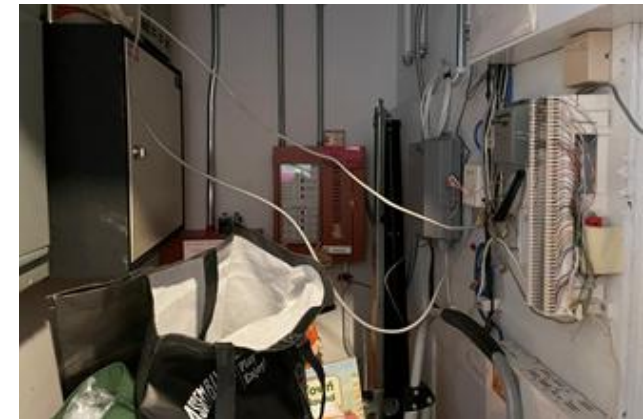
Miniscan Fire Alarm System

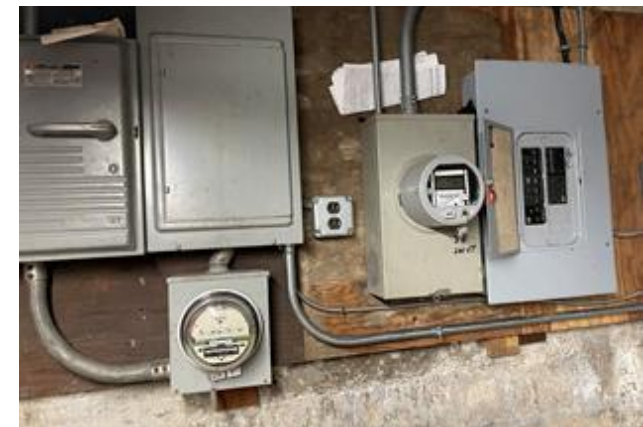
Electric service, meters and panel

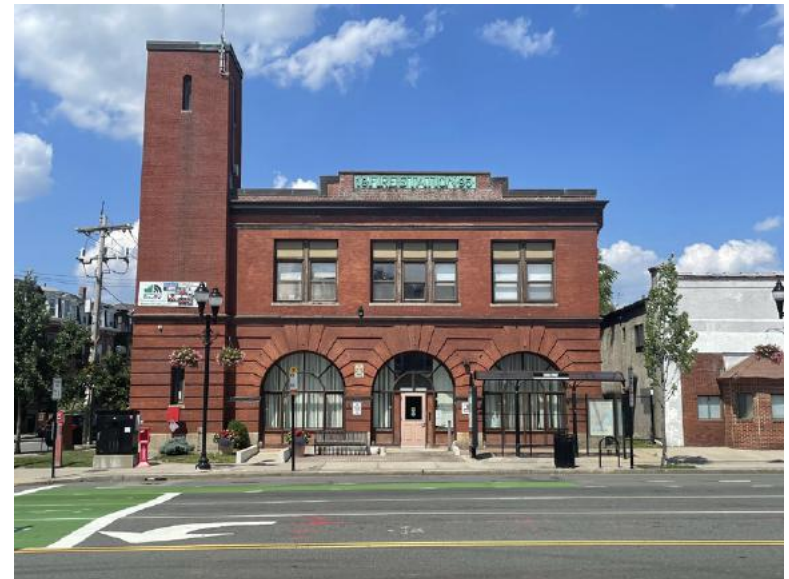
Broadway Elevation, 2021

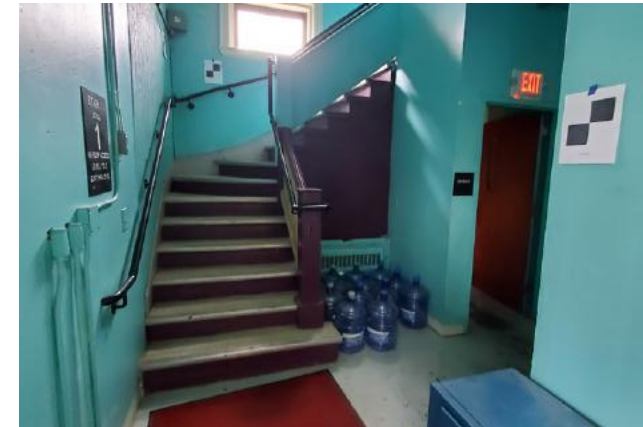
Internal stairwell, first floor

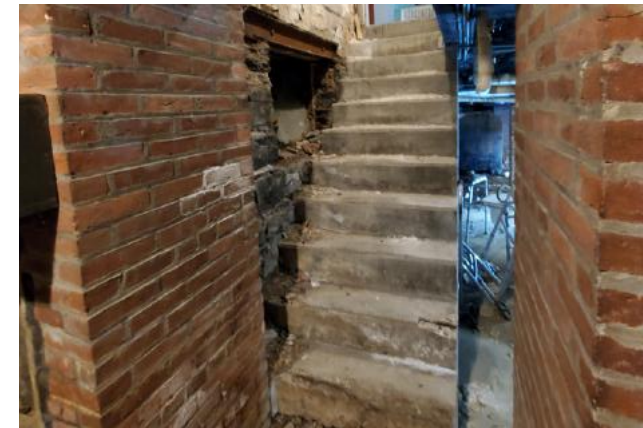
Basement; concrete basement Stair in poor condition

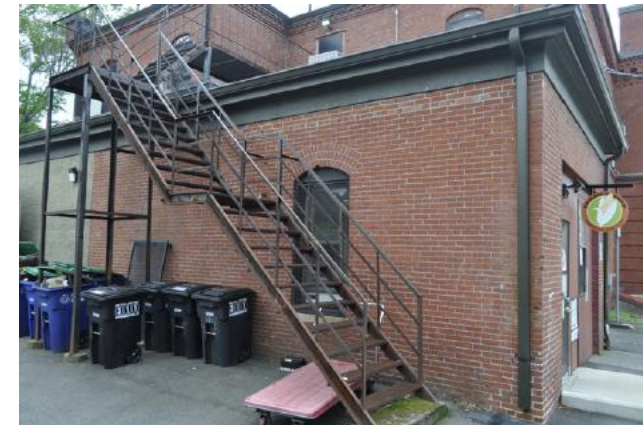
External steel fire escape, north elevation

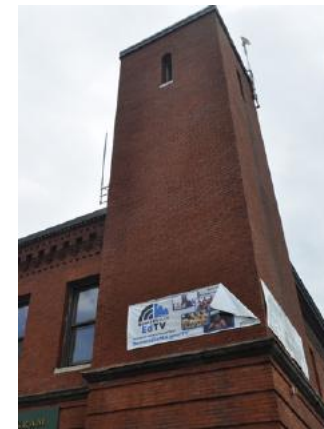
Corner tower with soiling pattern evident; graffiti paint-over, northwest corner

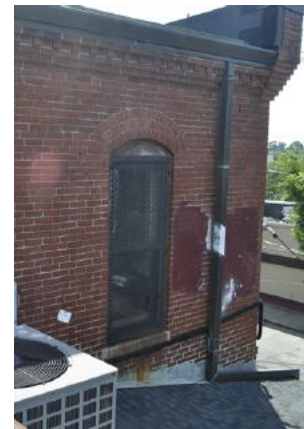
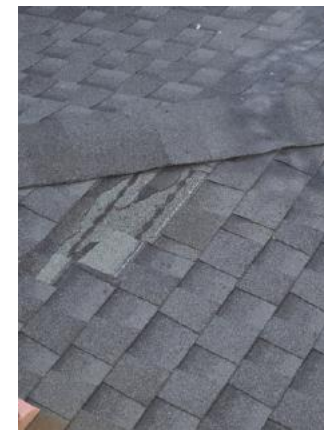
Lost roof shingles at one-story roof; weathered window millwork

The single-story wing to the north has a hipped roof with asphalt shingles. It is in fair condition, with areas of wear. Issues with graffiti at the rear of the building have also resulted in roof damage. Step flashing at this roof is in fairly good condition, and the gutters and downspouts are in fair condition with some areas of weathering.

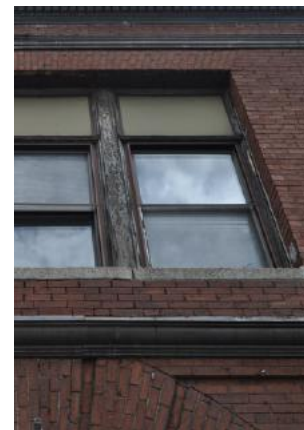
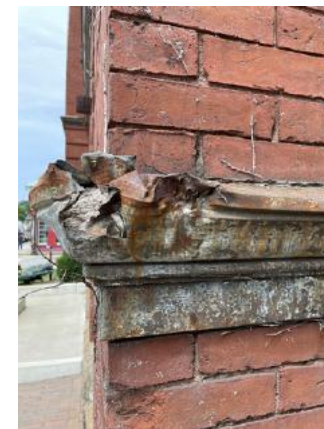
Damage to galvanized metal cornice at southeast corner of building; spalling and damage at entry brick return

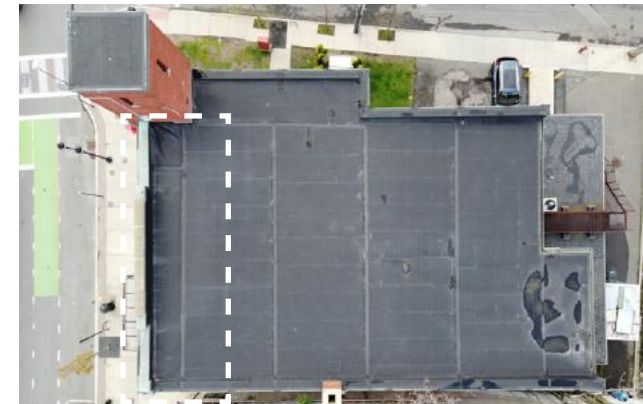
Key Plan of Thermal Anomaly

As part of this preliminary documentation and assessment effort, WJE also conducted qualitative infrared drone survey on the roofs of four buildings. Surveyed in the hours immediately following sunset, infrared anomalies can indicate the presence of moisture-laden roof components. Wet components have greater thermal mass than if they were dry, releasing their heat energy from the day more slowly and representing as heat islands in the infrared scan.

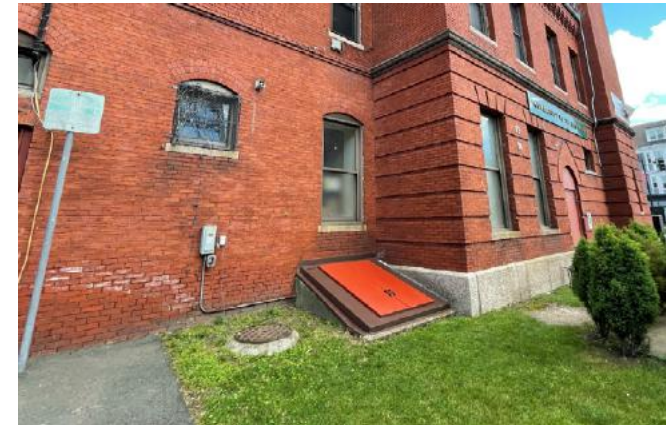
West side of building: manhole and basement access hatch

drainage systems are combined in this area. An unmarked manhole is located off the southwest side of the building.

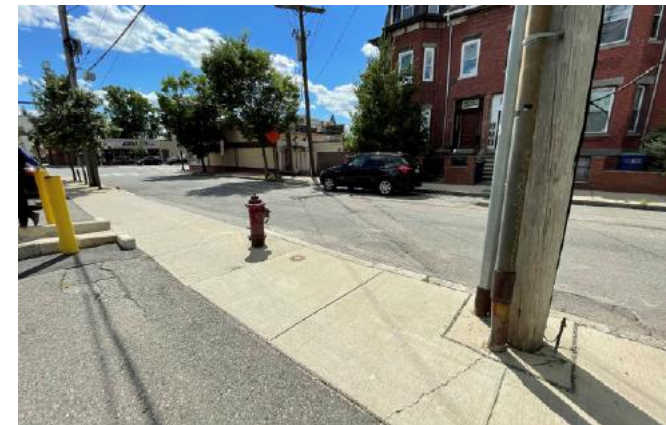
Condition of hardscape and sidewalk, Cross Street East

Site pavement appears to be in good condition with no significant cracking or drainage issues observed.

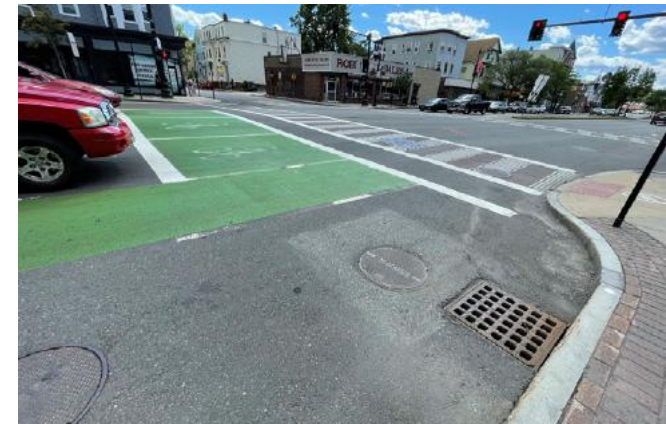
Catch basin and sidewalk on Broadway fronting building

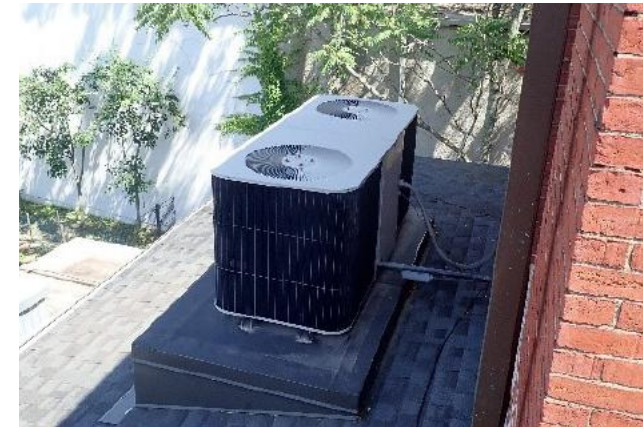
HVAC: Condensers for split DX air handling units

The building is cooled by two split DX air handlers, one on each floor serving overhead ductwork distribution. The unit on the first floor is in fair condition; the unit on the upper floor is nearing the end of its service life. Condensing units are located on the low roof and appear to be in good or fair condition. The food pantry area also contains ceiling fans.

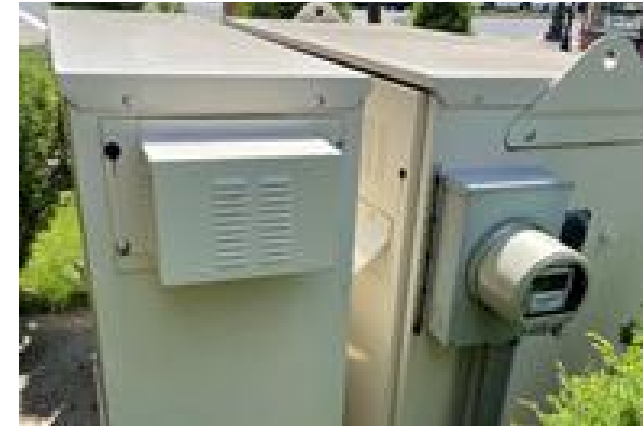
Pad-mounted transformer, west elevation

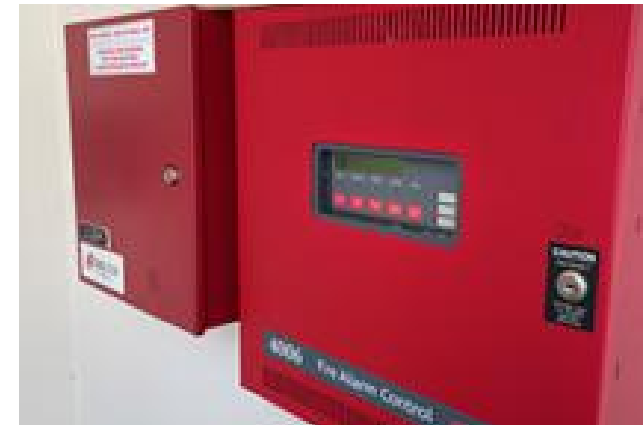
Simplex Fire Alarm System

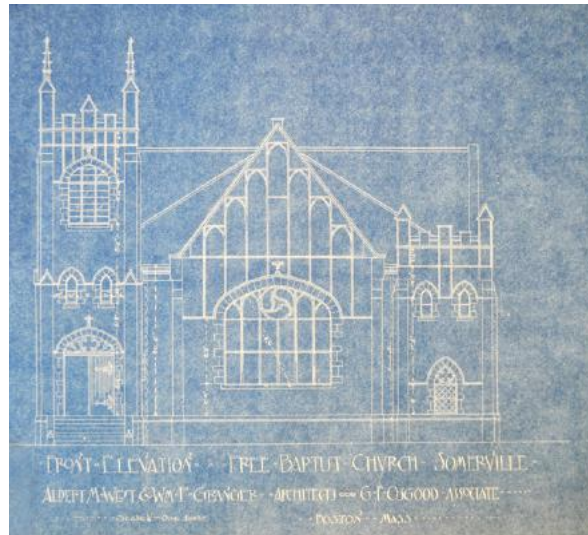
File Drawings, 1896 "Randall Memorial Free Baptist Church", Massachusetts Archives, B.1.25.2613; East (Front) Elevation, First Floor Plan

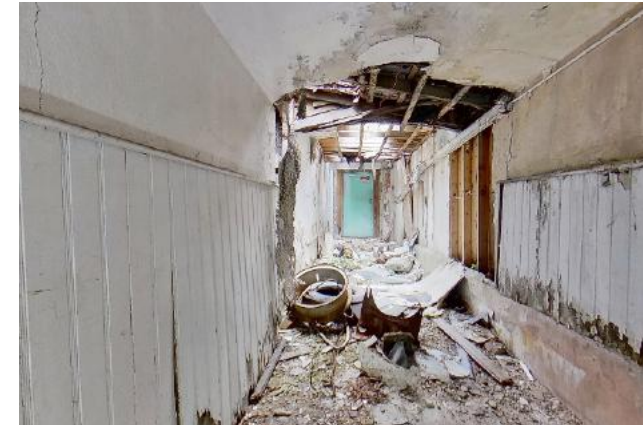
Collapsing "Office" wing constructed in south alley

The one-story "Office" wing running in the south alley is in very poor condition, having essentially collapsed.

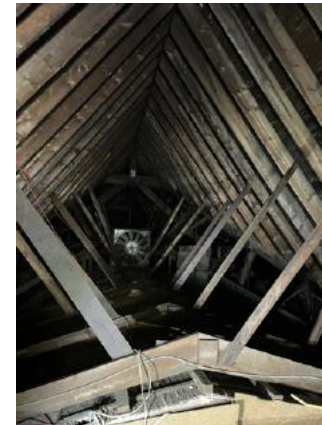
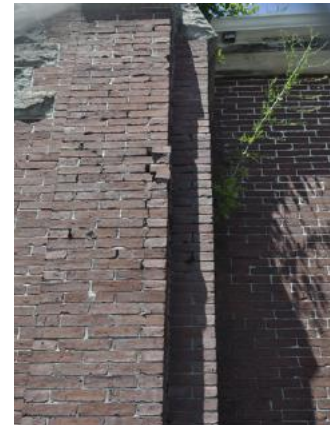
Main attic roof trusses; typical brick cracking and displacement on buttress

roof trusses above the ceiling also appear sound. It is expected that some number of the roof rafters would need require sistering or replacement.

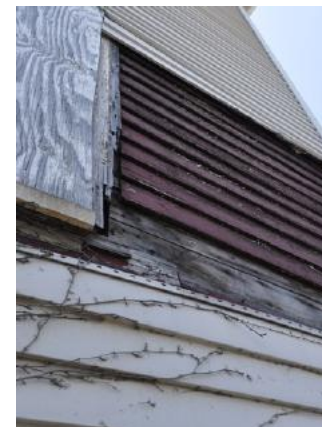
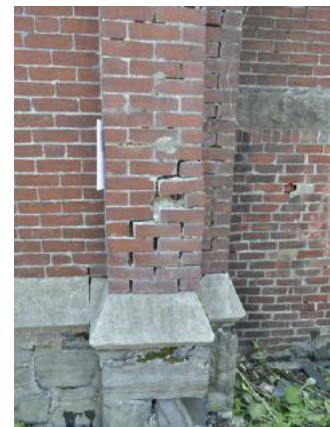
Wood clapboard siding beneath aluminum at west wing; brick displacement

The primary vertical structure of the wood-framed west wing is in poor condition. This wing consists of exterior wood bearing walls and wood clapboard covered in aluminum siding. Noticeable settlement on the center of the west facade indicates either a geotechnical issue at the foundation, or the presence of rot at the sill plate. Closer examination will take place in the next few weeks.

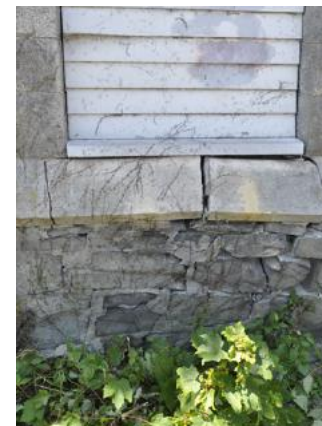
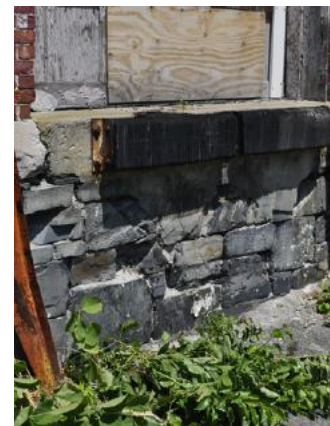
Cracked water table and random ashlar base displacement and loss of pointing; loading dock and garage door at center window, east elevation

The masonry facades consist of a random ashlar stone base, oversized limestone water table, and red brick masonry above. The ashlar and limestone water table are in poor condition, with significant areas of cracking and displacement. Some ashlar has partially collapsed. Both zones require 100% repointing with numerous locations of patching, rebuilding, and dutchman repair. All the brick masonry needs 100% repaint, with significant brick stitching in some areas, and brick unit replacement equivalent to 5% of all brick units. The three primary gables are clad with aluminum siding, making an assessment of the historic finish in these

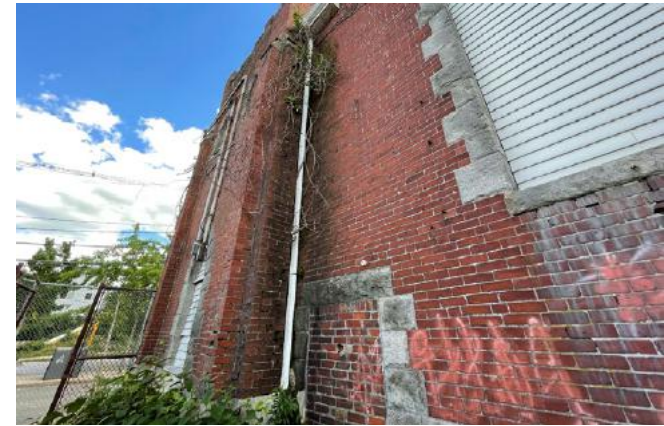
Detached aluminum downspout and bio-growth, north facade

The roofing is in poor condition across the board, with multiple campaigns of asphalt shingles exposed on the main roof. The main roof design results in a geometry that concentrates large areas of rain runoff to very short eave runs, two per facade. Tremendous water volume must pass through these pinch points to gutters and downspouts nestled behind masonry buttresses. The condition of the aluminum gutters and downspouts in these areas is poor, disconnected, or non-existent. The large amount of runoff in these locations is directly linked to biological growth and the extremely poor condition of the buttress masonry.

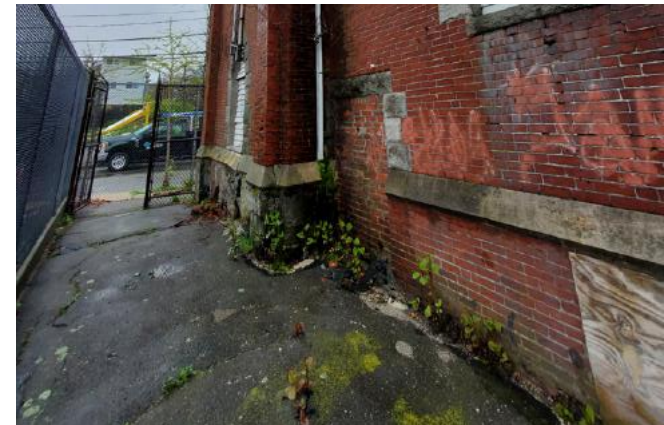
Severe weathering and displacement, brick and stone masonry at buttress

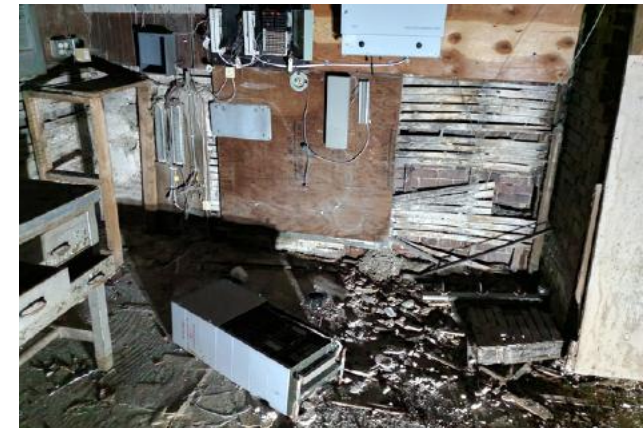
First Floor, northeast corner; electrical and telephone services and panels

Power has been disconnected from the building. The electrical service and distribution is beyond its useful service life. Equipment was inspected visually but was not evaluated for capacity during the site visit.

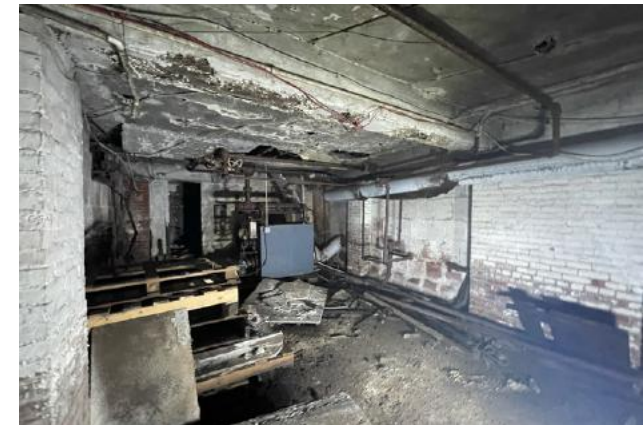
Basement with defunct boiler
