Community Services and Activities Master Plan

VOLUME I - FINAL REPORT

NOVEMBER 24, 2021

**BEYER
BLINDER
BELLE**

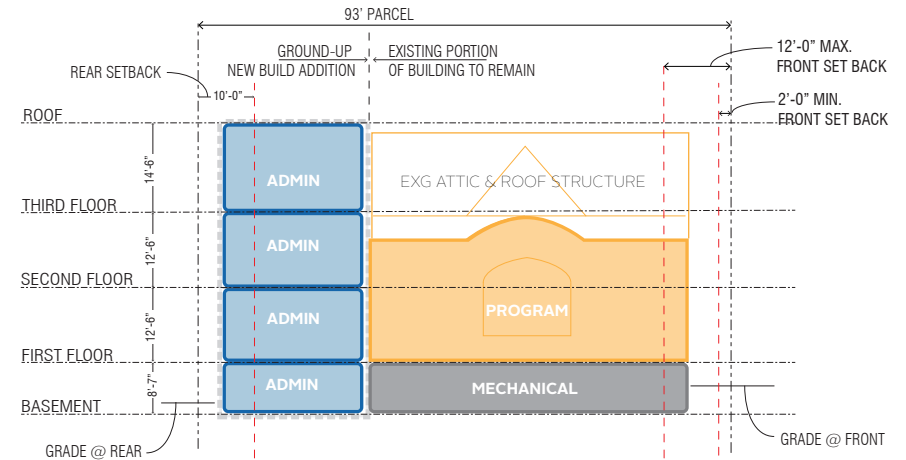
SECTION A

The study illustrated here was developed for the purposes of cost estimating and benchmarking an adaptive reuse rehabilitation scheme by the City in order to gain community and administrative space. As the poor structural condition of the wood-framed west wing likely necessitates its demolition, a three-story addition on the same footprint is proposed behind the existing masonry massing to remain. The primary historic structure would be renovated as a large, signature multipurpose space, while the new build at the rear would provide staff and support spaces. While dramatic, the multipurpose space would be relatively inflexible. It should be noted that this is a study and not a recommended scheme. Refer to the cost estimates for the likely level of investment required for rehabilitation. Also refer to the Technical Appendices for further information.

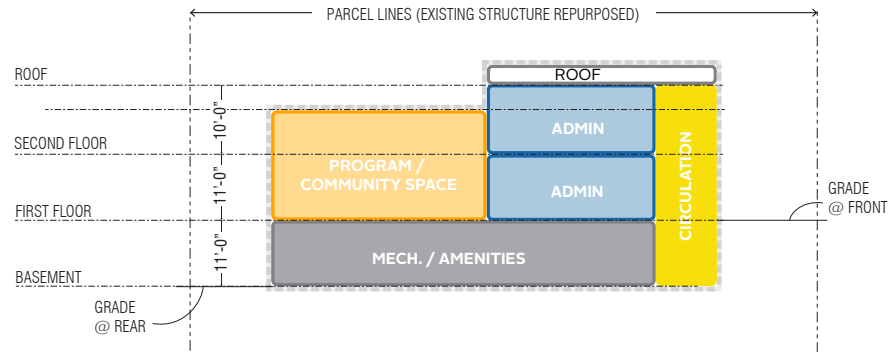
OPTION 1 - SECTION

Option 1 illustrates the possibility of utilizing the historic building for community program space alongside associated staff and support functions. A targeted administrative and city program use is not determined. Option 2 illustrates opportunities for use of the building as a residential redevelopment. The residential unit mix includes studio, 1, and 2 bedroom apartments with shared amenities in the building basement. If redeveloped under Option 2, the project could potentially be eligible for the Historic Preservation Tax Credit Program.
