**CITY OF SOMERVILLE, MASSACHUSETTS
COMMUNITY PRESERVATION COMMITTEE
FY20 FUNDING CYCLE
APPLICATION COVER PAGE**

PROJECT NAME: Addressable Fire Alarm System

PROJECT LOCATION: 277 Broadway Somerville, MA 02145

ONE SENTENCE DESCRIPTION OF PROJECT: The Elizabeth Peabody House is seeking funds to install an addressable fire alarm system in our historic building.

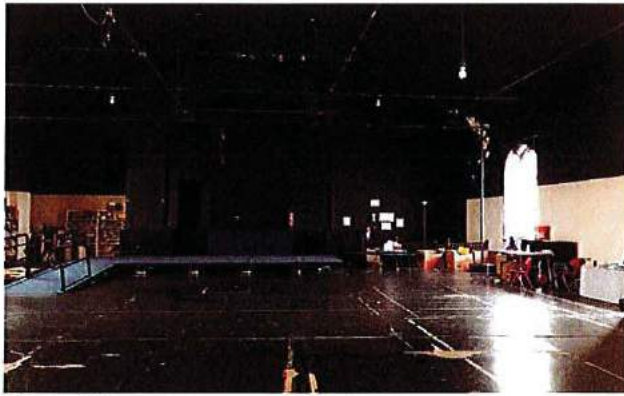
Photo #7

During the investigation it was noticed that there are various types and ages of the detectors. All detectors have a shelf life and should be routinely replaced as they age should be completely replaced not one at a time. By doing a wholesale replacement it ensures the proper protection throughout the building.

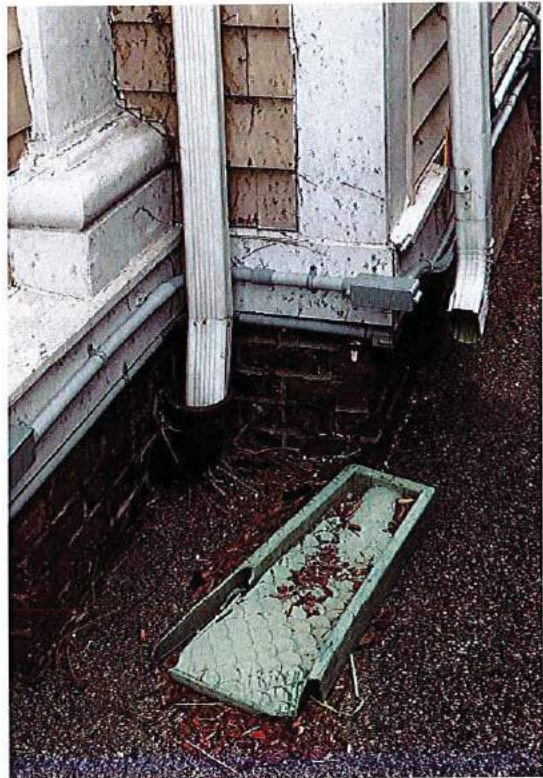
Some rain leaders do not reach grade. Of those that do, some downspouts are directed into storm drainage piping, and some are directed onto splash blocks pitching onto grade. Roof water run-off control should be improved to protect the walls and foundations, and also to eliminate ice build-up on the winter.

2 Downspouts at the southwest corner

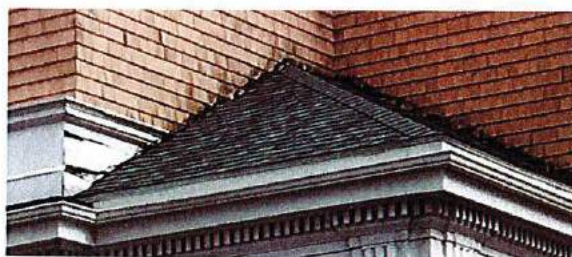
There appears to be active water infiltration where the low roof edges intersect the tower. This may be due to flashing not having been installed by the roofers, or other movement created by summer heat or winter ice. Damage from the water intrusion can be seen in the front stairs. See photos to the right.

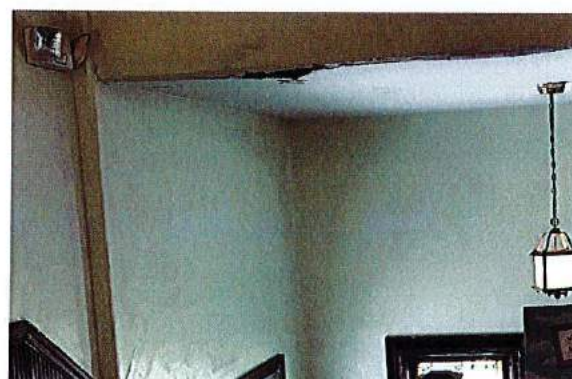
3 Roof-wall intersection and possible leak above the north stair.

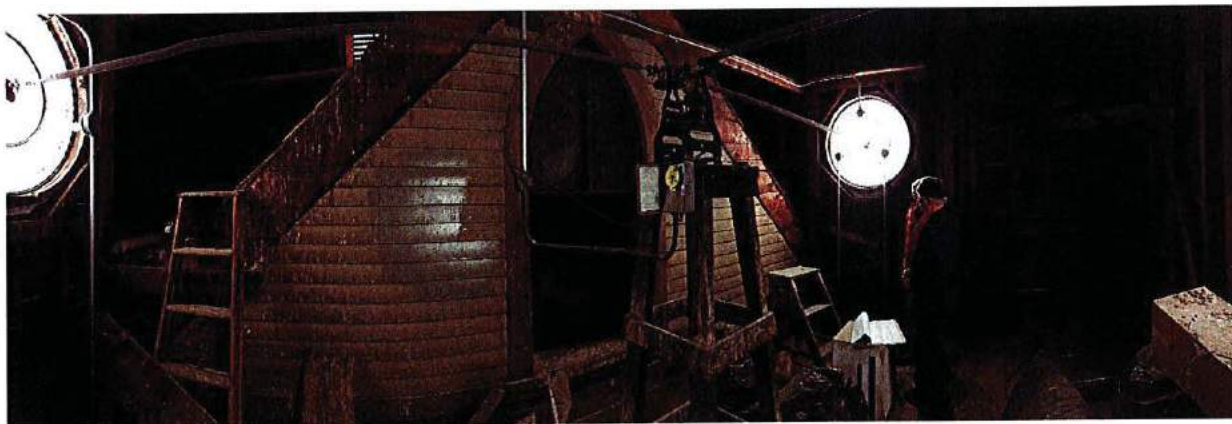
7 Panorama view of the interior of the clock tower showing the end gable of the original church. The geared mechanism to run the clocks is to the right of the ogee window. Note also the crossed-braced framing in the exterior walls.

- *Periodically monitor the tower to make sure that the hatch is closed and no birds get in.*
- *Dispose of the roofing waste stored in the tower.*
- *See also the structural report.*
