# City of Somerville

Community Services and Activities Master Plan

FINAL REPORT VOLUME II - ADDITIONAL APPENDICES

NOVEMBER 24, 2021

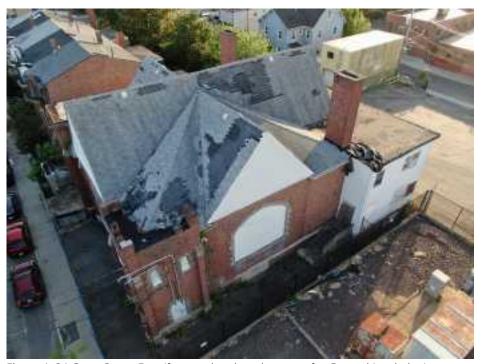
Figure 1. 24 Cross Street East (former church and storage for General Insulation)

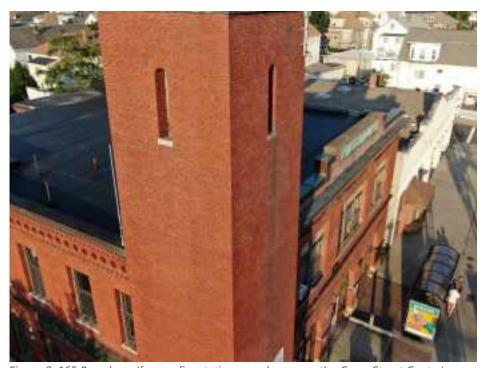
Figure 2. 165 Broadway (former fire station, now known as the Cross Street Center)

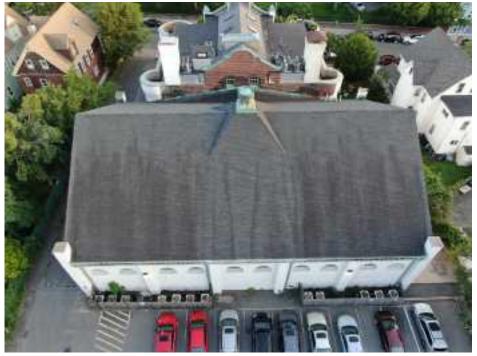
Figure 3. 191 Highland Avenue (Armory)

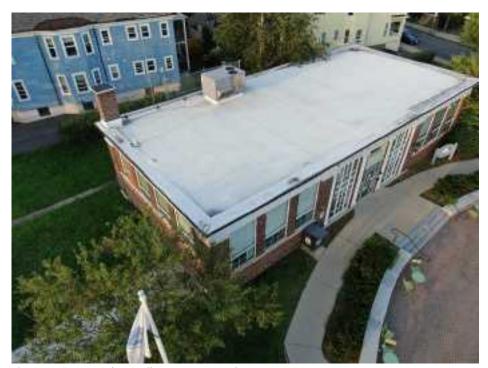
Figure 4. 115 Broadway (Library East Branch)

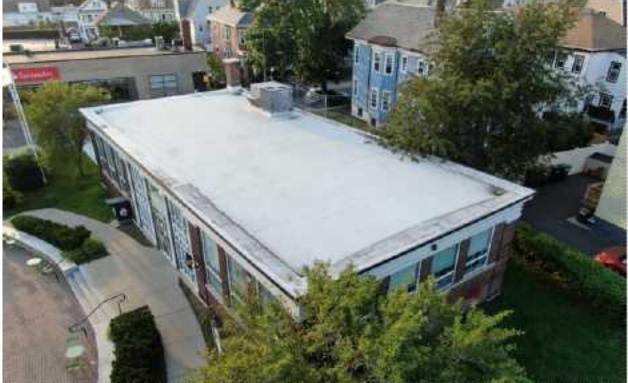
No thermal anomalies were noted at the Library. Refer to Figure 11 for overall photos of the roof.

Figure 11. Overall view of IR image (above) and visual light reference image (below)

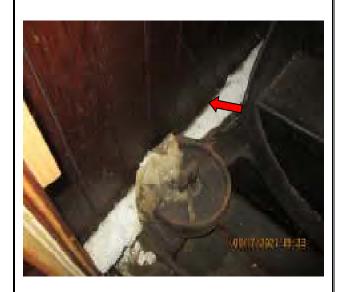
#### Photo 3

View of Asbestos-Containing Pipe Insulation, 1<sup>st</sup> Floor Rear Storage Room Closet & Rear Stairwell

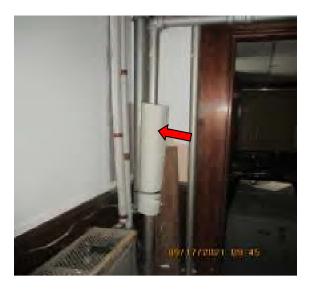
# Photo 4

Another View of Asbestos-Containing Pipe Insulation, 1st Floor Rear Stairwell

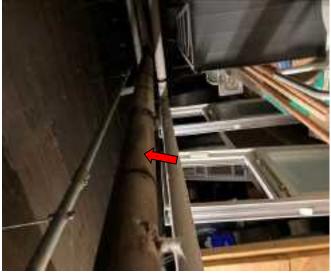
#### Photo 4

View of Asbestos-Containing Pipe/Fitting Insulation, Basement

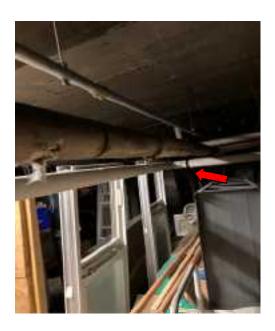
Photo 6

View of Presumed Asbestos-Containing Pipe Elbow Insulation
